City of Norman
ADA Self-Evaluation and Transition Plan
Building Cost Projection Summary
5/1/2018

Municipal Complex - Building A

Accessibility Evaluation

Inspection Date: 09/20/2017

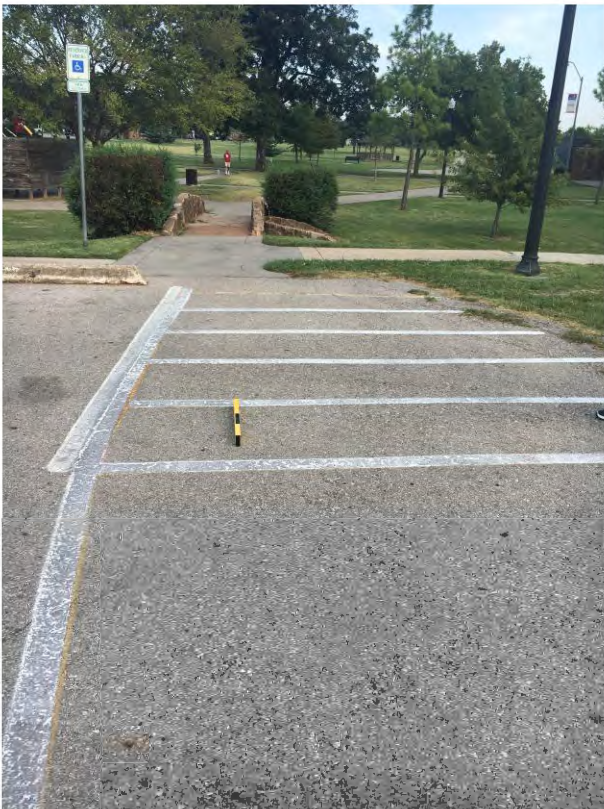
Finding: 1

The access aisle has a 2.6% running slope.

2010 ADAS Section 502.4

4 (High): Parking or exterior conditions (DOJ's level 1) – moderately out of compliance.

Modify paving to achieve slopes no greater than 2% in all directions.

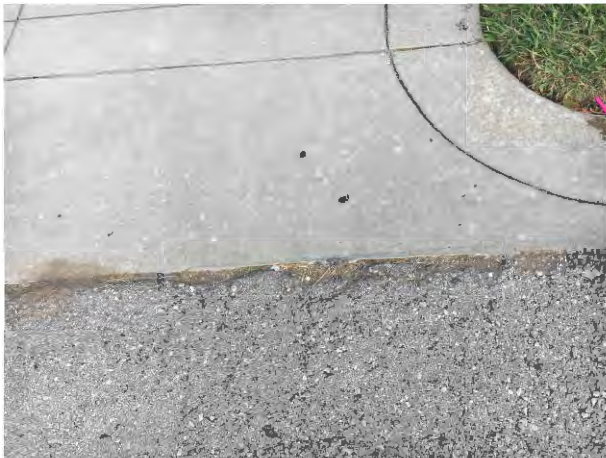
Finding: 2

The concrete expansion joint where the asphalt parking meets the paved sidewalk has a 1-1/2" gap.

2010 ADAS Section 302.3

6 (Medium): Access to goods and services (DOJ level 2) moderately out of compliance. Parking or exterior conditions (DOJ's level 1) – minimally out of compliance. Restrooms (DOJ level 3) – severely out of compliance.

Fill in the gap to create a smooth transition.

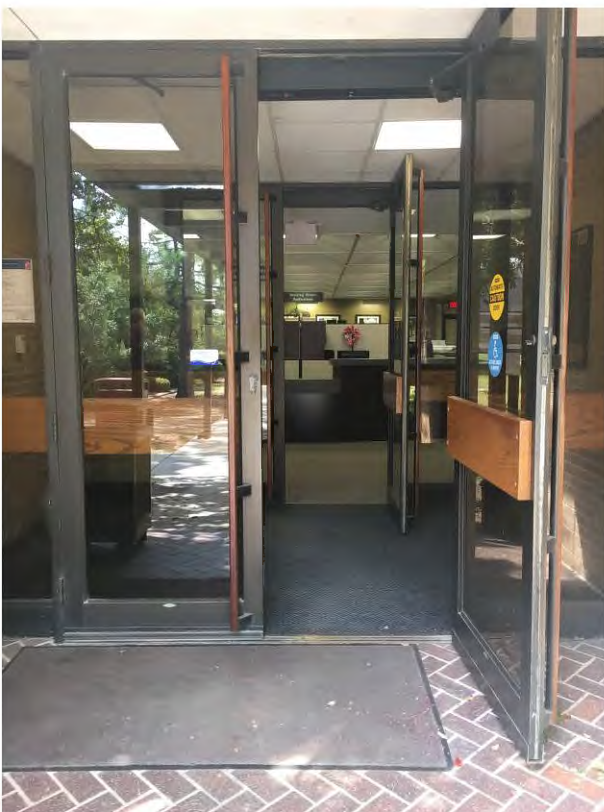
Finding: 3

3 (High): Element is more than twice the allowable requirement. No known complaint. AND (for exterior conditions) not near a hospital, school, transit stop, govt. bldg., or other pedestrian attractor.

Replace landing (7' deep x 11'-4" wide) to achieve slopes no greater than 2% in all directions.

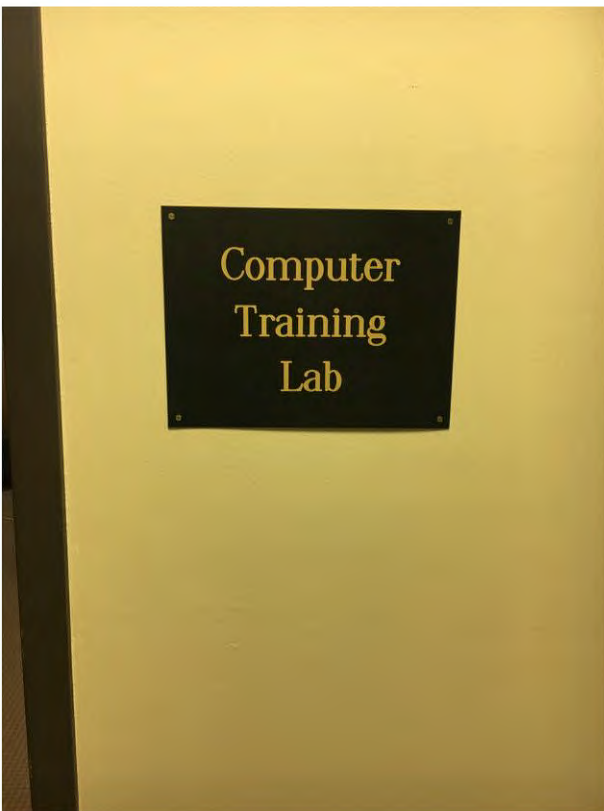
There are 5 room signs that are missing Braille and tactile characters.

Replace with signage that has Braille and tactile characters and mount signage on the latch side of the doors.
