City of Norman ADA Self-Evaluation and Transition Plan Park Cost Projection Summary 5/1/2018

Site Accessibility Evaluation

201 W Daws St Norman, OK 73069

Accessibility Evaluation

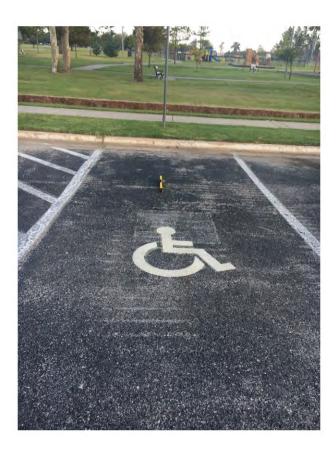
Finding: 1

The running slope of the right accessible parking stall is between 3.0% and 5.7%.

2010 ADAS Section 502.4

Modify paving to achieve slopes no greater than 2% in all directions.

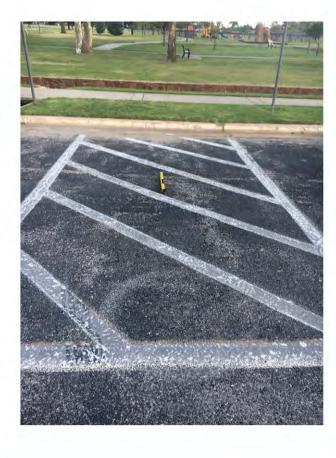
Finding: 2

The running slope of the access aisle (long dimension) exceeds 2%.

2010 ADAS Section 502.4

Modify Paving to achieve slopes no greater than 2% in all directions.

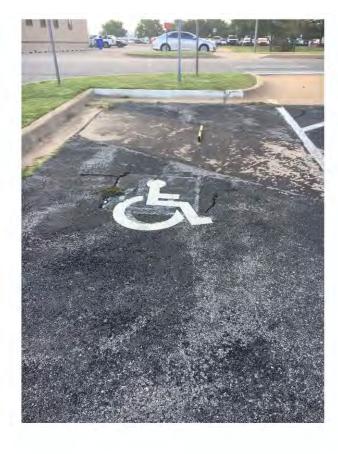
Finding: 3

The running slope on the left parking space facing Daws has a running slope of 4.8%. Additionally, the pavement is cracked and broken.

2010 ADAS Section 502.4

Modify paving to achieve slopes no greater than 2% in all directions.

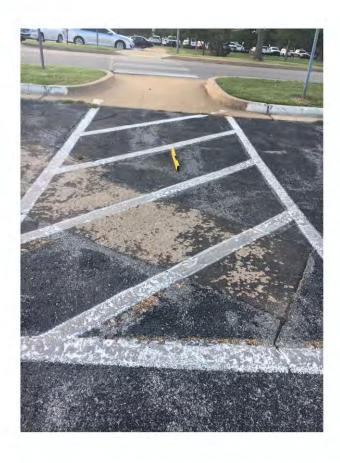
Finding: 4

The access aisle facing Daws has a 6.6% running slope.

2010 ADAS Section 502.4

Modify paving to achieve slopes no greater than 2% in all directions.

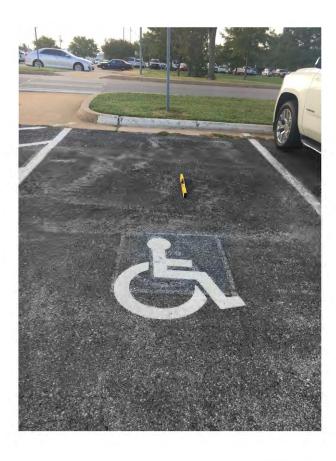
Finding: 5

The running slope on the right parking space facing Daws has a running slope of 7.5%.

2010 ADAS Section 502.4

Modify paving to achieve slopes no greater than 2% in all directions.

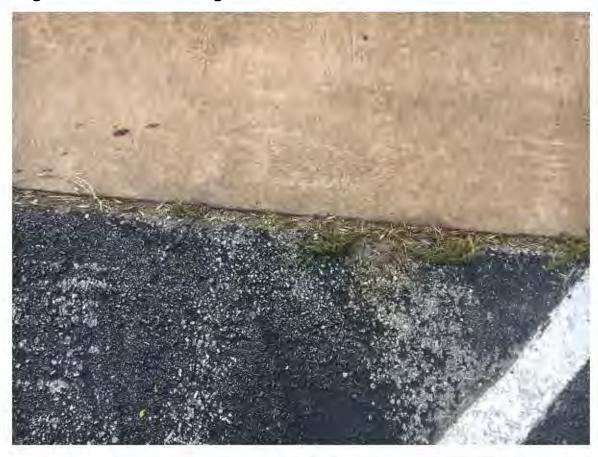
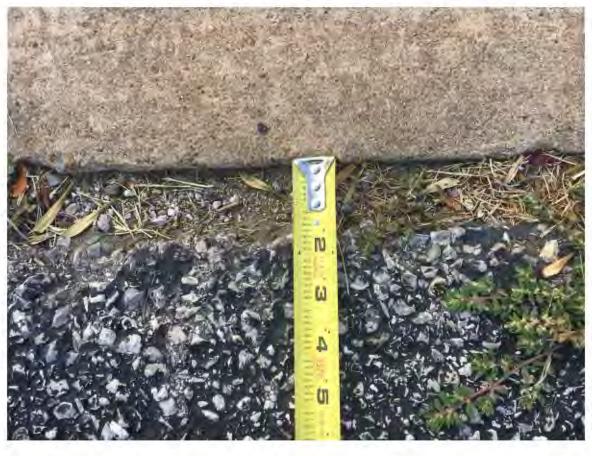
Finding #6 Additional Finding Photos

The concrete where the asphalt parking meets the curb ramp to cross Daws has a 1-1/2" gap.

2010 ADAS Section 302.3

Fill in gap to create a smooth transition.

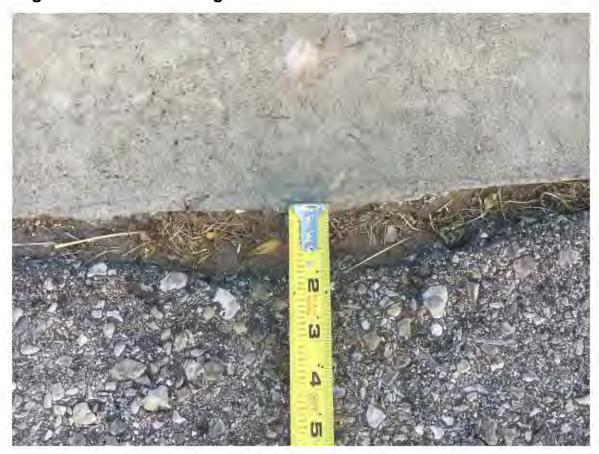
Finding #8 Additional Finding Photos

The concrete expansion joint where the asphalt parking meets the paved sidewalk has a 1-1/2" gap.

2010 ADAS Section 302.3

Fill in area to create a smooth transition.

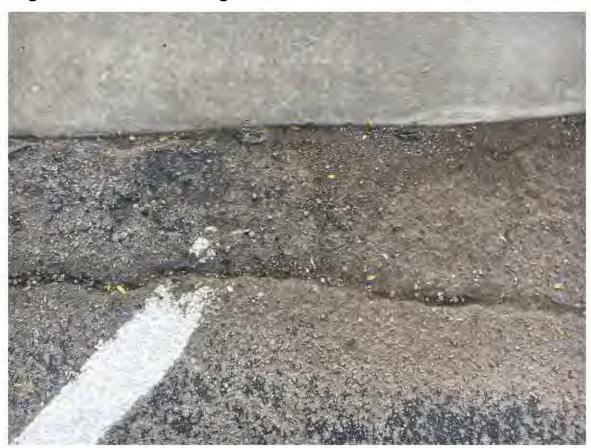
Finding #10 Additional Finding Photos

The path leading from the accessible parking to the sidewalk has cracked, uneven pavement.

2010 ADAS Section 303.3

Remove and replace concrete to achieve a smooth transition.

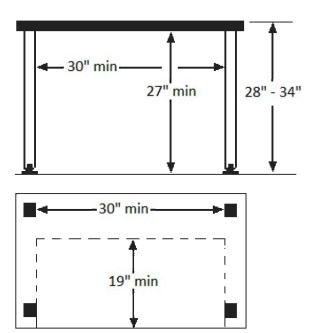
Finding: 11

There are no accessible picnic tables provided at the Andrew's Park Building.

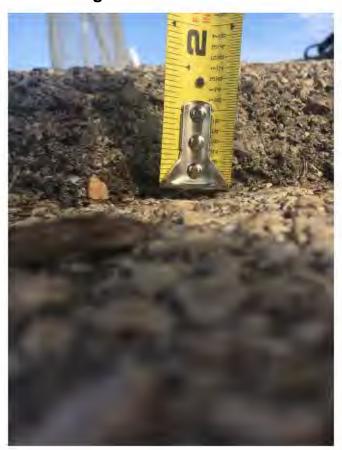
Finding #32 Additional Finding Photos

The left entrance into the basketball courts has broken, uneven pavement with a change in level of 1-5/8".

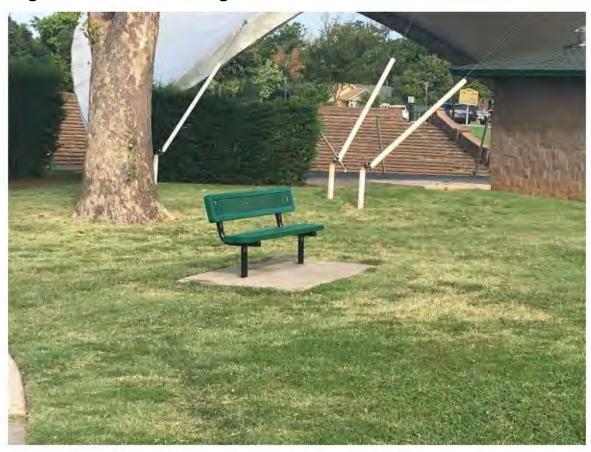
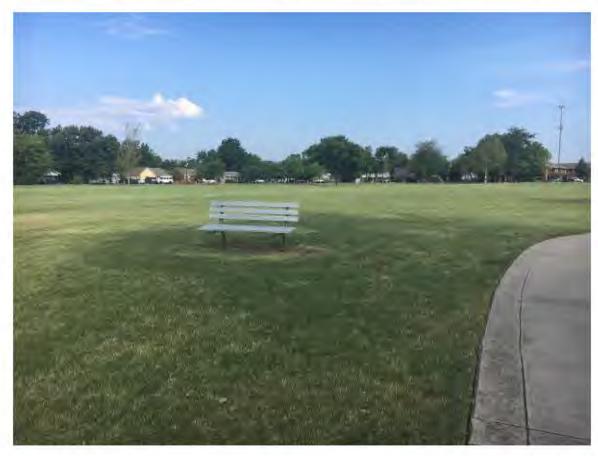
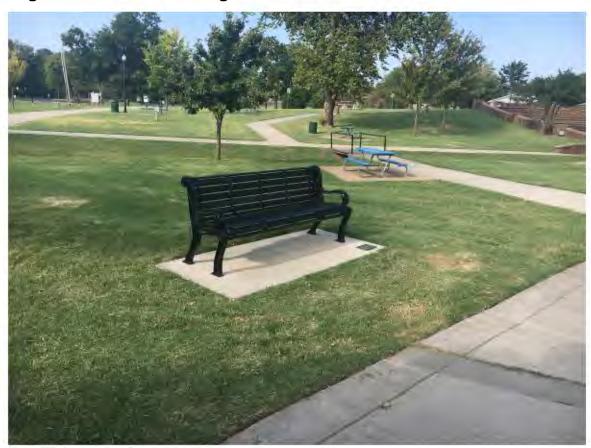
Finding #49 Additional Finding Photos

There is no accessible route to 4 of the benches throughout the park.

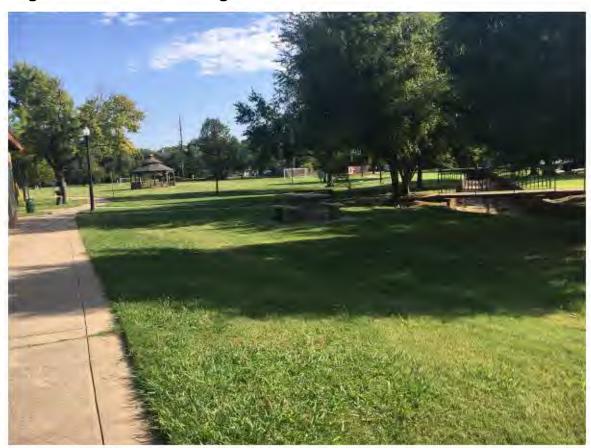
Finding #25 Additional Finding Photos

There are 2 stone picnic tables near the shelter, neither of which are accessible or have an accessible route leading to them.

Replace one of the picnic tables with an accessible unit and provide an accessible connecting route.
