Oklahoma Dept. of Transportation - Bridge Inspection Report

0918		<u>Structure</u> 14N3170E12		<u>Local ID:</u> 022A	<u>Suff. Rating:</u> 27.20	SD
Inspection Date:	10/10/22		Troy Travis			
Invoice No.:	HWL141022	Inspected With:	Colby Warden

County: CLEVELAND Division: 3 Facility Carried: 60th AVE NE Structure: 14N3170E1210005 NBI#: 09189 Feature Intersected: ROCK CREEK

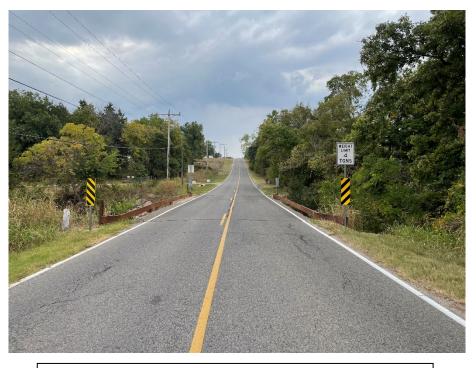
Roadway view with load posting of 4 tons, looking south

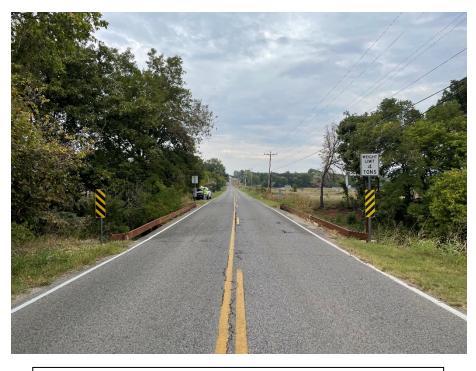
Roadway view with load posting of 4 tons, looking north

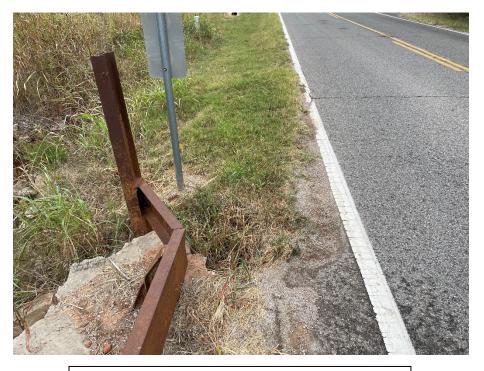
875 / 1	Masonry Wingwall	(EA)	4.00	0%	0.00	0%	0.00	75%	3.00	25%	1.00	,
PX - E	rosion at southeast corner of structu	ire is en	croaching onto	the road	way, as we	II as north	west ditch.					
890 / 4	Steel SIP Form	(LF)	1.00	0%	0.00	0%	0.00	100%	1.00	0%	0.00	
Forms	are rusty & have significant section	loss.										
958 / 4	Concrete Cracking SF	(EA)	1.00	0%	0.00	100%	1.00	0%	0.00	0%	0.00	
Cracks	s are moderate in size & density.											
963 / 4	Steel Section Loss SF	(EA)	1.00	0%	0.00	100%	1.00	0%	0.00	0%	0.00	
Minor	to moderate section loss & deep pitt	•		eam ends	, abutments	s, supplen	nentary caps	s & railing				
968 / 4	Erosion SF	(EA)	1.00	0%	0.00	100%	1.00	0%	0.00	0%	0.00	
PX - E	rosion at southeast corner of structu	ire is end	croaching onto	the road	way, as we	ll as north	west ditch.

Southeast ditch erosion, looking south

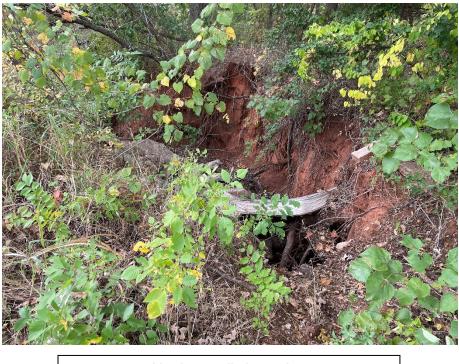
Northwest ditch erosion

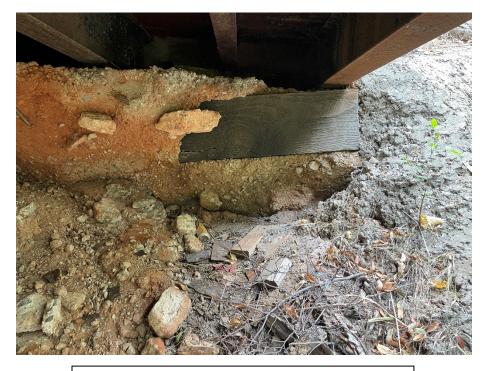
Erosion at west end of south abutment

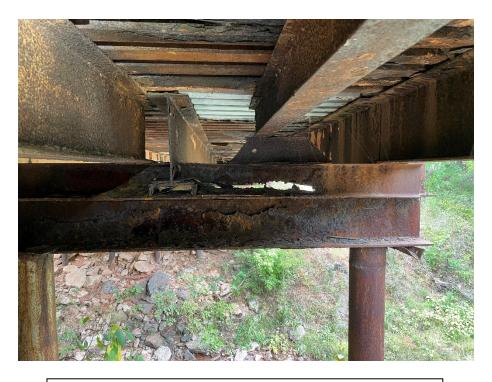
231 / 4	Steel Pier Cap	ft	52.00	0%	0.00	90%	47.00	10%	5.00	0%	0.00	
PX - B	ottom flanges have severe rust & de	ep pittin	g. Web of cap	s losing s	ection, sup	plementar	ry caps have	e advance	d corrosion	ı.		
918 / 4	St.(substr)Prot.Coat	(EA)	436.00	0%	0.00	0%	0.00	0%	0.00	100%	436.00	
Pa	aint system has failed.											
301 / 4	Pourable Joint Seal	ft	52.00	0%	0.00	100%	52.00	0%	0.00	0%	0.00	
Joints	are covered by asphalt overlay.				-							
330 / 4	Metal Bridge Railing	ft	131.00	0%	0.00	0%	0.00	100%	131.00	0%	0.00	
Rust is	s prevalent with minor pitting.Rail is t	oo low.										
919 / 4	St.(Rail) Prot. Coat	(SF)	286.00	0%	0.00	0%	0.00	0%	0.00	100%	286.00	
Pa	aint system has failed.											
865 / 4	St.Open Gird End(5Ft	(LF)	160.00	0%	0.00	0%	0.00	100%	160.00	0%	0.00	
PX-W	esternmost beam end has significar	t sectior	n loss.					I				
FX - B	ottom flanges have severe rust & de	ep pittin	g. Section los	s on bean	n ends at be	oth piers a	are approxim	ately 5%.

Section loss to secondary support on pier cap at east end

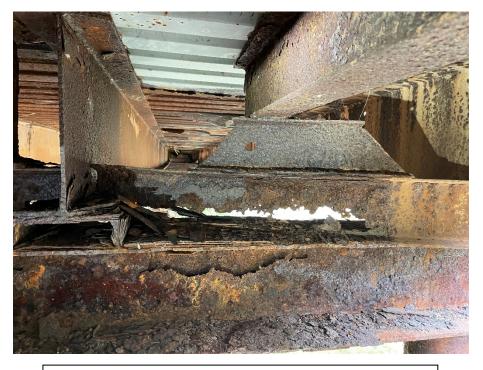
Section loss to secondary support on pier cap at east end

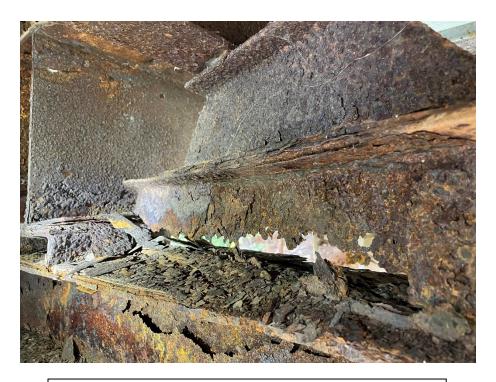
Section loss to secondary support on pier cap at east end

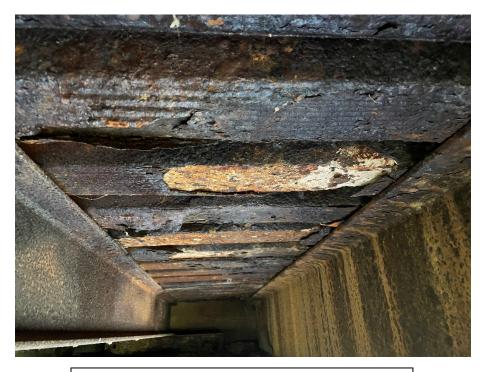
Typical view of SIP forms

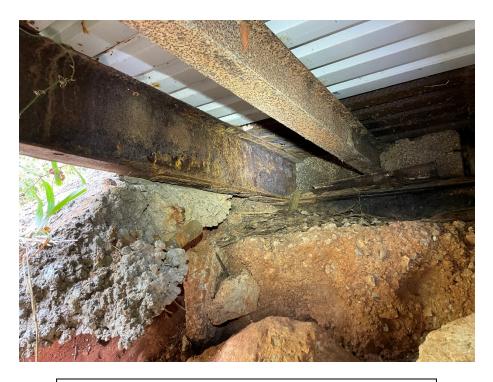
Loss of section to end of beam 1 at north abutment

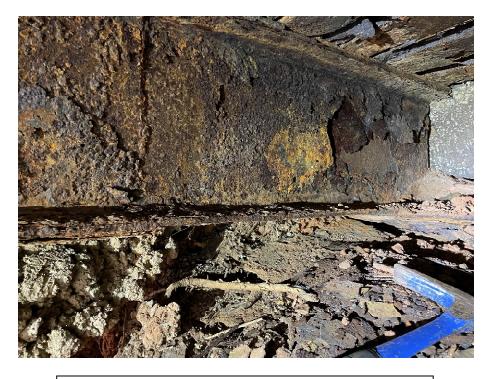
Loss of section to end of beam 1 at north abutment

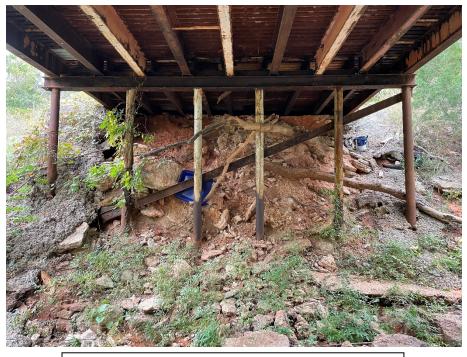
Typical condition of superstructure, looking at northside of pier 1
