# Bishop Creek Watershed Based Plan

In Partnership with:  
Friends of Bishop Creek  
Oklahoma Conservation Commission  
City of Norman

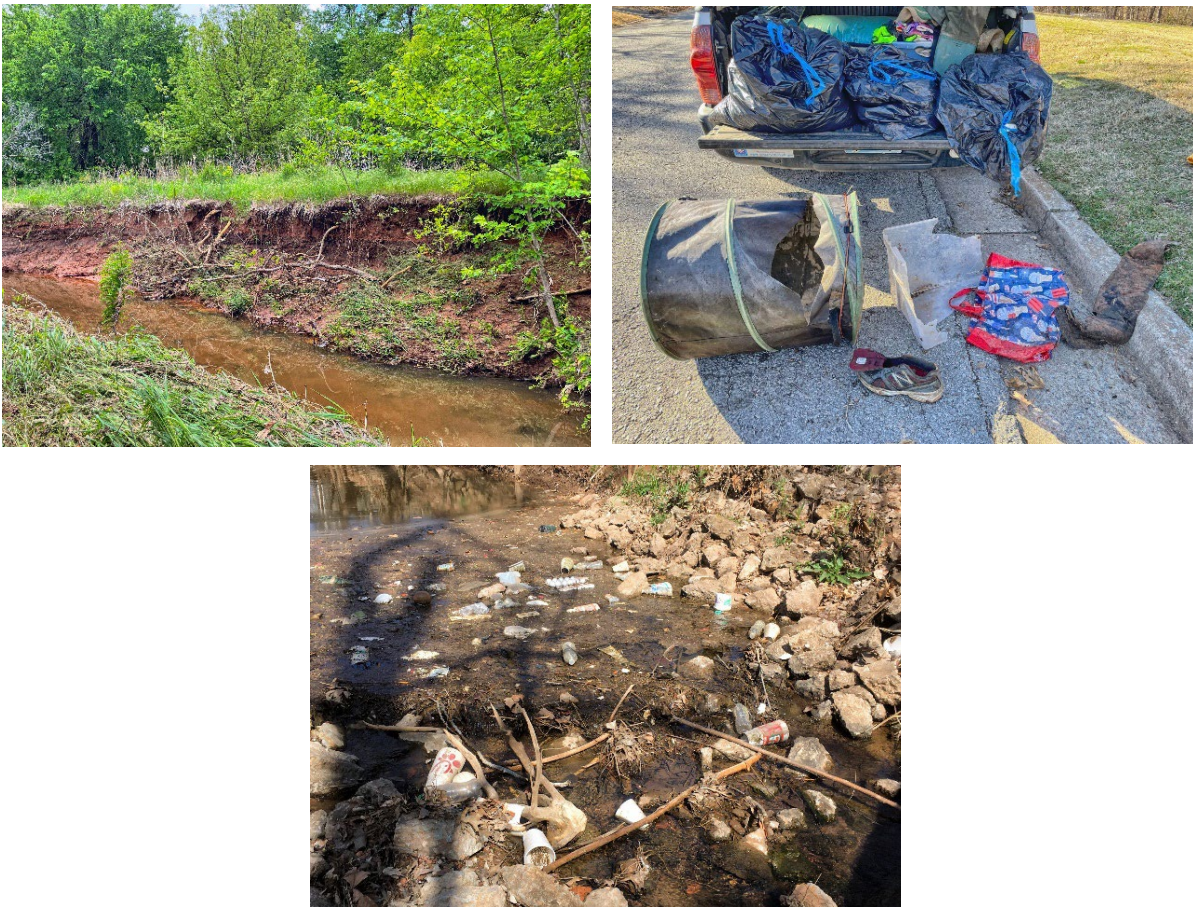
Figure 2 Clockwise from top left: a section of eroding bank; trash removed from Bishop Creek; trash in Bishop Creek. Photos by Karen Chapman
