City of Norman
ADA Self-Evaluation and Transition Plan
Signalized Intersection Cost Projection Summary
4/30/2018

Kimley-Horn and Associates, Inc. Priority: 2
Project Description for Signalized Intersection

Corridor : 24th Ave NW GPS ID: 1
Project Name: Intersection of W Robinson St and 24th Ave NW
City: Norman

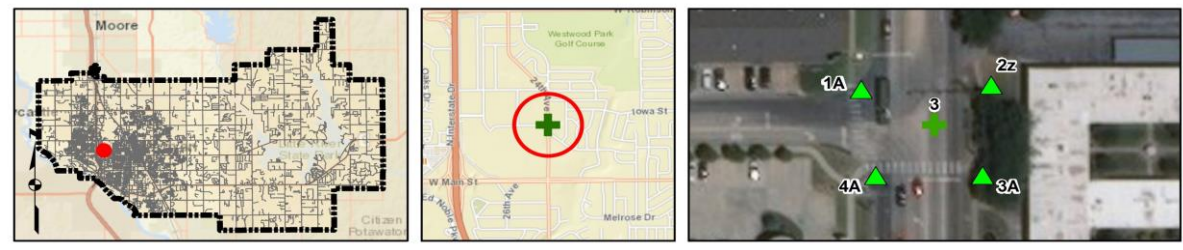
Project Location

Intersection Issues	Crosswalk				Possible Solutions
	N	E	S	W	
Path of travel pavement condition	N/A	N/A	Good	Good	
Path of travel running slope is greater than 5%	N/A	N/A			
Path of travel cross slope is greater than 5%	N/A	N/A			
Crosswalk width is less than 6'	N/A	N/A			
Crosswalk striping condition	N/A	N/A	Good	Good

Landing area does not exist and is needed					
Landing area is less than 5' x 5' or slopes greater than 2%	X		X	X	
Missing or no pedestrian push buttons					
Pedestrian push button is offset more than 5' from the nearest crosswalk edge				X	
Pedestrian push button offset more than 10' from curb face					
Pedestrian push button is not parallel to crosswalk					
Pedestrian push button height is greater than 48"					
Pedestrian push button diameter is not 2"					
Pedestrian push button sign does not exist					
Pedestrian push button sign is not MUTCD approved	X		X	X	
Clear floor space does not exist and is needed					
Clear floor space for pedestrian push button is less than 30" x 48" or has a slope greater than 2%	X		X	X	
Missing or no pedestrian signal heads					
Curb ramp transition onto roadway is greater than 0.25"	X		X		
Counter slope of the gutter or street at the foot of the curb ramp is greater than 5%

Ponding occurs at base of curb ramp			X

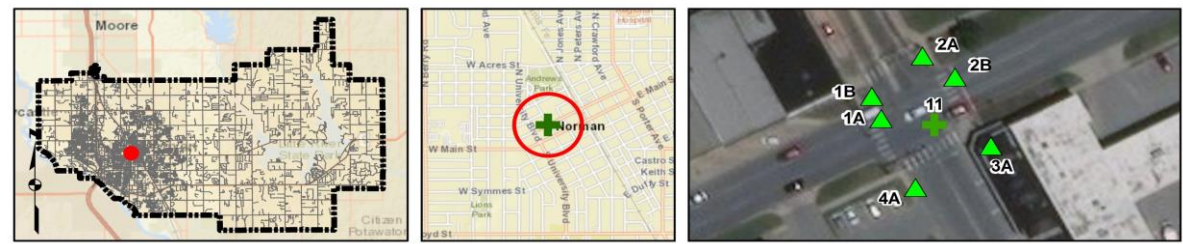
Project Location

Intersection Issues	Crosswalk				Possible Solutions
	N	E	S	W	
Path of travel pavement condition	Dangerous	Good	Good	Dangerous	Repave roadway and install crosswalk pavement markings
Path of travel running slope is greater than 5%					
Path of travel cross slope is greater than 5%					
Crosswalk width is less than 6'					
Crosswalk striping condition	Good	Good	Good	Good

Curb Ramp Issues	Curb Ramp ID ('Z' or 'I' in ramp label indicates no existing ramp)						Possible Solutions
	1A	1B	2A	2B	3A	4A	
Curb ramp does not exist and is needed							
Curb ramp does not land in crosswalk							
No 4' x 4' clear space at base of curb ramp							
Curb side is not 90° or has traversable adjacent surface							
Flare cross slope is greater than 10%	X	X	X	X			Remove and replace curb ramp
Curb ramp running slope is greater than 8.3%							
Blended transition running slope is greater than 5%							
Cut-thru ramp running slope is greater than 5%							
Curb ramp cross slope is greater than 2%				X			
Cut-thru ramp cross slope is greater than 5%							
Curb ramp width is less than 48"							
Cut-thru ramp width is less than 60"							
Permanent obstruction (>0.25") in curb ramp/landing/flares					X		
Temporary obstruction (>0.25") in curb ramp/landing/flares							
No textured surface at base of curb ramp	X	X	X	X	X	X	For intersection, commercial driveway, and park ramps, install color truncated domes

No color contrast at base of curb ramp	X	X	X	X	X	X	
Landing area does not exist and is needed						X	
Landing area is less than 5' x 5' or slopes greater than 2%							Install landing area
Missing or no pedestrian push buttons							Install push button pole and relocate pedestrian push buttons
Pedestrian push button is offset more than 5' from the nearest crosswalk edge							
Pedestrian push button offset more than 10' from curb face	X	X					
Pedestrian push button is not parallel to crosswalk							
Pedestrian push button height is greater than 48"							
Pedestrian push button diameter is not 2"							
Pedestrian push button sign does not exist							
Pedestrian push button sign is not MUTCD approved	X	X	X	X	X	X	Remove and replace pedestrian push button sign
Clear floor space does not exist and is needed						X	
Clear floor space for pedestrian push button is less than 30" x 48" or has a slope greater than 2%	X		X		X		Install clear floor space

Remove and replace clear floor space							
Missing or no pedestrian signal heads							
Curb ramp transition onto roadway is greater than 0.25"			X		X	X	Fix curb ramp transition
Counter slope of the gutter or street at the foot of the curb ramp is greater than 5%							
Ponding occurs at base of curb ramp

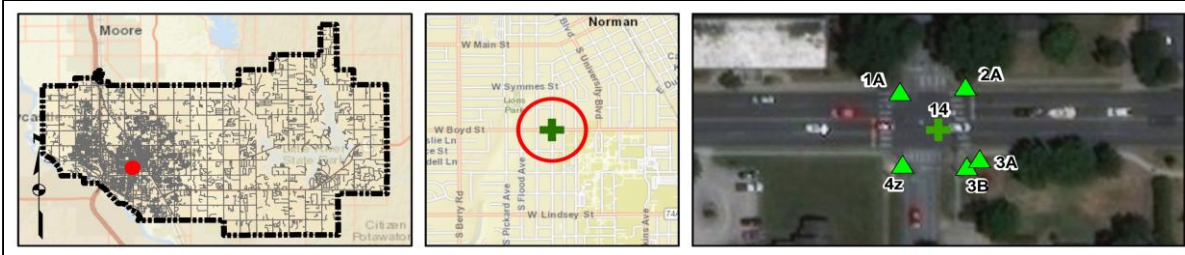
Project Location

Intersection Issues	Crosswalk				Possible Solutions
	N	E	S	W	
Path of travel pavement condition	Dangerous	Poor	Dangerous	Good	Repave roadway and install crosswalk pavement markings
Path of travel running slope is greater than 5%					
Path of travel cross slope is greater than 5%					
Crosswalk width is less than 6'					
Crosswalk striping condition	Worn	Good	Good	Good	Remove and replace crosswalk pavement markings

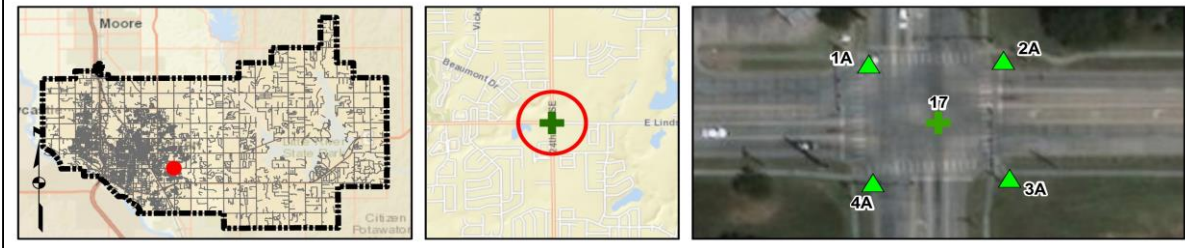
Project Location

Intersection Issues	Crosswalk				Possible Solutions
	N	E	S	W	
Path of travel pavement condition	Good	Good	Good	Good	
Path of travel running slope is greater than 5%					
Path of travel cross slope is greater than 5%					
Crosswalk width is less than 6'					
Crosswalk striping condition	Good	Good	Good	Good

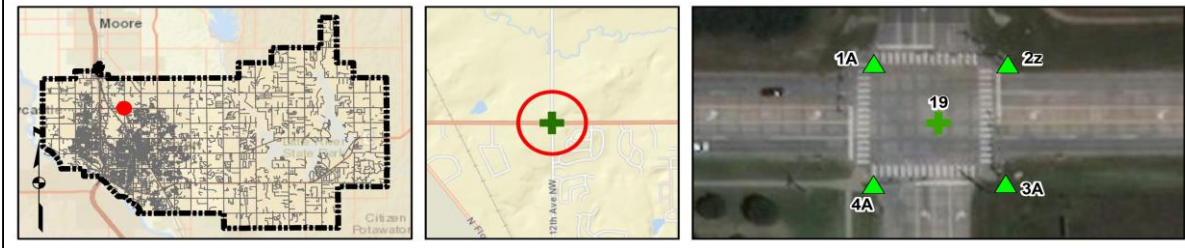
Project Location

Intersection Issues	Crosswalk				Possible Solutions
	N	E	S	W	
Path of travel pavement condition	Good	Poor	Good	Poor	Repave roadway and install crosswalk pavement markings
Path of travel running slope is greater than 5%					
Path of travel cross slope is greater than 5%					
Crosswalk width is less than 6'					
Crosswalk striping condition	Good	Good	Good	Good
