City of Norman
ADA Self-Evaluation and Transition Plan
Sidewalk Cost Projection Summary - Park Pedestrian Bridges
5/1/2018

Client: City of Norman Date: 5/1/18
 Program: ADA Self-Evaluation and Transition Plan Prepared By: MB
 KHA No.: 061298800 Checked By: CMP

Project Name: Andrews Park Bridge 1 (Lat. 35.22367; Long. -97.4464) GPS ID: 200
 Bridge Length: 25 ft
 City: Norman

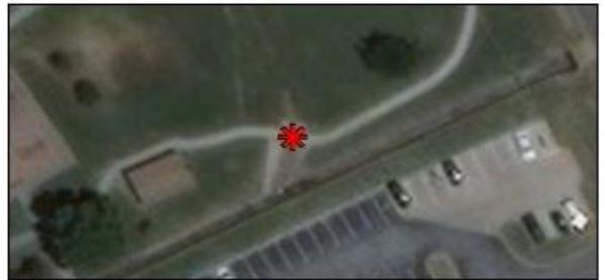
Field Observations

Bridge Issues	Recommendations
Bridge deck running slope is greater than 8.33%	
Clear width of bridge (or between handrails, if provided) is less than 36 inches	
Bridge deck cross slope is greater than 2.08%	
The rise of the bridge deck run is greater than 30 inches	
Vertical discontinuity greater than 1/4 inch in bridge deck	
The landing at the end of the bridge has a slope greater than 2.08%	
The landing width at the end of the bridge is less than bridge width	
The landing length at the end of the bridge is less than 60 inches	
Vertical discontinuity greater than 1/4 inch at sidewalk connection to bridge deck	
Joint width greater than 1/2 inch at sidewalk connection to bridge deck	
Handrail Issues	
Handrails are not provided where the bridge deck running slope is greater than 5% and rise is greater than 6 inches	
The surface of the bridge deck does not extend at least 1 foot beyond the inside face of the handrail OR a barrier is not provided that prevents the passage of a 4 inch diameter sphere, where any portion of the sphere is within 4 inches of the finish surface

Handrail is not provided on both sides of the bridge deck	
Handrail is not provided along the full length of the bridge deck	
The top of the gripping surface of handrail is less than 34 inches or greater than 38 inches above walking surface	
Clearance between handrail gripping surface and adjacent surface is less than 1.5 inches	
Handrail gripping surface is not continuous along length	
Handrail gripping surface is obstructed along top, side, or greater than 20% of bottom	
Where provided, horizontal projection is less than 1.5 inches below the bottom of the handrail gripping surface	
Handrail gripping surfaces with a circular cross section have an outside diameter less than 1.25 inches or greater than 2 inches	
Handrail gripping surfaces with a non-circular cross section have perimeter dimension of less than 4 inches or greater than 6.25 inches or cross-section dimension greater than 2.25 inches

Handrail gripping surface or adjacent surface has sharp or abrasive elements or non-rounded edges	
Handrails extend horizontally above the landing for less than 12 inches beyond the edge of the bridge deck	
Pavement leading up to bridge is elevated from ground surface	X Install additional handrail (see sidewalk reports)

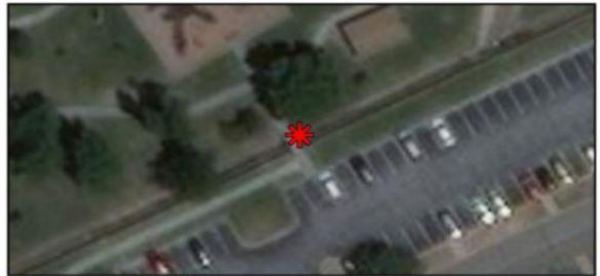
Field Observations

Bridge Issues	Recommendations
Bridge deck running slope is greater than 8.33%	
Clear width of bridge (or between handrails, if provided) is less than 36 inches	
Bridge deck cross slope is greater than 2.08%	
The rise of the bridge deck run is greater than 30 inches	
Vertical discontinuity greater than 1/4 inch in bridge deck	
The landing at the end of the bridge has a slope greater than 2.08%	
The landing width at the end of the bridge is less than bridge width	
The landing length at the end of the bridge is less than 60 inches	
Vertical discontinuity greater than 1/4 inch at sidewalk connection to bridge deck	
Joint width greater than 1/2 inch at sidewalk connection to bridge deck	
Handrail Issues	Recommendations
Handrails are not provided where the bridge deck running slope is greater than 5% and rise is greater than 6 inches	
The surface of the bridge deck does not extend at least 1 foot beyond the inside face of the handrail OR a barrier is not provided that prevents the passage of a 4 inch diameter sphere, where any portion of the sphere is within 4 inches of the finish surface

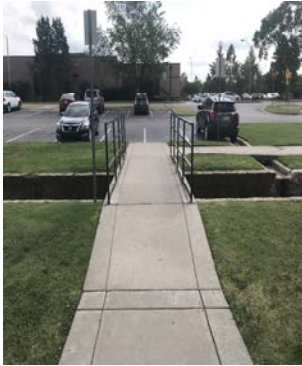
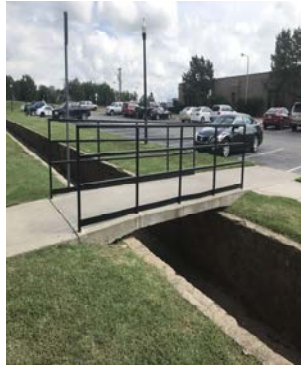
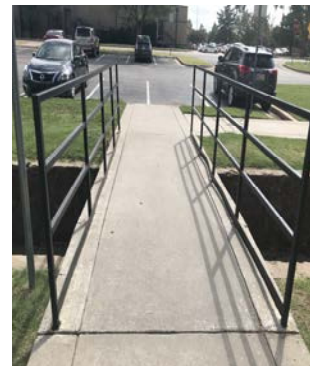
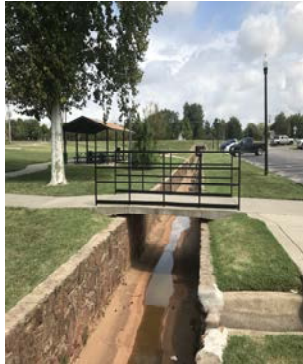
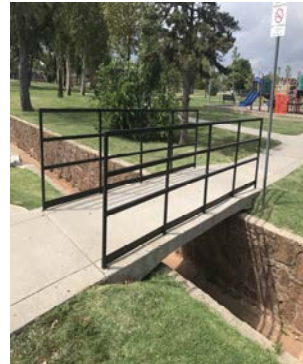
Handrail is not provided on both sides of the bridge deck	
Handrail is not provided along the full length of the bridge deck	
The top of the gripping surface of handrail is less than 34 inches or greater than 38 inches above walking surface	
Clearance between handrail gripping surface and adjacent surface is less than 1.5 inches	
Handrail gripping surface is not continuous along length	
Handrail gripping surface is obstructed along top, side, or greater than 20% of bottom	
Where provided, horizontal projection is less than 1.5 inches below the bottom of the handrail gripping surface	
Handrail gripping surfaces with a circular cross section have an outside diameter less than 1.25 inches or greater than 2 inches	
Handrail gripping surfaces with a non-circular cross section have perimeter dimension of less than 4 inches or greater than 6.25 inches or cross-section dimension greater than 2.25 inches

Handrail gripping surface or adjacent surface has sharp or abrasive elements or non-rounded edges	
Handrails extend horizontally above the landing for less than 12 inches beyond the edge of the bridge deck	
Pavement leading up to bridge is elevated from ground surface

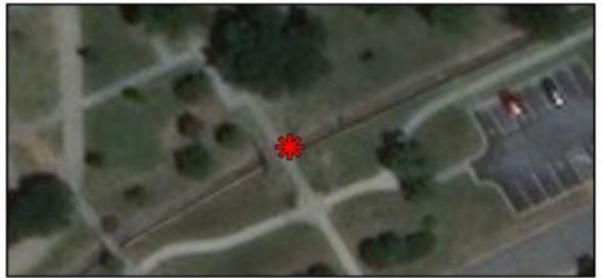
Field Observations

Bridge Issues	Recommendations
Bridge deck running slope is greater than 8.33%	
Clear width of bridge (or between handrails, if provided) is less than 36 inches	
Bridge deck cross slope is greater than 2.08%	
The rise of the bridge deck run is greater than 30 inches	
Vertical discontinuity greater than 1/4 inch in bridge deck	
The landing at the end of the bridge has a slope greater than 2.08%	
The landing width at the end of the bridge is less than bridge width	
The landing length at the end of the bridge is less than 60 inches	
Vertical discontinuity greater than 1/4 inch at sidewalk connection to bridge deck	
Joint width greater than 1/2 inch at sidewalk connection to bridge deck

Handrail Issues	Recommendations
Handrails are not provided where the bridge deck running slope is greater than 5% and rise is greater than 6 inches	
The surface of the bridge deck does not extend at least 1 foot beyond the inside face of the handrail OR a barrier is not provided that prevents the passage of a 4 inch diameter sphere, where any portion of the sphere is within 4 inches of the finish surface	
Handrail is not provided on both sides of the bridge deck	
Handrail is not provided along the full length of the bridge deck	
The top of the gripping surface of handrail is less than 34 inches or greater than 38 inches above walking surface	
Clearance between handrail gripping surface and adjacent surface is less than 1.5 inches	
Handrail gripping surface is not continuous along length	
Handrail gripping surface is obstructed along top, side, or greater than 20% of bottom	
Where provided, horizontal projection is less than 1.5 inches below the bottom of the handrail gripping surface

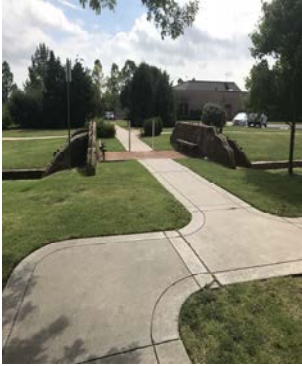
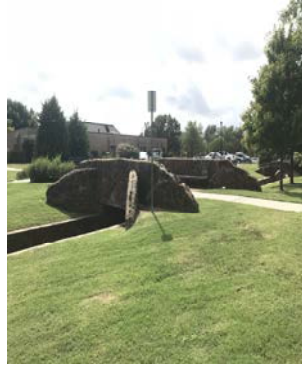
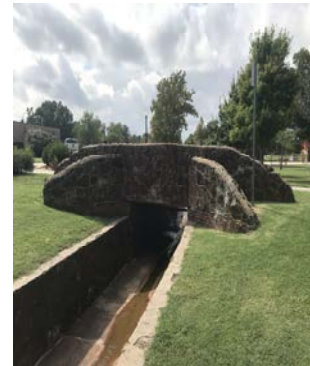
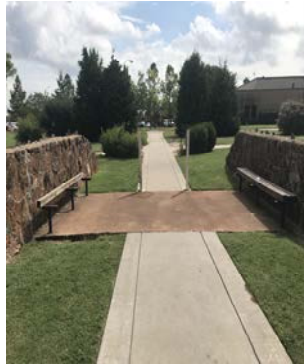
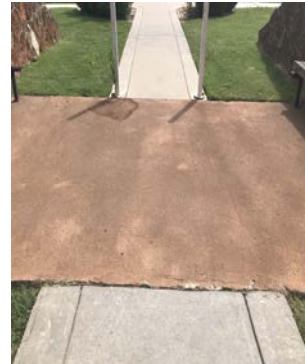
Handrail gripping surfaces with a circular cross section have an outside diameter less than 1.25 inches or greater than 2 inches	
Handrail gripping surfaces with a non-circular cross section have perimeter dimension of less than 4 inches or greater than 6.25 inches or cross-section dimension greater than 2.25 inches	
Handrail gripping surface or adjacent surface has sharp or abrasive elements or non-rounded edges	
Handrails extend horizontally above the landing for less than 12 inches beyond the edge of the bridge deck	
Pavement leading up to bridge is elevated from ground surface

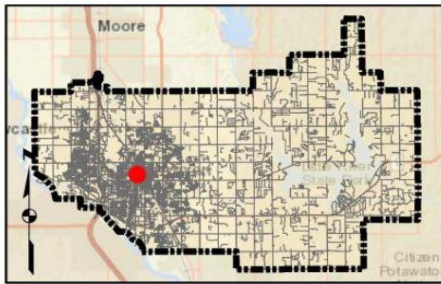
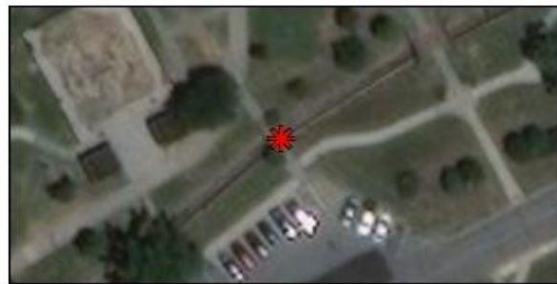
Field Observations

Bridge Issues	Recommendations
Bridge deck running slope is greater than 8.33%	
Clear width of bridge (or between handrails, if provided) is less than 36 inches	
Bridge deck cross slope is greater than 2.08%	X Replace bridge deck
The rise of the bridge deck run is greater than 30 inches	
Vertical discontinuity greater than 1/4 inch in bridge deck	X Replace bridge deck
The landing at the end of the bridge has a slope greater than 2.08%	
The landing width at the end of the bridge is less than bridge width	
The landing length at the end of the bridge is less than 60 inches	
Vertical discontinuity greater than 1/4 inch at sidewalk connection to bridge deck	
Joint width greater than 1/2 inch at sidewalk connection to bridge deck

Handrail Issues	Recommendations
Handrails are not provided where the bridge deck running slope is greater than 5% and rise is greater than 6 inches	
The surface of the bridge deck does not extend at least 1 foot beyond the inside face of the handrail OR a barrier is not provided that prevents the passage of a 4 inch diameter sphere, where any portion of the sphere is within 4 inches of the finish surface	
Handrail is not provided on both sides of the bridge deck	
Handrail is not provided along the full length of the bridge deck	
The top of the gripping surface of handrail is less than 34 inches or greater than 38 inches above walking surface	
Clearance between handrail gripping surface and adjacent surface is less than 1.5 inches	
Handrail gripping surface is not continuous along length	
Handrail gripping surface is obstructed along top or side	
Where provided, horizontal projection is less than 1.5 inches below the bottom of the handrail gripping surface

Item No.	Item Description	Quantity	Unit	Unit Price	Item Cost
1	Site Preparation, Access and Dewatering	1	LS	\$ 5,000.00	\$ 5,000.00
2	Bridge and Channel Wall Demolition	1	LS	\$ 2,500.00	\$ 2,500.00
3	Reinforced Concrete Bridge Abutment Footing	5	CY	\$ 750.00	\$ 3,750.00
4	Reinforced Concrete Bridge Abutment Backwall	6	CY	\$ 850.00	\$ 5,100.00
5	Repair Existing Masonry Walls at Abutment Connections	1	LS	\$ 1,500.00	\$ 1,500.00
6	Prefabricated Steel Ped Bridge	1	LS	\$ 10,000.00	\$ 10,000.00
7	Prefabricated Steel Handrail	30	LF	\$ 75.00	\$ 2,250.00
8	Sidewalk Replacement	30	SY	\$ 50.00	\$ 1,500.00
9	Irrigation Repairs	1	LS	\$ 1,500.00	\$ 1,500.00
10	Sod to Match Existing	150	SY	\$ 5.00	\$ 750.00

Notes: 1. All items and quantities are conceptual only and assume replacement of bridge. No design has been performed, and other solutions may exist to achieve compliance. 2. No costs have been included for traffic control for vehicles or pedestrians. 3. Assumes access is close and no special effort required to perform work.

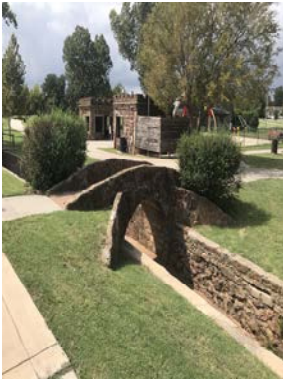
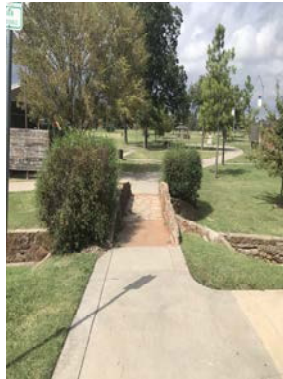
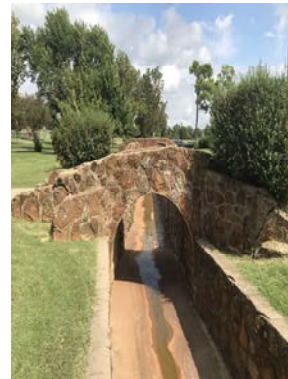
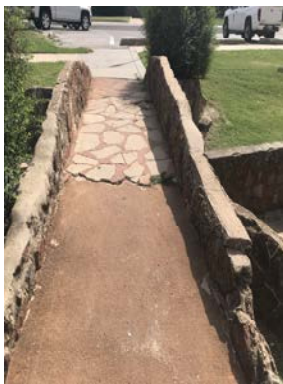
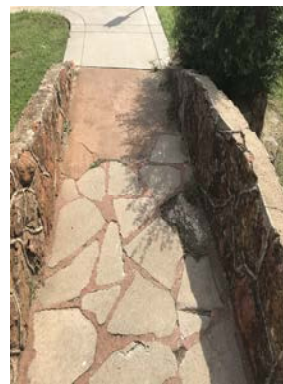
Handrail gripping surfaces with a non-circular cross section have perimeter dimension of less than 1.25 inches or greater than 2 inches	
Handrail gripping surfaces with a non-circular cross section have perimeter dimension of less than 4 inches or greater than 6.25 inches or cross-section dimension greater than 2.25 inches	
Handrail gripping surface or adjacent surface has sharp or abrasive elements or non-rounded edges	
Handrails extend horizontally above the landing for less than 12 inches beyond the edge of the bridge deck

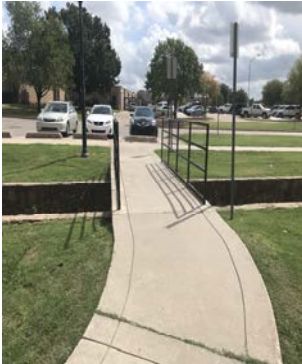
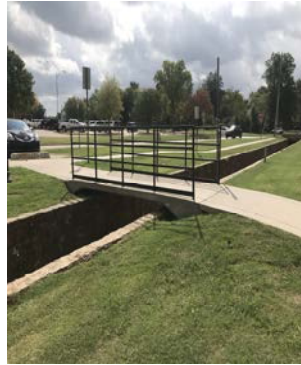
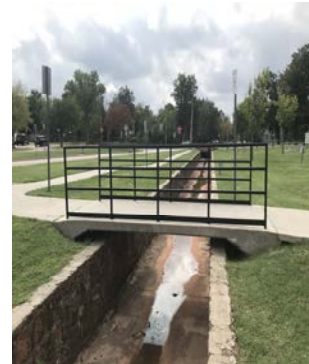
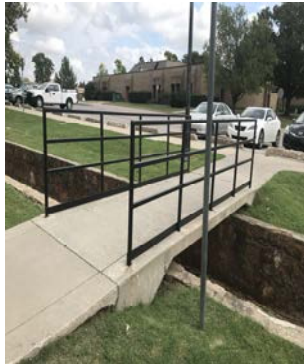
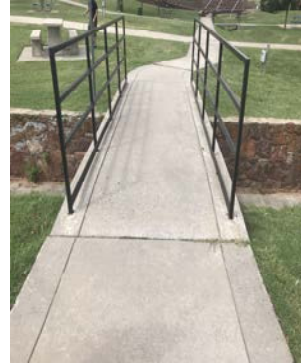
Field Observations

Bridge Issues	Recommendations
Bridge deck running slope is greater than 8.33%	
Clear width of bridge (or between handrails, if provided) is less than 36 inches	
Bridge deck cross slope is greater than 2.08%	
The rise of the bridge deck run is greater than 30 inches	
Vertical discontinuity greater than 1/4 inch in bridge deck	
The landing at the end of the bridge has a slope greater than 2.08%	
The landing width at the end of the bridge is less than bridge width	
The landing length at the end of the bridge is less than 60 inches	
Vertical discontinuity greater than 1/4 inch at sidewalk connection to bridge deck	
Joint width greater than 1/2 inch at sidewalk connection to bridge deck	
Handrail Issues	
Handrails are not provided where the bridge deck running slope is greater than 5% and rise is greater than 6 inches	
The surface of the bridge deck does not extend at least 1 foot beyond the inside face of the handrail OR a barrier is not provided that prevents the passage of a 4 inch diameter sphere, where any portion of the sphere is within 4 inches of the finish surface

Handrail is not provided on both sides of the bridge deck	
Handrail is not provided along the full length of the bridge deck	
The top of the gripping surface of handrail is less than 34 inches or greater than 38 inches above walking surface	
Clearance between handrail gripping surface and adjacent surface is less than 1.5 inches	
Handrail gripping surface is not continuous along length	
Handrail gripping surface is obstructed along top, side, or greater than 20% of bottom	
Where provided, horizontal projection is less than 1.5 inches below the bottom of the handrail gripping surface	
Handrail gripping surfaces with a circular cross section have an outside diameter less than 1.25 inches or greater than 2 inches	
Handrail gripping surfaces with a non-circular cross section have perimeter dimension of less than 4 inches or greater than 6.25 inches or cross-section dimension greater than 2.25 inches

Handrail gripping surface or adjacent surface has sharp or abrasive elements or non-rounded edges	
Handrails extend horizontally above the landing for less than 12 inches beyond the edge of the bridge deck	
Pavement leading up to bridge is elevated from ground surface	X Install additional handrail (see sidewalk reports)

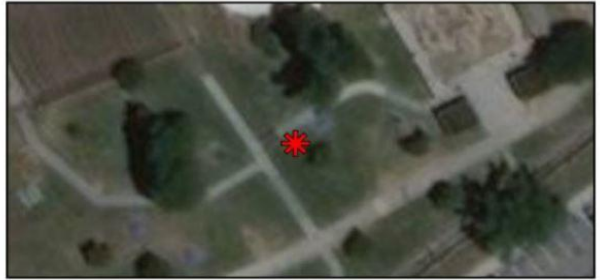
Field Observations

Bridge Issues	Recommendations
Bridge deck running slope is greater than 8.33%	
Clear width of bridge (or between handrails, if provided) is less than 36 inches	
Bridge deck cross slope is greater than 2.08%	
The rise of the bridge deck run is greater than 30 inches	
Vertical discontinuity greater than 1/4 inch in bridge deck	
The landing at the end of the bridge has a slope greater than 2.08%	
The landing width at the end of the bridge is less than bridge width	
The landing length at the end of the bridge is less than 60 inches	
Vertical discontinuity greater than 1/4 inch at sidewalk connection to bridge deck	
Joint width greater than 1/2 inch at sidewalk connection to bridge deck	
Handrail Issues	Recommendations
Handrails are not provided where the bridge deck running slope is greater than 5% and rise is greater than 6 inches	
The surface of the bridge deck does not extend at least 1 foot beyond the inside face of the handrail OR a barrier is not provided that prevents the passage of a 4 inch diameter sphere, where any portion of the sphere is within 4 inches of the finish surface

Handrail is not provided on both sides of the bridge deck	
Handrail is not provided along the full length of the bridge deck	
The top of the gripping surface of handrail is less than 34 inches or greater than 38 inches above walking surface	X Remove and replace handrail
Clearance between handrail gripping surface and adjacent surface is less than 1.5 inches	
Handrail gripping surface is not continuous along length	
Handrail gripping surface is obstructed along top, side, or greater than 20% of bottom	
Where provided, horizontal projection is less than 1.5 inches below the bottom of the handrail gripping surface	
Handrail gripping surfaces with a circular cross section have an outside diameter less than 1.25 inches or greater than 2 inches	
Handrail gripping surfaces with a non-circular cross section have perimeter dimension of less than 4 inches or greater than 6.25 inches or cross-section dimension greater than 2.25 inches

Item No.	Item Description	Quantity	Unit	Unit Price	Item Cost
1	Coffer Dam and Dewatering	0	LS	\$ 20,000.00	\$ -
2	Weir Demolition	0	LS	\$ 20,000.00	\$ -
3	24" Reinforced Concrete Piers	0	LF	\$ 150.00	\$ -
4	Reinforced Concrete Weir	0	CY	\$ 600.00	\$ -
5	Reinforced Concrete Riprap	0	SY	\$ 30.00	\$ -
6	18" Rock Riprap	0	CY	\$ 120.00	\$ -
7	Sawcut Vertical Discontinuity	0	EA	\$ 150.00	\$ -
8	Repair Pitting Concrete	0	EA	\$ 150.00	\$ -
9	Concrete Trail Replacement	0	SY	\$ 30.00	\$ -
10	Bridge and Approach Railing	2	LS	\$ 3,000.00	\$ 6,000.00
11	Bridge Abutments	0	EA	\$ 30,000.00	\$ -
12	Bridge Approach Paving	0	SY	\$ 75.00	\$ -
13	Bridge Demolition	0	LS	\$ 30,000.00	\$ -
14	Set New Ped Bridge	0	LS	\$ 75,000.00	\$ -
				Subtotal:	\$ 6,000.00
				Engineering: (% +/-)	15% \$ 1,000.00
				Contingency: (% +/-)	30% \$ 2,000.00
				Estimated Project Cost:	\$ 9,000.00

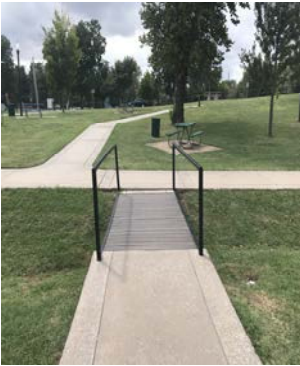
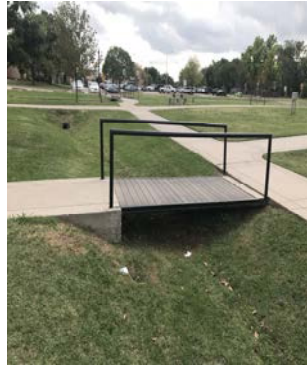
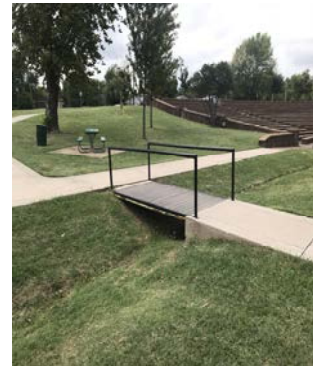
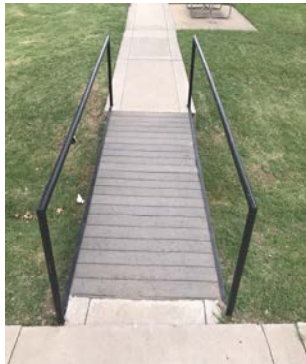
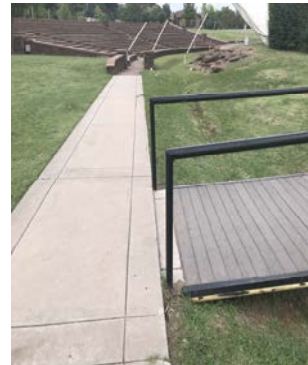
Handrail gripping surface or adjacent surface has sharp or abrasive elements or non-rounded edges	
Handrails extend horizontally above the landing for less than 12 inches beyond the edge of the bridge deck	
Pavement leading up to bridge is elevated from ground surface	X Install additional handrail (see sidewalk reports)

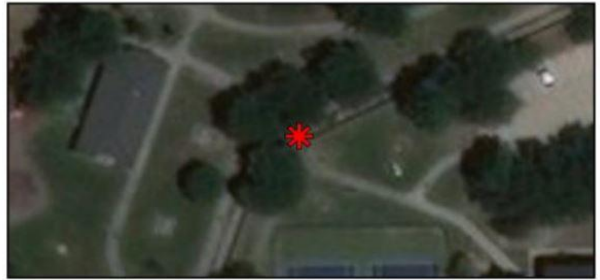
Field Observations

Bridge Issues	Recommendations
Bridge deck running slope is greater than 8.33%	
Clear width of bridge (or between handrails, if provided) is less than 36 inches	
Bridge deck cross slope is greater than 2.08%	
The rise of the bridge deck run is greater than 30 inches	
Vertical discontinuity greater than 1/4 inch in bridge deck	
The landing at the end of the bridge has a slope greater than 2.08%	
The landing width at the end of the bridge is less than bridge width	
The landing length at the end of the bridge is less than 60 inches	
Vertical discontinuity greater than 1/4 inch at sidewalk connection to bridge deck	
Joint width greater than 1/2 inch at sidewalk connection to bridge deck	
Handrail Issues	Recommendations
Handrails are not provided where the bridge deck running slope is greater than 5% and rise is greater than 6 inches	
The surface of the bridge deck does not extend at least 1 foot beyond the inside face of the handrail OR a barrier is not provided that prevents the passage of a 4 inch diameter sphere, where any portion of the sphere is within 4 inches of the finish surface

Item No.	Item Description	Quantity	Unit	Unit Price	Item Cost
1	Coffer Dam and Dewatering	0	LS	\$ 20,000.00	\$ -
2	Weir Demolition	0	LS	\$ 20,000.00	\$ -
3	24" Reinforced Concrete Piers	0	LF	\$ 150.00	\$ -
4	Reinforced Concrete Weir	0	CY	\$ 600.00	\$ -
5	Reinforced Concrete Riprap	0	SY	\$ 30.00	\$ -
6	18" Rock Riprap	0	CY	\$ 120.00	\$ -
7	Sawcut Vertical Discontinuity	0	EA	\$ 150.00	\$ -
8	Repair Pitting Concrete	0	EA	\$ 150.00	\$ -
9	Concrete Trail Replacement	0	SY	\$ 30.00	\$ -
10	Bridge and Approach Railing	2	LS	\$ 3,000.00	\$ 6,000.00
11	Bridge Abutments	0	EA	\$ 30,000.00	\$ -
12	Bridge Approach Paving	0	SY	\$ 75.00	\$ -
13	Bridge Demolition	0	LS	\$ 30,000.00	\$ -
14	Set New Ped Bridge	0	LS	\$ 75,000.00	\$ -
				Subtotal:	\$ 6,000.00
				Engineering: (% +/-)	15% \$ 1,000.00
				Contingency: (% +/-)	30% \$ 2,000.00
				Estimated Project Cost:	\$ 9,000.00

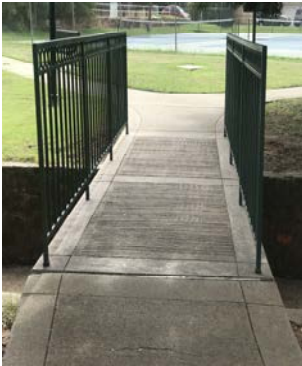
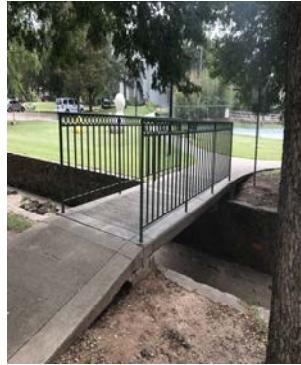
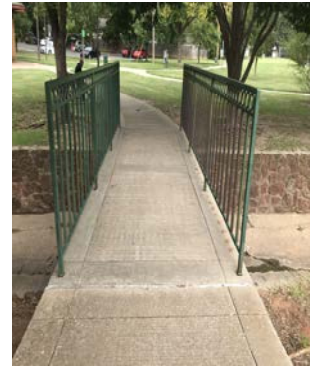
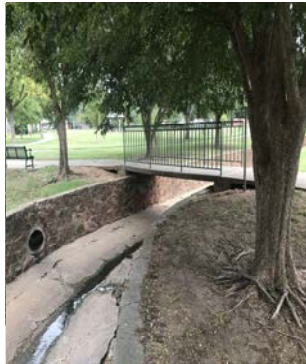
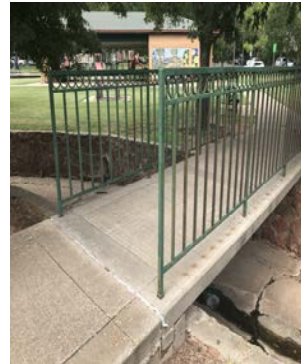
Handrail is not provided on both sides of the bridge deck	
Handrail is not provided along the full length of the bridge deck	
The top of the gripping surface of handrail is less than 34 inches or greater than 38 inches above walking surface	X Remove and replace handrail
Clearance between handrail gripping surface and adjacent surface is less than 1.5 inches	
Handrail gripping surface is not continuous along length	
Handrail gripping surface is obstructed along top, side, or greater than 20% of bottom	X Remove and replace handrail
Where provided, horizontal projection is less than 1.5 inches below the bottom of the handrail gripping surface	
Handrail gripping surfaces with a circular cross section have an outside diameter less than 1.25 inches or greater than 2 inches	
Handrail gripping surfaces with a non-circular cross section have perimeter dimension of less than 4 inches or greater than 6.25 inches or cross-section dimension greater than 2.25 inches

Handrail gripping surface or adjacent surface has sharp or abrasive elements or non-rounded edges	
Handrails extend horizontally above the landing for less than 12 inches beyond the edge of the bridge deck	
Pavement leading up to bridge is elevated from ground surface	X Install additional handrail (see sidewalk reports)

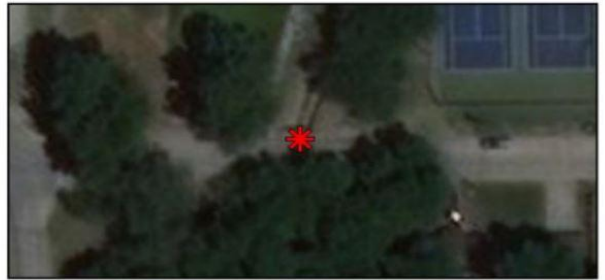
Field Observations

Bridge Issues	Recommendations
Bridge deck running slope is greater than 8.33%	
Clear width of bridge (or between handrails, if provided) is less than 36 inches	
Bridge deck cross slope is greater than 2.08%	
The rise of the bridge deck run is greater than 30 inches	
Vertical discontinuity greater than 1/4 inch in bridge deck	
The landing at the end of the bridge has a slope greater than 2.08%	
The landing width at the end of the bridge is less than bridge width	
The landing length at the end of the bridge is less than 60 inches	
Vertical discontinuity greater than 1/4 inch at sidewalk connection to bridge deck	
Joint width greater than 1/2 inch at sidewalk connection to bridge deck	
Handrail Issues	Recommendations
Handrails are not provided where the bridge deck running slope is greater than 5% and rise is greater than 6 inches	
The surface of the bridge deck does not extend at least 1 foot beyond the inside face of the handrail OR a barrier is not provided that prevents the passage of a 4 inch diameter sphere, where any portion of the sphere is within 4 inches of the finish surface

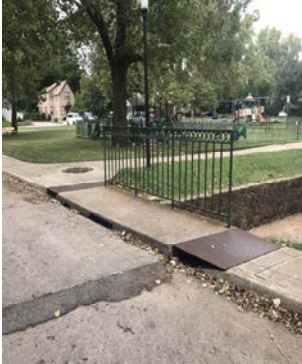
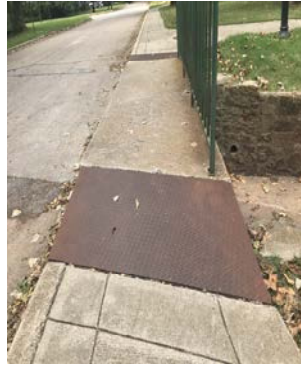
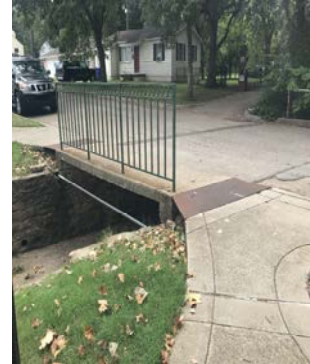
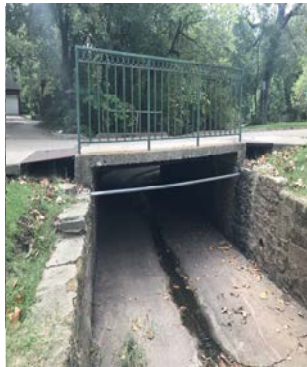
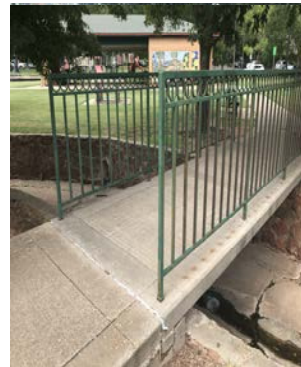
Handrail is not provided on both sides of the bridge deck	
Handrail is not provided along the full length of the bridge deck	
The top of the gripping surface of handrail is less than 34 inches or greater than 38 inches above walking surface	X Remove and replace handrail
Clearance between handrail gripping surface and adjacent surface is less than 1.5 inches	
Handrail gripping surface is not continuous along length	
Handrail gripping surface is obstructed along top, side, or greater than 20% of bottom	X Remove and replace handrail
Where provided, horizontal projection is less than 1.5 inches below the bottom of the handrail gripping surface	
Handrail gripping surfaces with a circular cross section have an outside diameter less than 1.25 inches or greater than 2 inches	
Handrail gripping surfaces with a non-circular cross section have perimeter dimension of less than 4 inches or greater than 6.25 inches or cross-section dimension greater than 2.25 inches

Handrail gripping surface or adjacent surface has sharp or abrasive elements or non-rounded edges	
Handrails extend horizontally above the landing for less than 12 inches beyond the edge of the bridge deck	
Pavement leading up to bridge is elevated from ground surface	X Install additional handrail (see sidewalk reports)
