City of Norman
ADA Self-Evaluation and Transition Plan
Building Cost Projection Summary
5/1/2018

Municipal Complex - Building A

Accessibility Evaluation

Inspection Date: 09/20/2017

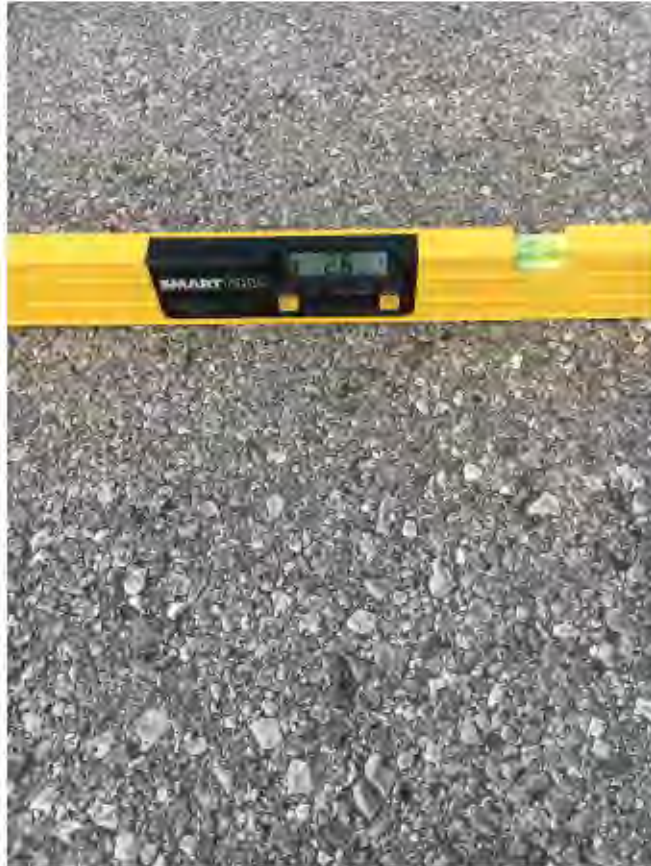
Finding #1 Additional Finding Photos

The access aisle has a 2.6% running slope.

4 (High): Parking or exterior conditions (DOJ's level 1) – moderately out of compliance.

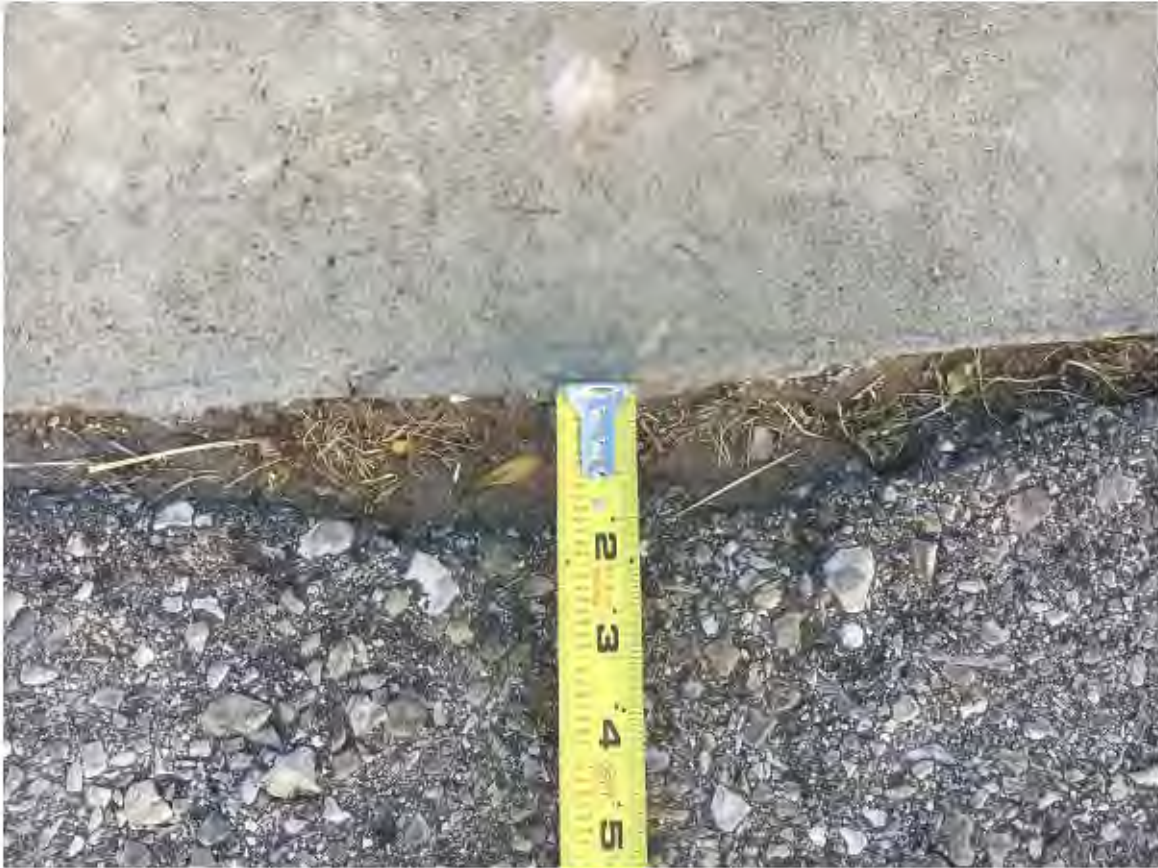
Finding #2 Additional Finding Photos

6 (Medium): Access to goods and services (DOJ level 2) moderately out of compliance. Parking or exterior conditions (DOJ's level 1) – minimally out of compliance. Restrooms (DOJ level 3) – severely out of compliance.

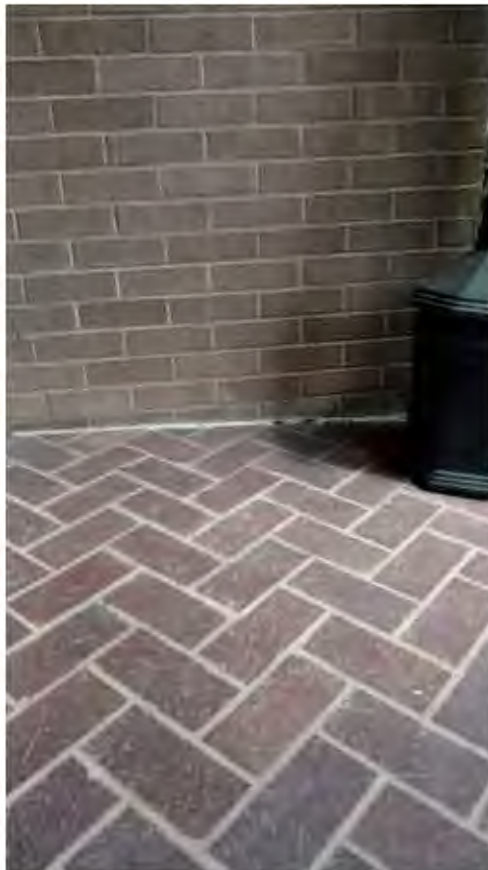
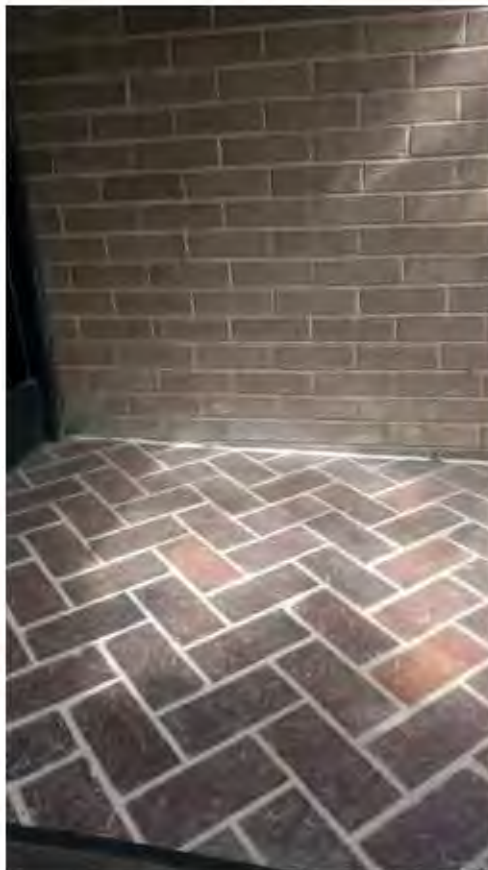
Finding #3 Additional Finding Photos

3 (High): Element is more than twice the allowable requirement. No known complaint. AND (for exterior conditions) not near a hospital, school, transit stop, govt. bldg., or other pedestrian attractor.

Replace landing (7' deep x 11'-4" wide) to achieve slopes no greater than 2% in all directions.

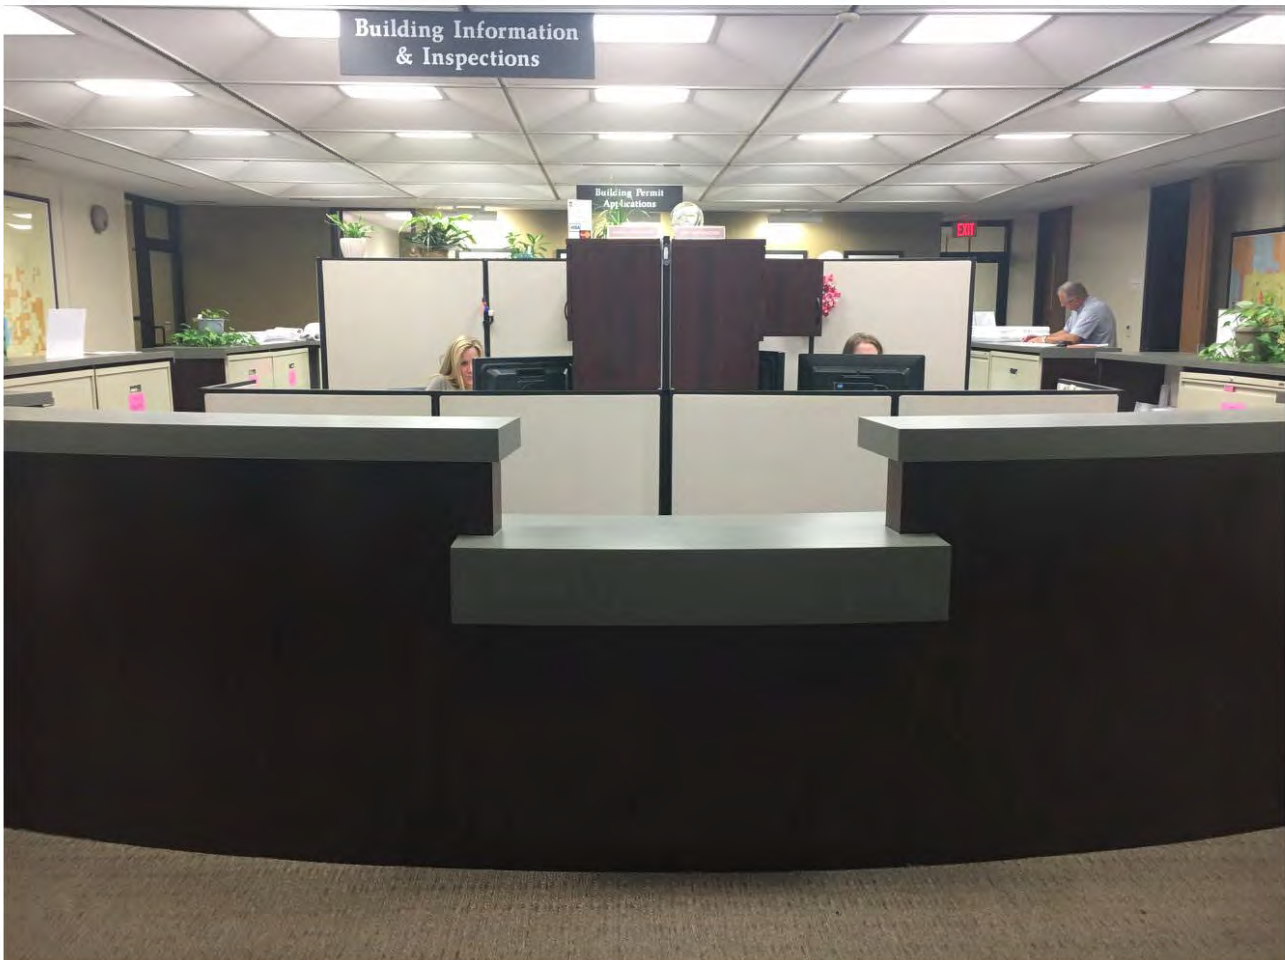
7 (Medium): Access to goods and services (DOJ level 2) minimally out of compliance. Restrooms (DOJ level 3) – Moderately out of compliance Drinking fountains or public phones (DOJ level 4 & 5) severely out of compliance.

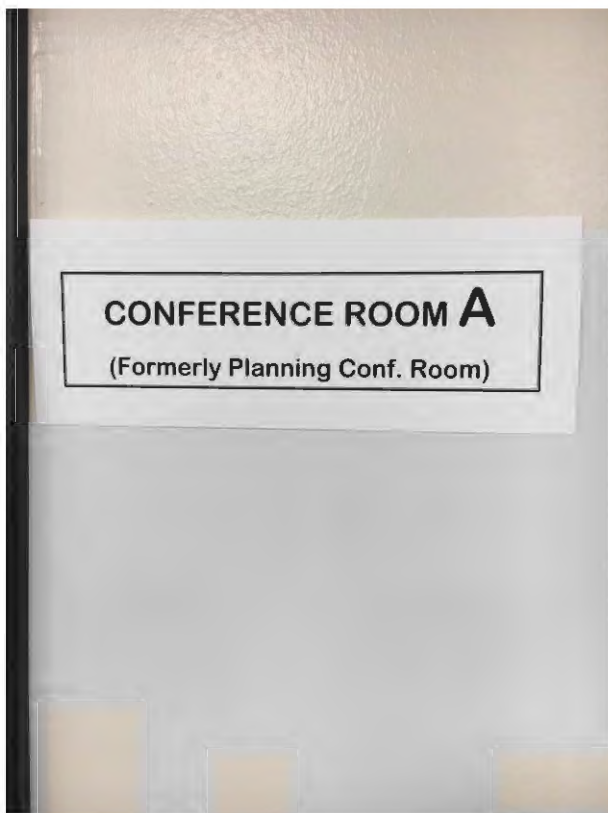
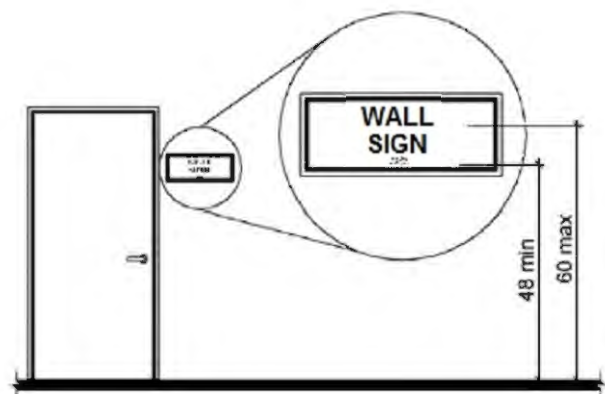
6 (Medium): Access to goods and services (DOJ level 2) moderately out of compliance. Parking or exterior conditions (DOJ's level 1) – minimally out of compliance. Restrooms (DOJ level 3) – severely out of compliance.

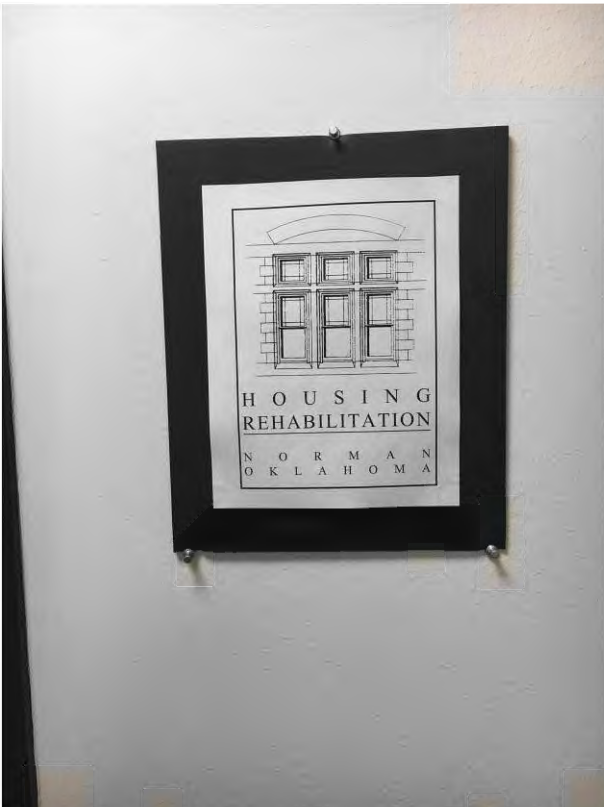
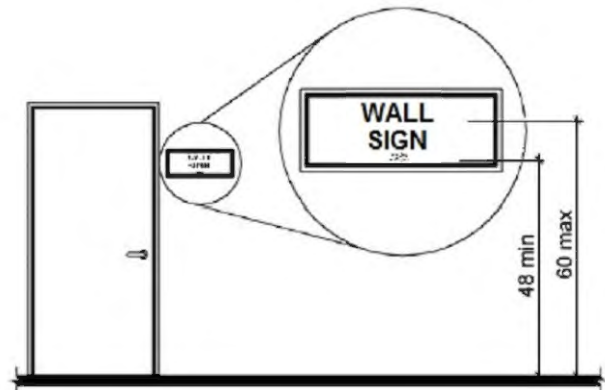
6 (Medium): Access to goods and services (DOJ level 2) moderately out of compliance. Parking or exterior conditions (DOJ's level 1) – minimally out of compliance. Restrooms (DOJ level 3) – severely out of compliance.

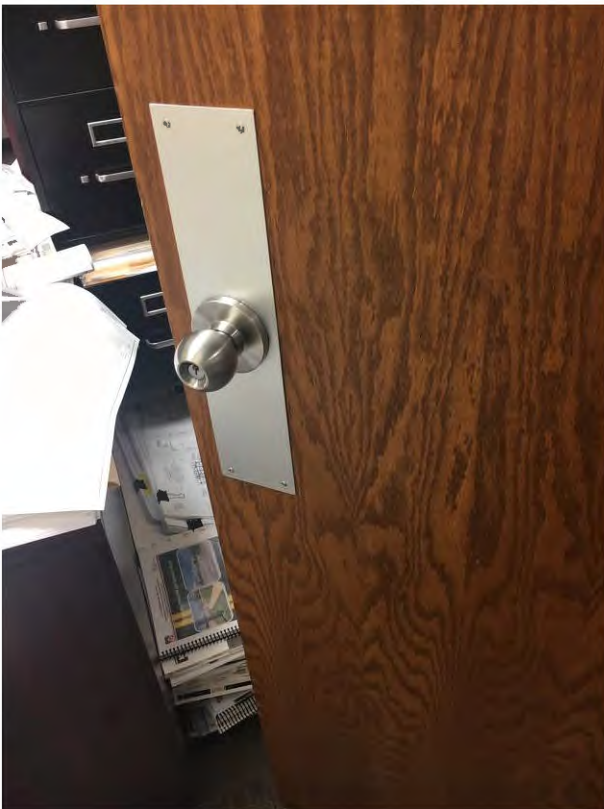
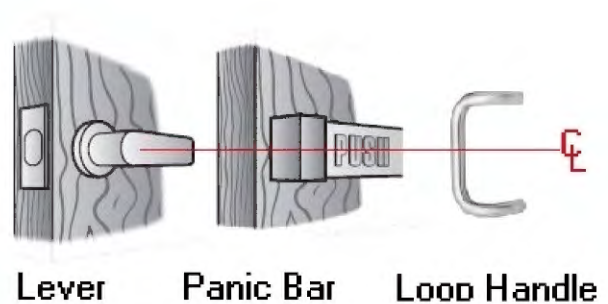
5 (Medium): Access to goods and services issues (DOJ level 2) - severely out of compliance.

Operating hardware must be centered between 34" and 44" above the floor or ground

Replace door knobs with lever style door hardware.

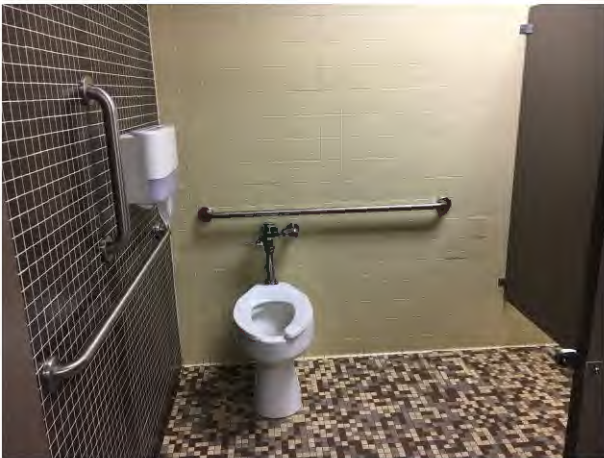
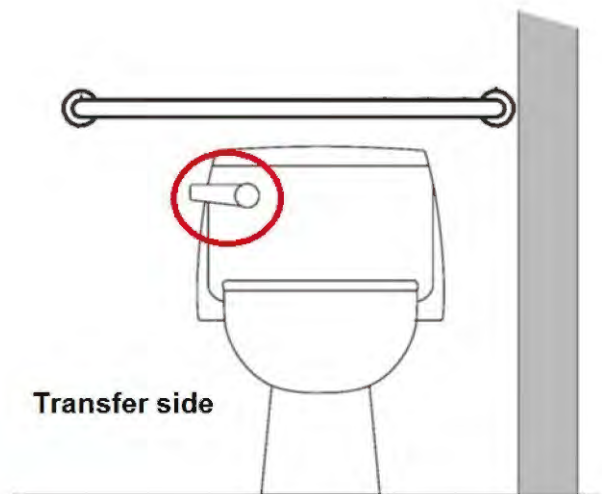
7 (Medium): Access to goods and services (DOJ level 2) minimally out of compliance. Restrooms (DOJ level 3) – Moderately out of compliance Drinking fountains or public phones (DOJ level 4 & 5) severely out of compliance.

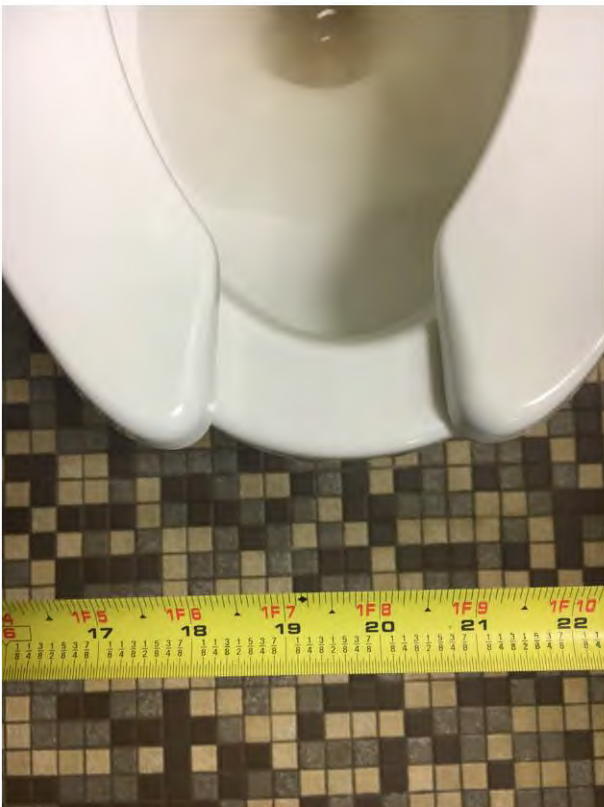
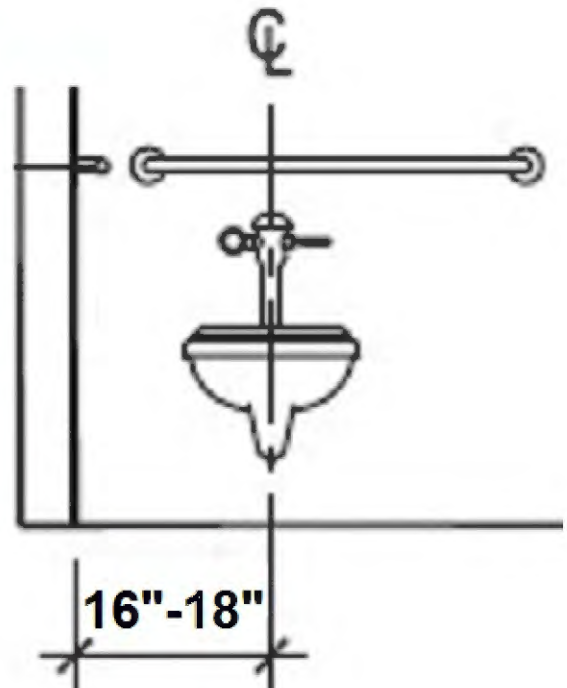
7 (Medium): Access to goods and services (DOJ level 2) minimally out of compliance. Restrooms (DOJ level 3) – Moderately out of compliance Drinking fountains or public phones (DOJ level 4 & 5) severely out of compliance.

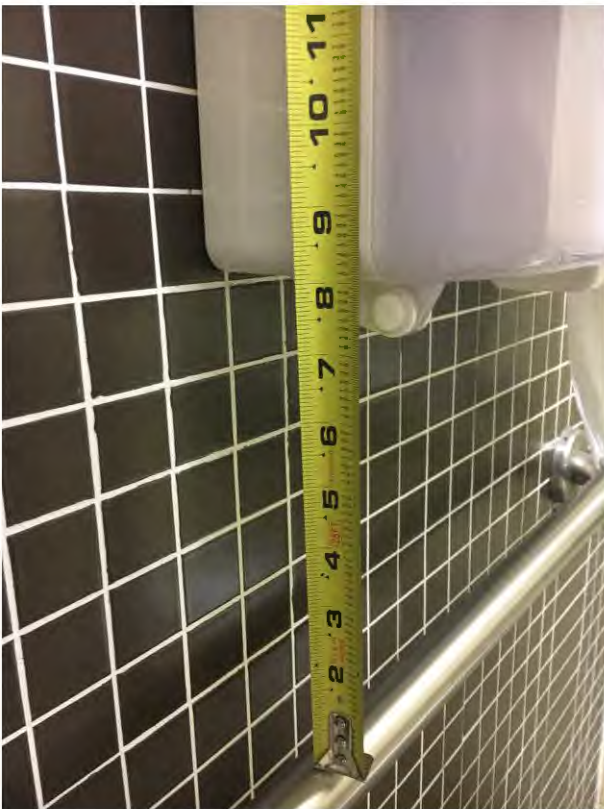
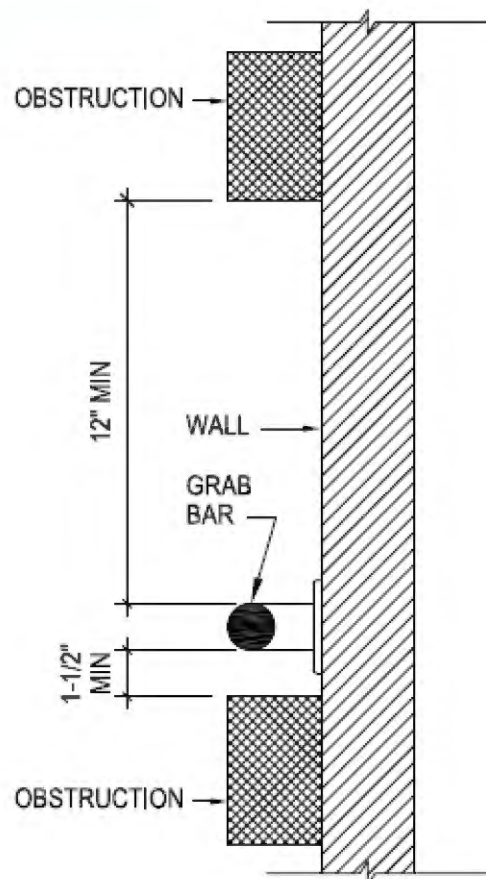
7 (Medium): Access to goods and services (DOJ level 2) minimally out of compliance. Restrooms (DOJ level 3) – Moderately out of compliance Drinking fountains or public phones (DOJ level 4 & 5) severely out of compliance.

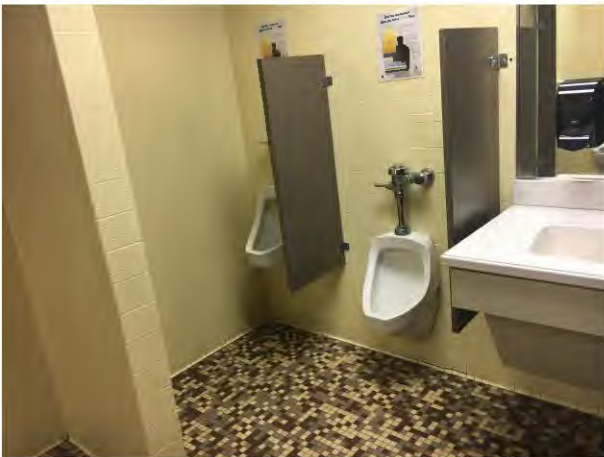
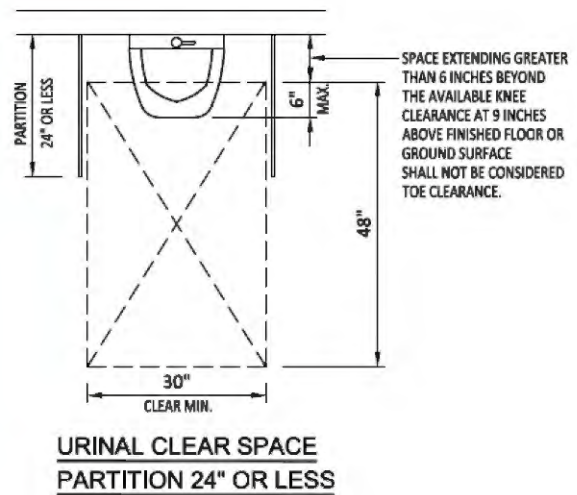
6 (Medium): Access to goods and services (DOJ level 2) moderately out of compliance. Parking or exterior conditions (DOJ's level 1) – minimally out of compliance. Restrooms (DOJ level 3) – severely out of compliance.

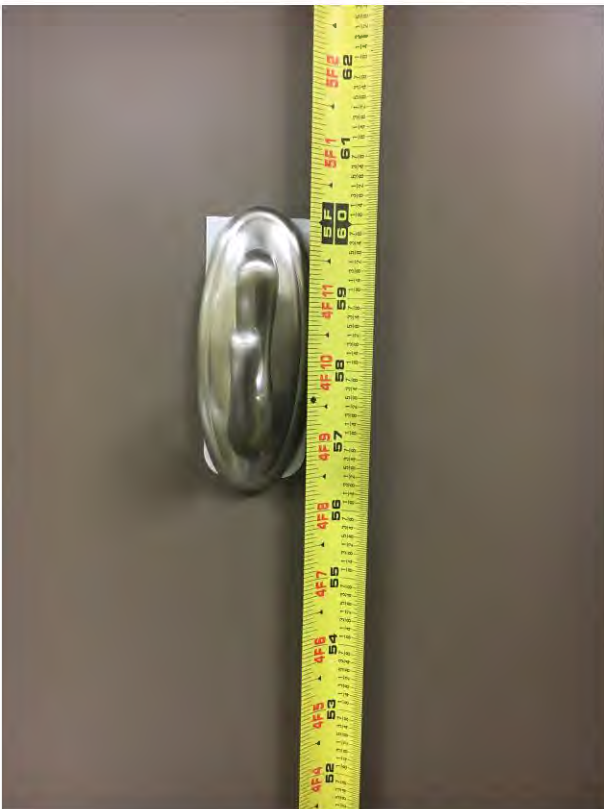
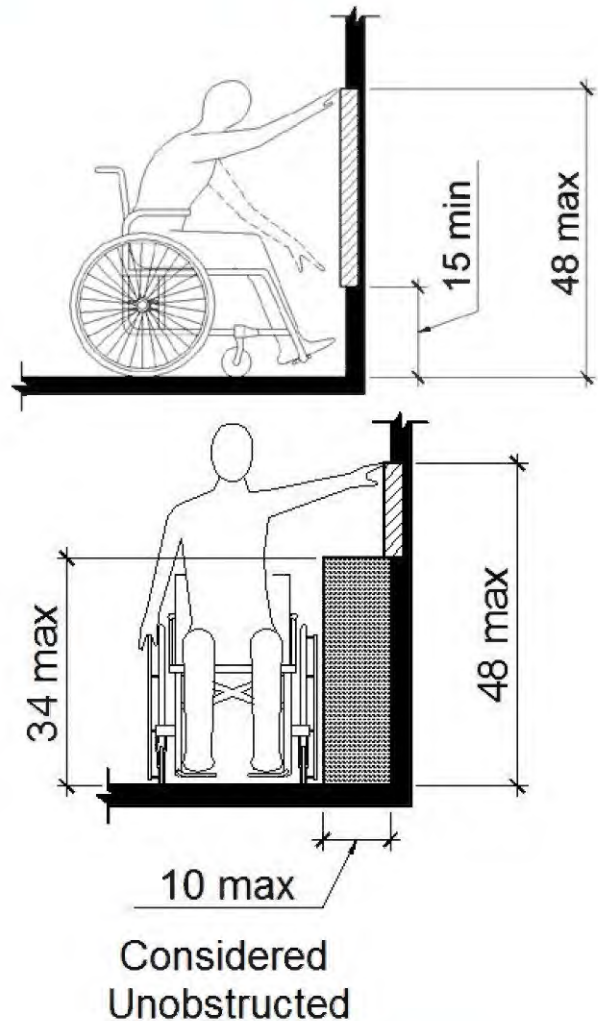
9 (Low): Restrooms (DOJ level 3) – minimally out of compliance.

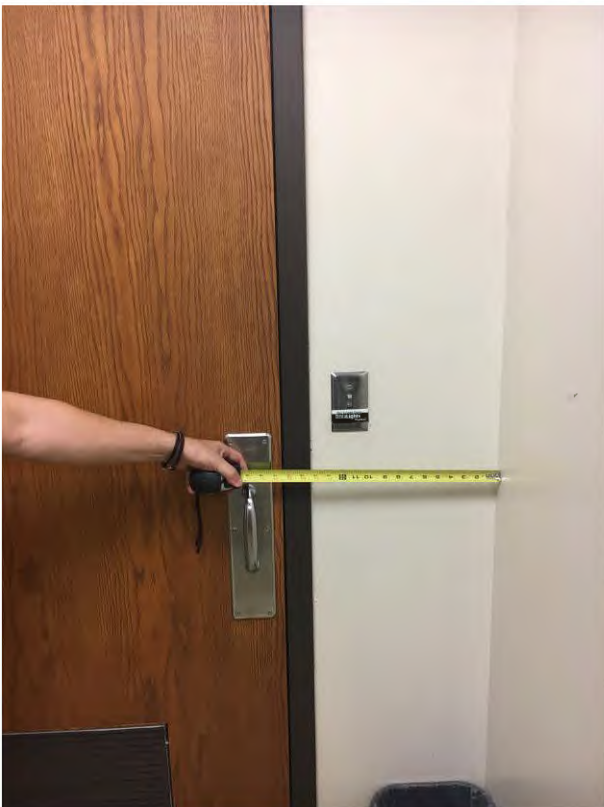
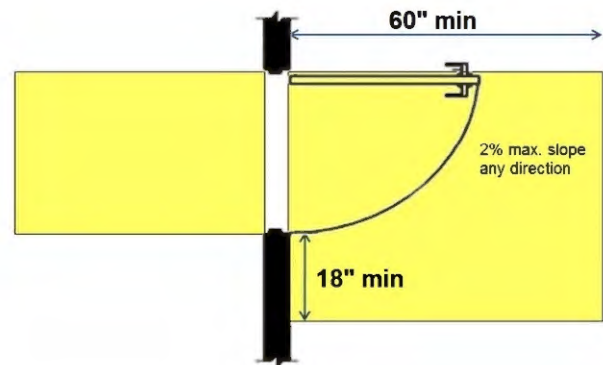
6 (Medium): Access to goods and services (DOJ level 2) moderately out of compliance. Parking or exterior conditions (DOJ's level 1) – minimally out of compliance. Restrooms (DOJ level 3) – severely out of compliance.

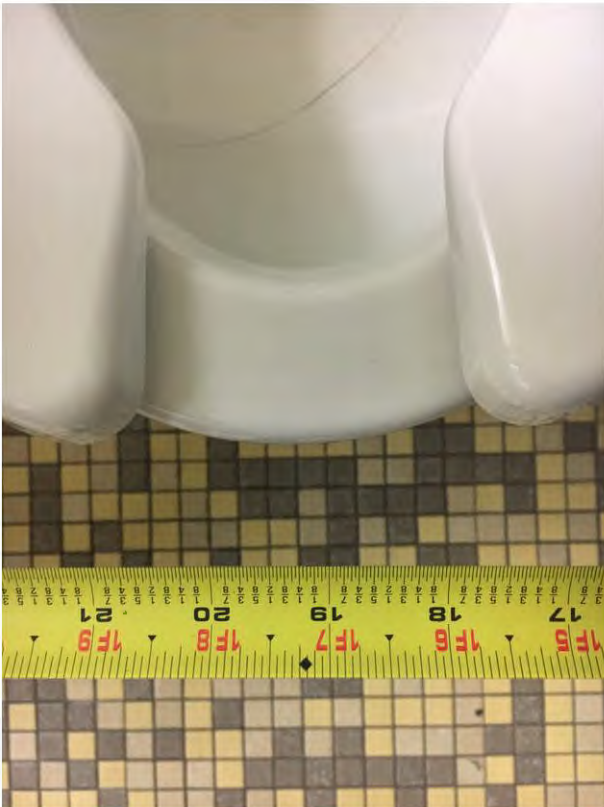
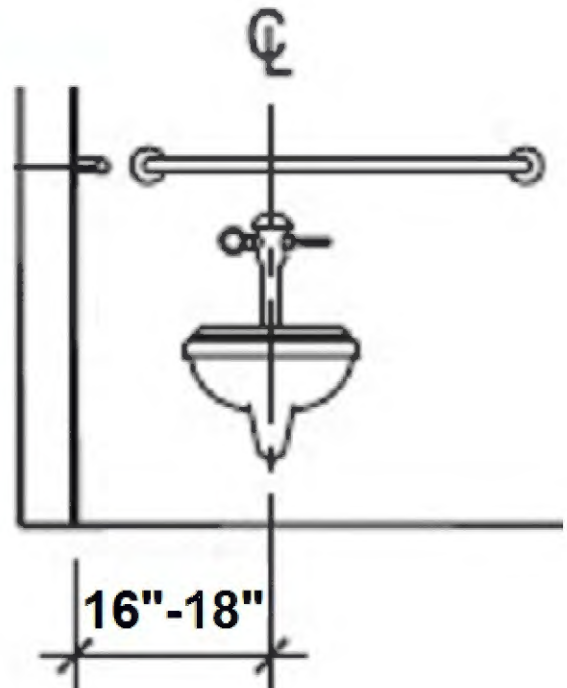
7 (Medium): Access to goods and services (DOJ level 2) minimally out of compliance. Restrooms (DOJ level 3) – Moderately out of compliance Drinking fountains or public phones (DOJ level 4 & 5) severely out of compliance.

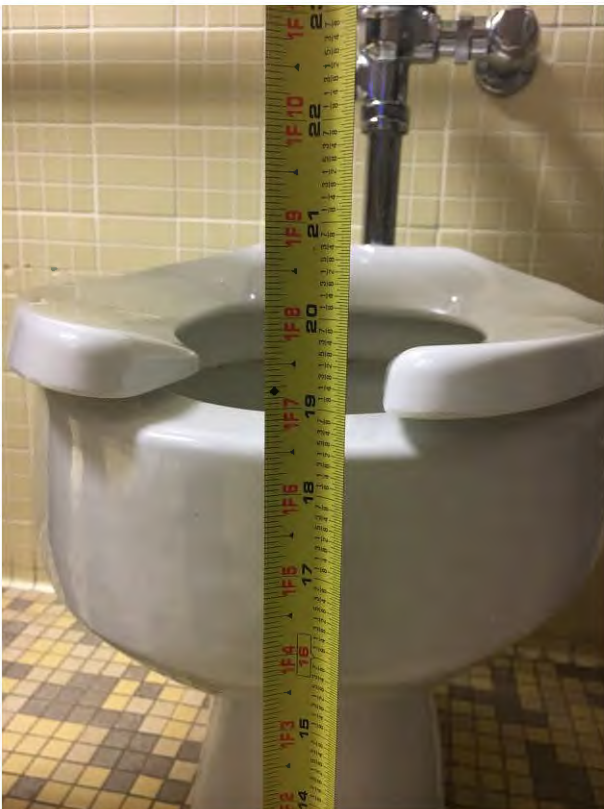
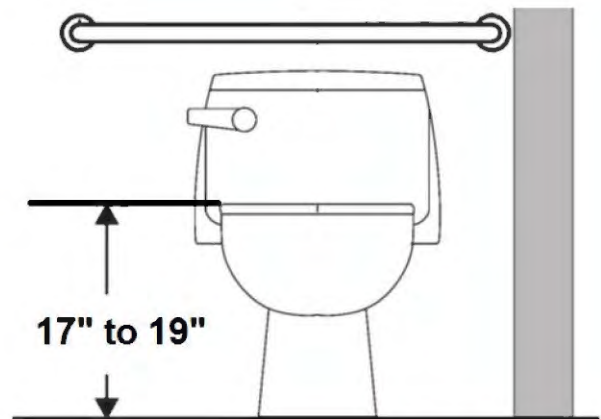
9 (Low): Restrooms (DOJ level 3) – minimally out of compliance.

Replace water closet seat with a shorter seat to achieve 17"-19" height.

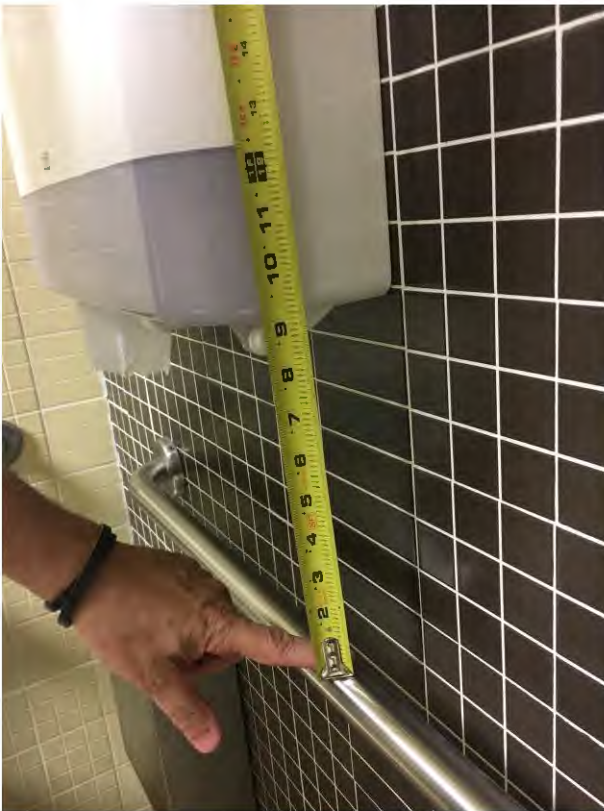
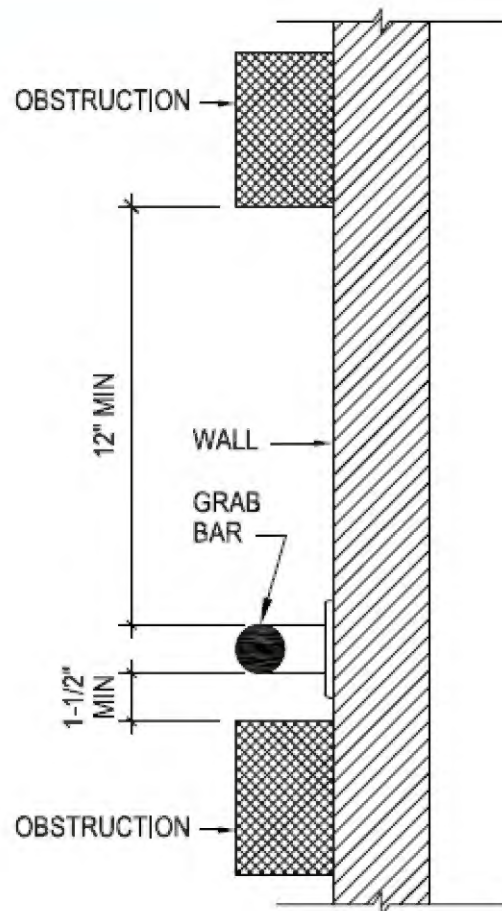
7 (Medium): Access to goods and services (DOJ level 2) minimally out of compliance. Restrooms (DOJ level 3) – Moderately out of compliance Drinking fountains or public phones (DOJ level 4 & 5) severely out of compliance.

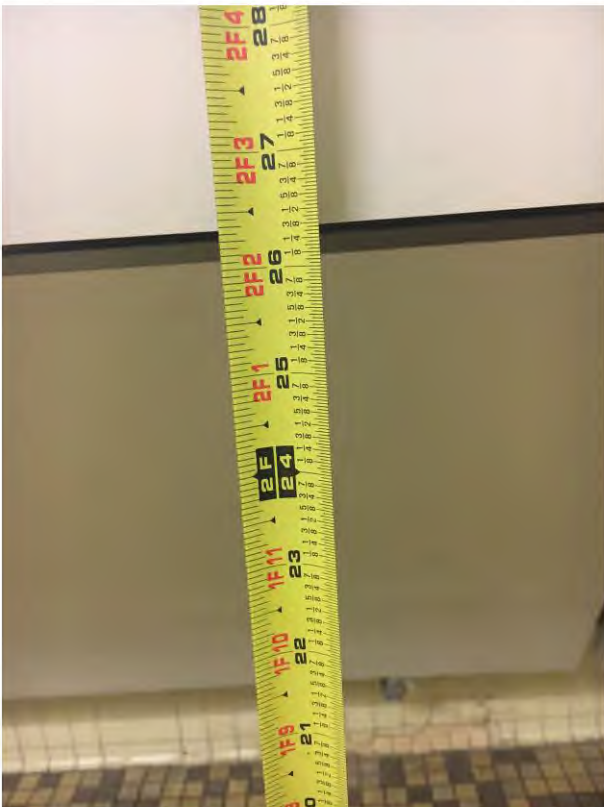
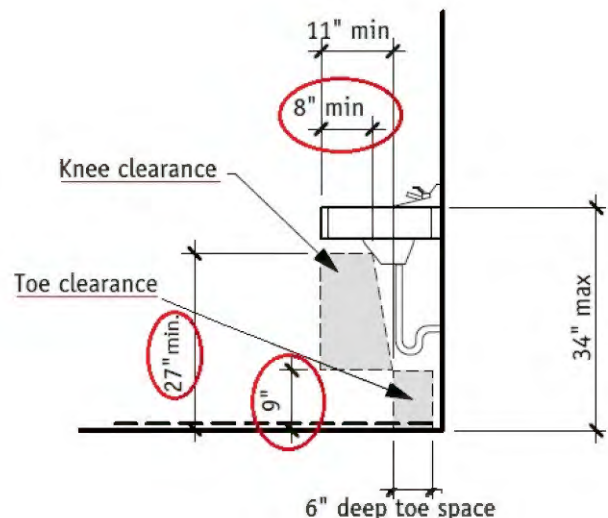
7 (Medium): Access to goods and services (DOJ level 2) minimally out of compliance. Restrooms (DOJ level 3) – Moderately out of compliance Drinking fountains or public phones (DOJ level 4 & 5) severely out of compliance.

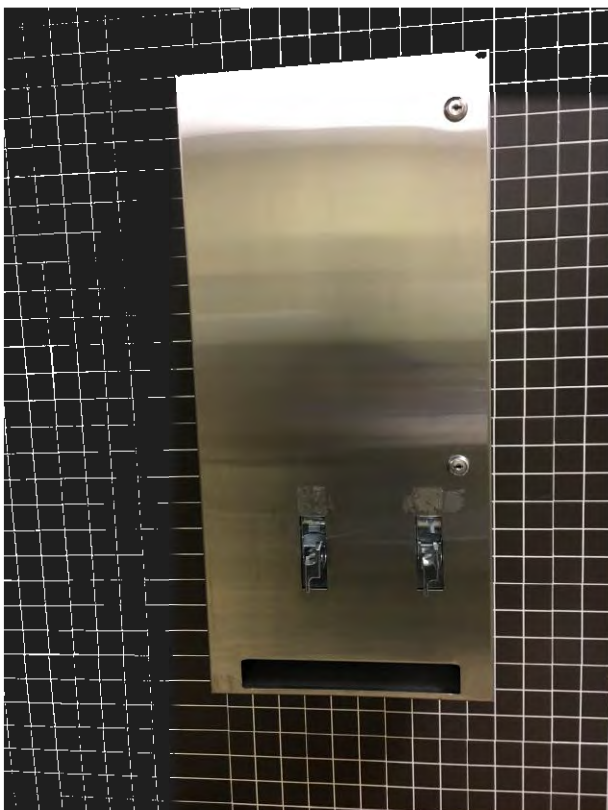
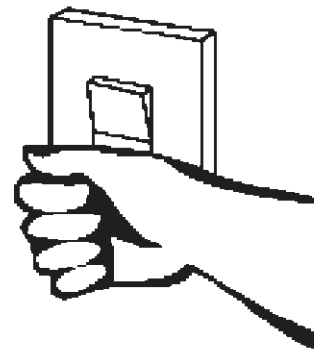
9 (Low): Restrooms (DOJ level 3) – minimally out of compliance.

Replace with a dispenser that has controls that do not require grasping and twisting to operate.

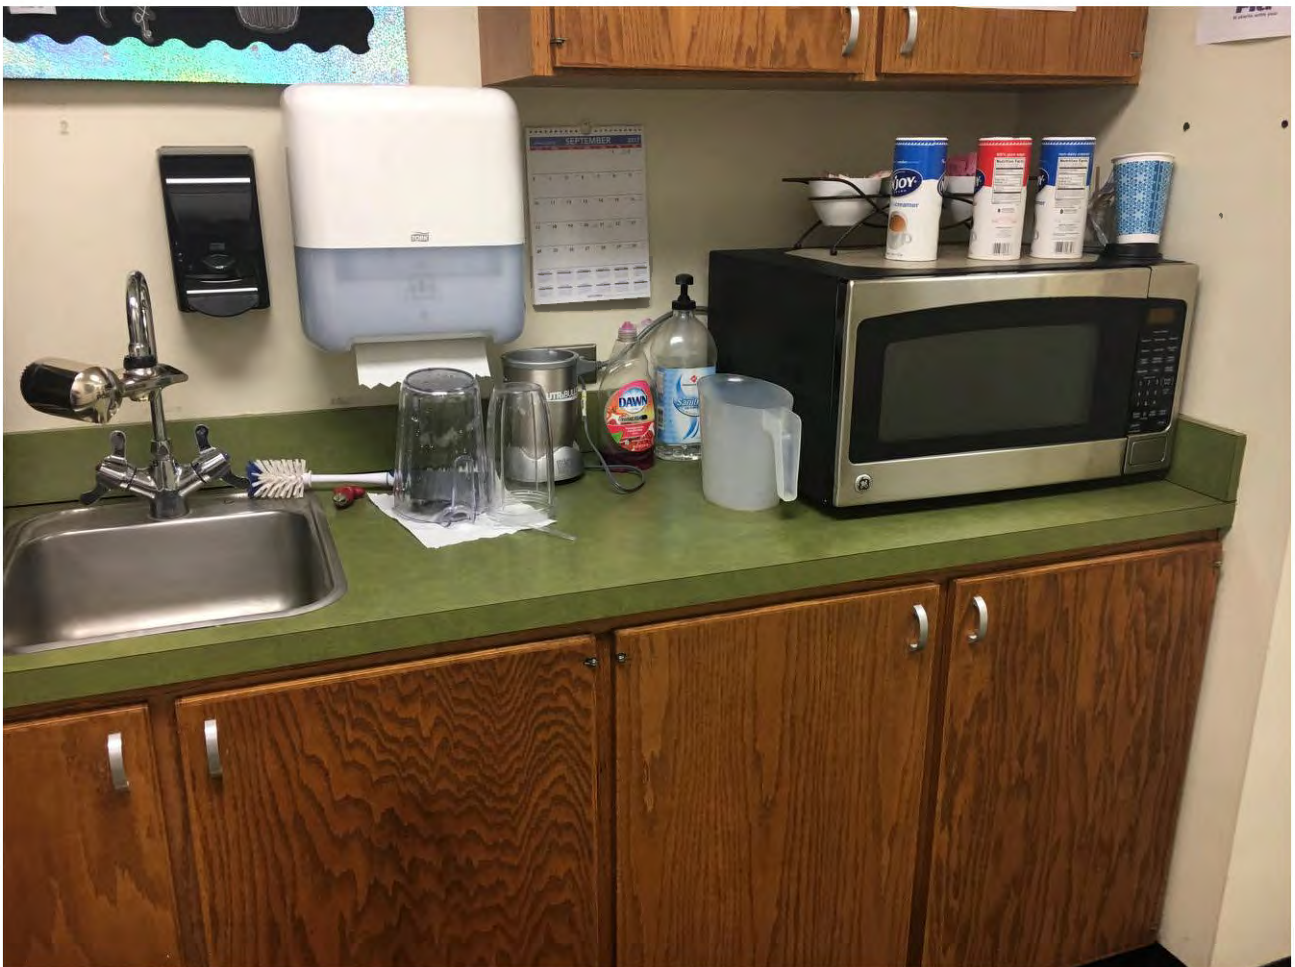
Finding: 19

7 (Medium): Access to goods and services (DOJ level 2) minimally out of compliance. Restrooms (DOJ level 3) – Moderately out of compliance Drinking fountains or public phones (DOJ level 4 & 5) severely out of compliance.

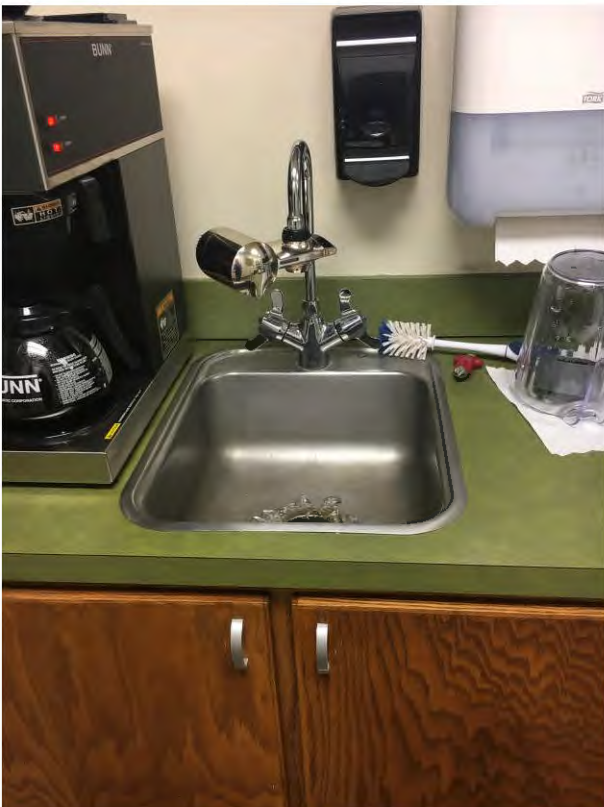
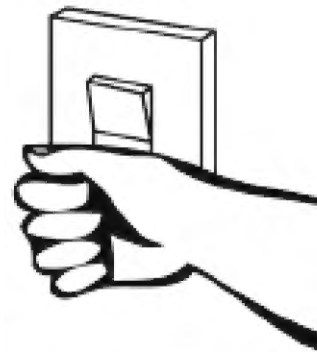
Finding: 20

6 (Medium): Access to goods and services (DOJ level 2) moderately out of compliance. Parking or exterior conditions (DOJ's level 1) – minimally out of compliance. Restrooms (DOJ level 3) – severely out of compliance.

Replace with lever style faucet controls.

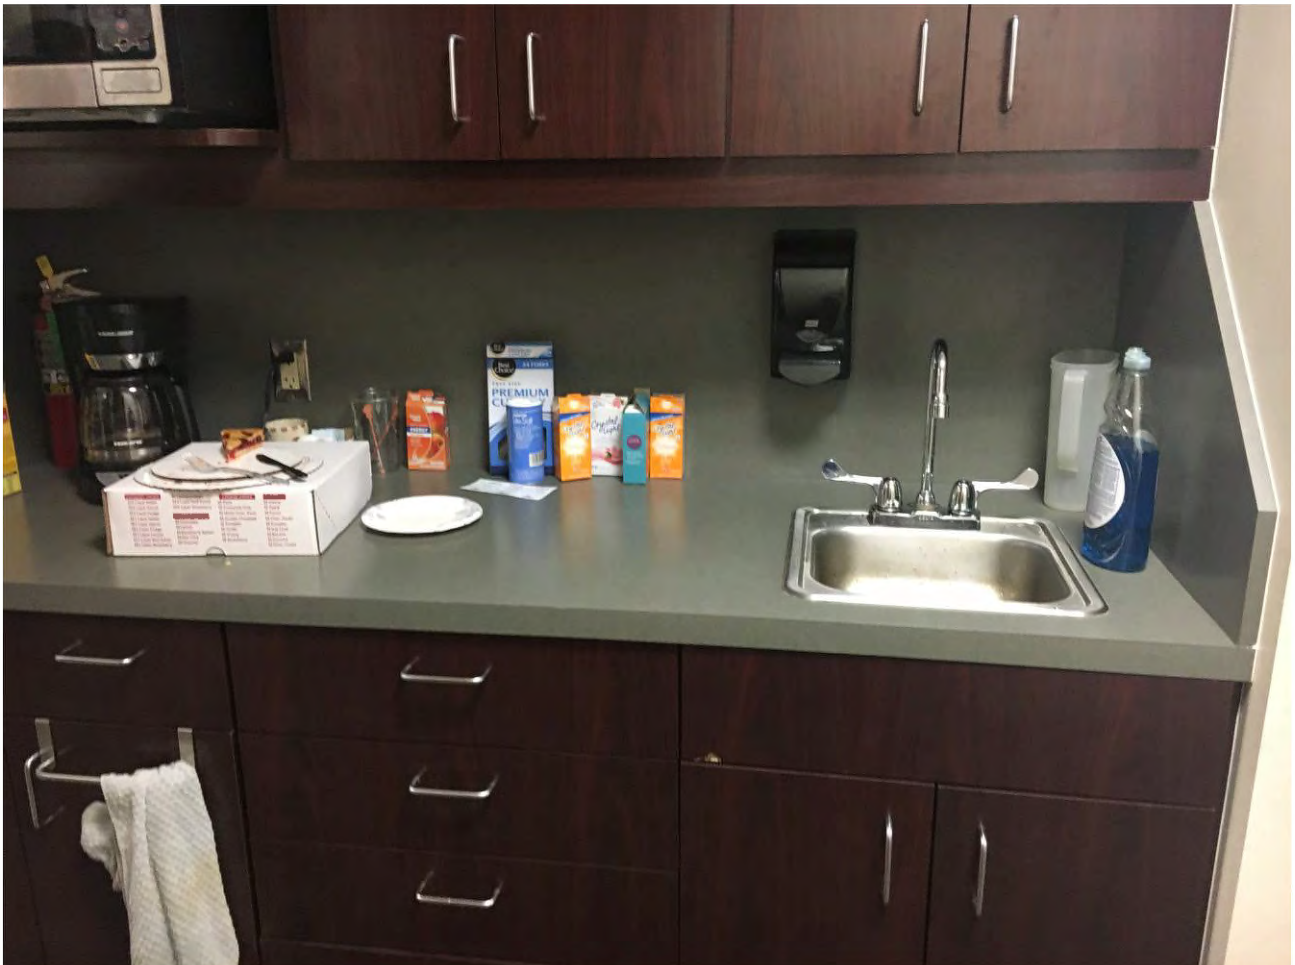
Finding: 21

7 (Medium): Access to goods and services (DOJ level 2) minimally out of compliance. Restrooms (DOJ level 3) – Moderately out of compliance Drinking fountains or public phones (DOJ level 4 & 5) severely out of compliance.

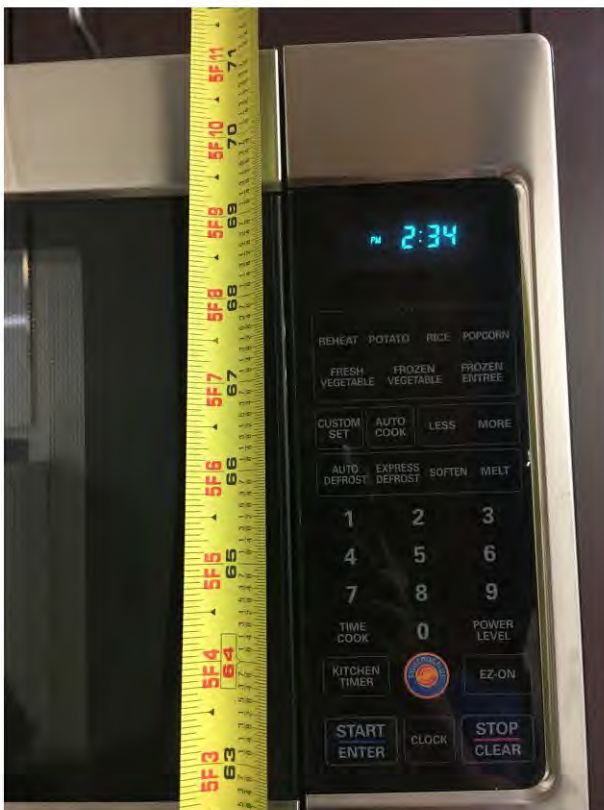
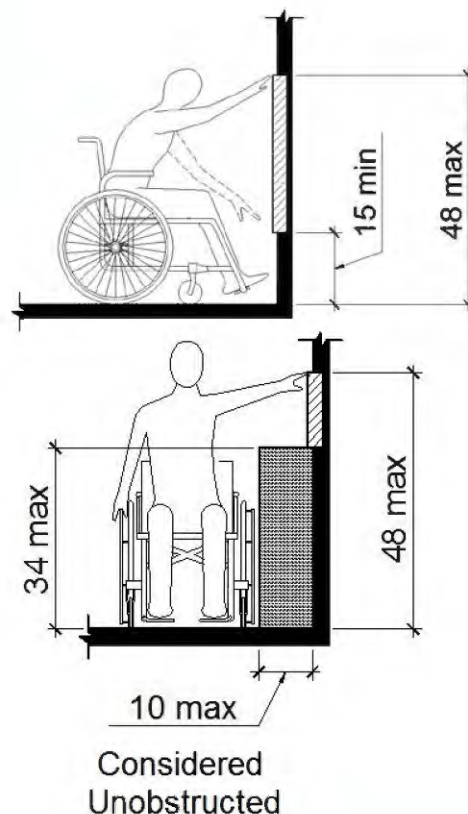
Finding: 22

11 (Low): Client is a Title II agency, elements are out of compliance but may be able to handled programmatically, or do not need to be handled unless or until they hire a person with a disability.

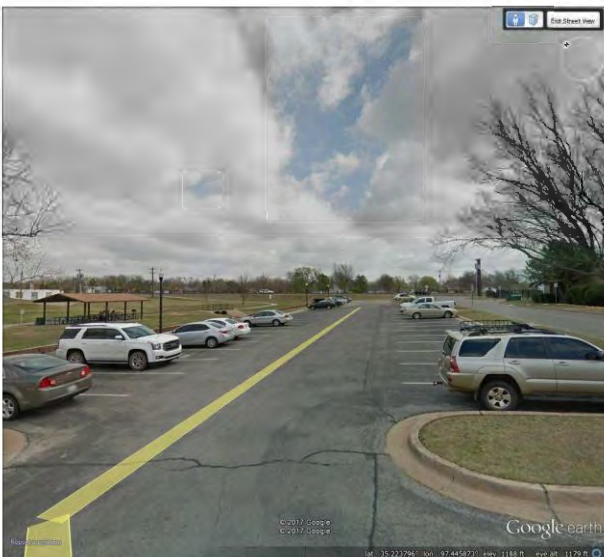
4 (High): Parking or exterior conditions (DOJ's level 1) – moderately out of compliance.

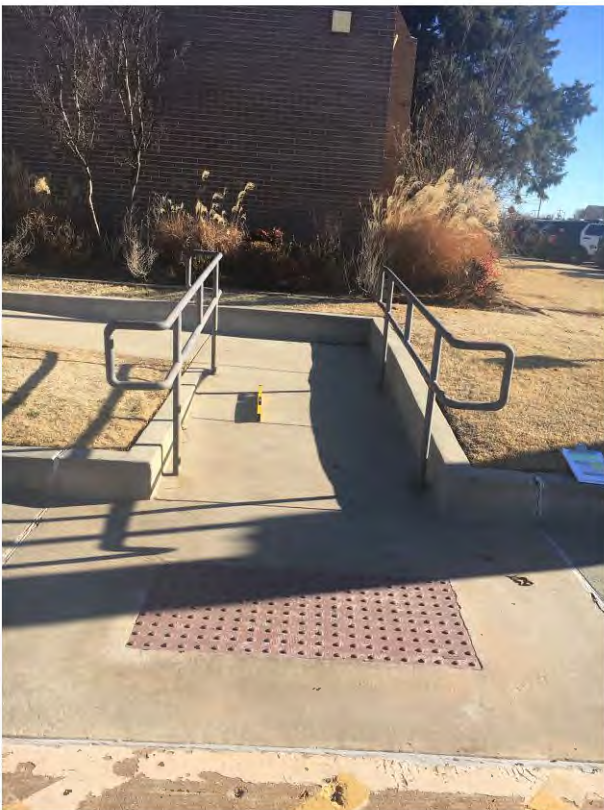
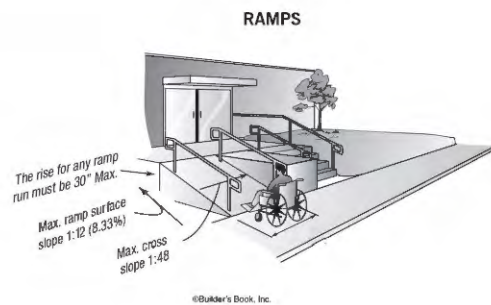
Finding: 2

3 (High): Element is more than twice the allowable requirement. No known complaint. AND (for exterior conditions) not near a hospital, school, transit stop, govt. bldg., or other pedestrian attractor.

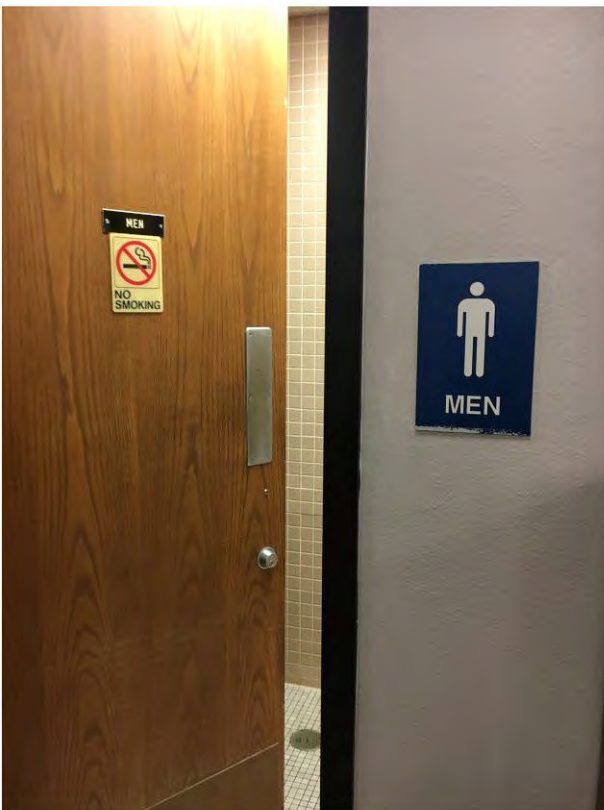
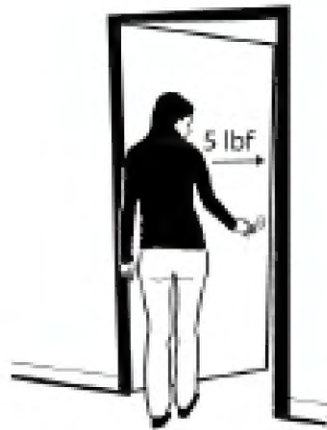
Finding: 3

9 (Low): Restrooms (DOJ level 3) – minimally out of compliance.

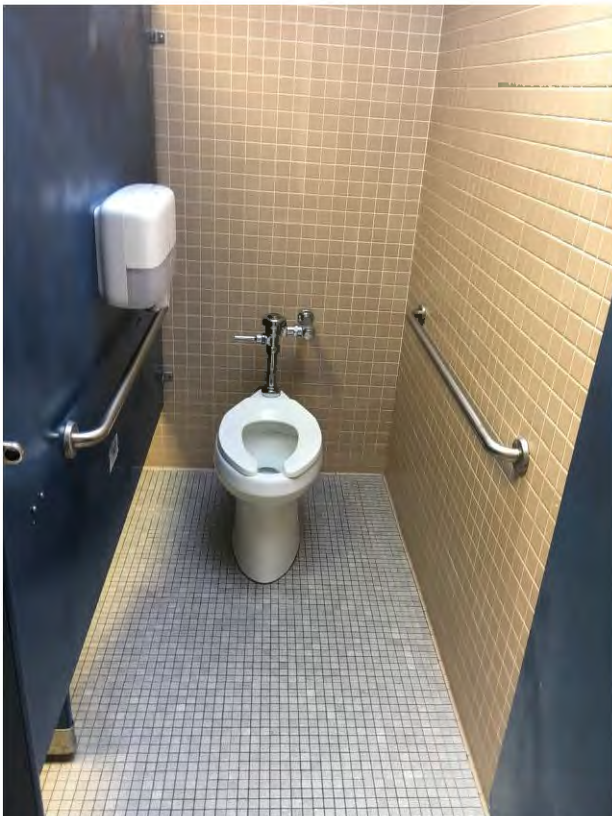
Finding: 4

6 (Medium): Access to goods and services (DOJ level 2) moderately out of compliance. Parking or exterior conditions (DOJ's level 1) – minimally out of compliance. Restrooms (DOJ level 3) – severely out of compliance.

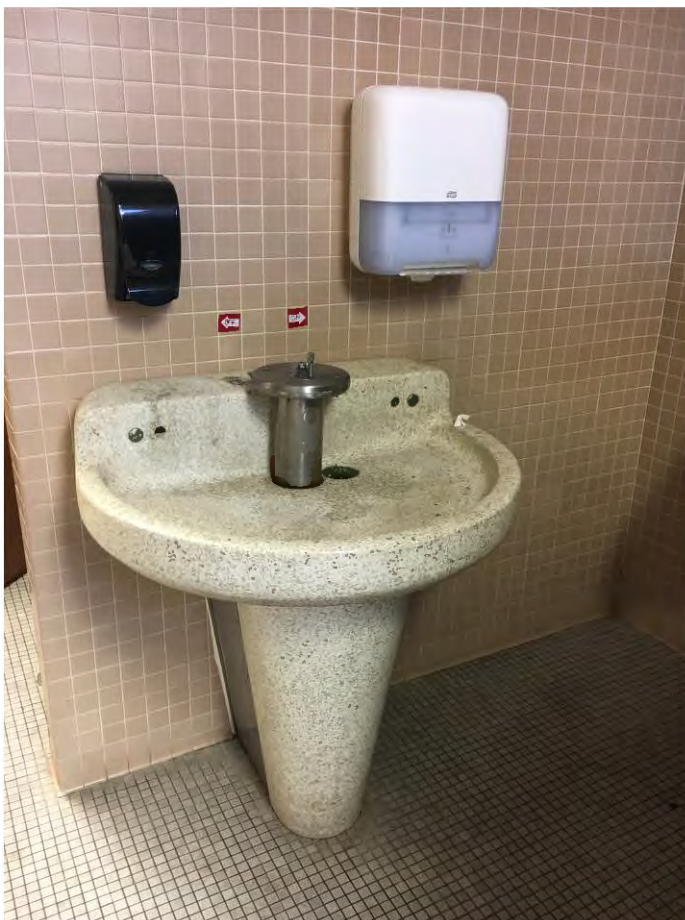
Finding: 5

6 (Medium): Access to goods and services (DOJ level 2) moderately out of compliance. Parking or exterior conditions (DOJ's level 1) – minimally out of compliance. Restrooms (DOJ level 3) – severely out of compliance.
