City of Norman
ADA Self-Evaluation and Transition Plan
Building Cost Projection Summary
5/1/2018

Municipal Complex - Building A

Accessibility Evaluation

Inspection Date: 09/20/2017

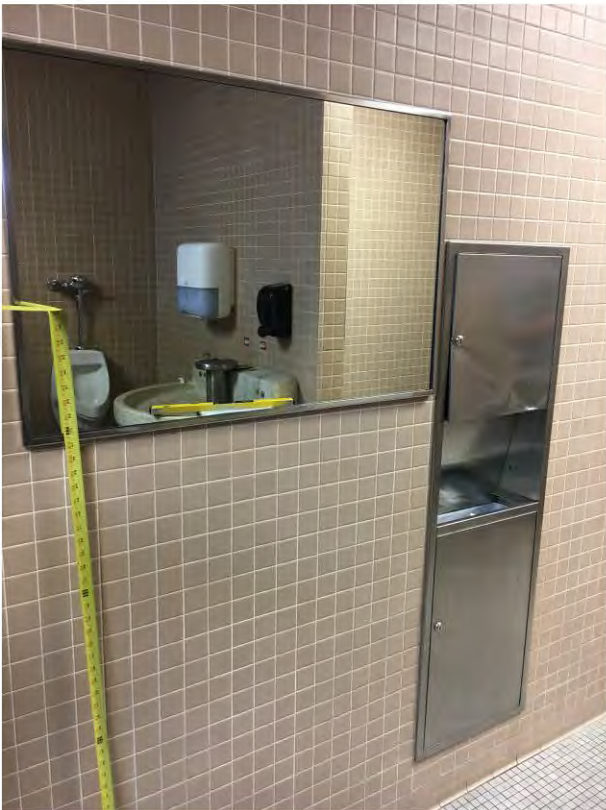
Finding: 6

7 (Medium): Access to goods and services (DOJ level 2) minimally out of compliance. Restrooms (DOJ level 3) – Moderately out of compliance Drinking fountains or public phones (DOJ level 4 & 5) severely out of compliance.

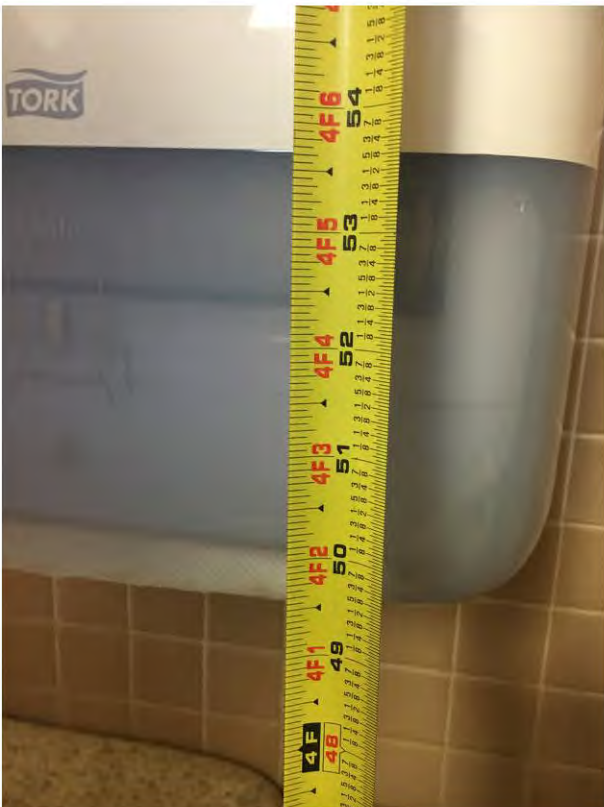
Finding: 7

8 (Medium): Drinking fountains or public phones (DOJ level 4 & 5) - moderately out of compliance.

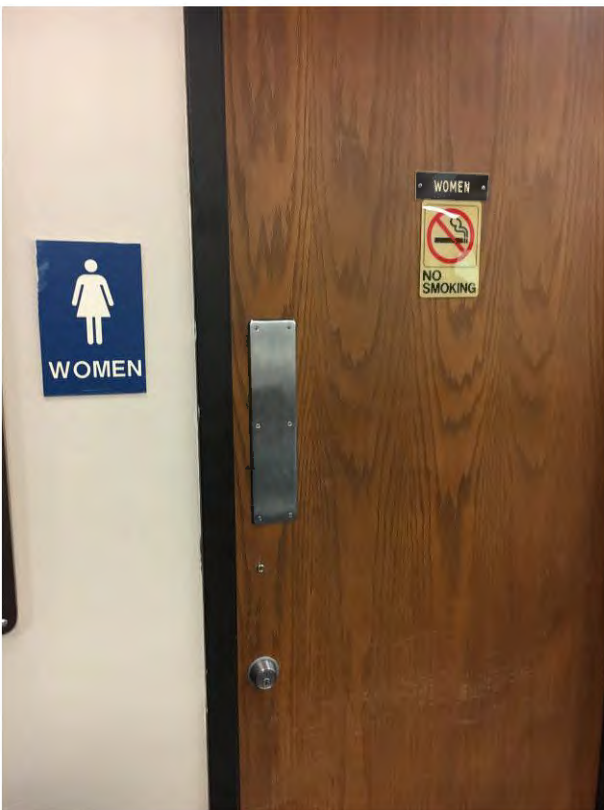
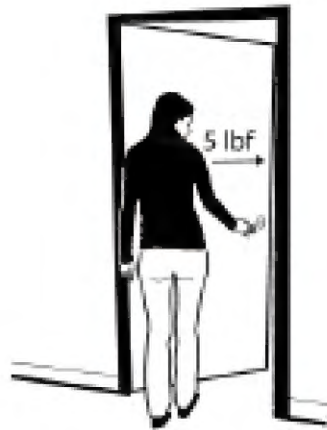
Finding: 8

9 (Low): Restrooms (DOJ level 3) – minimally out of compliance.

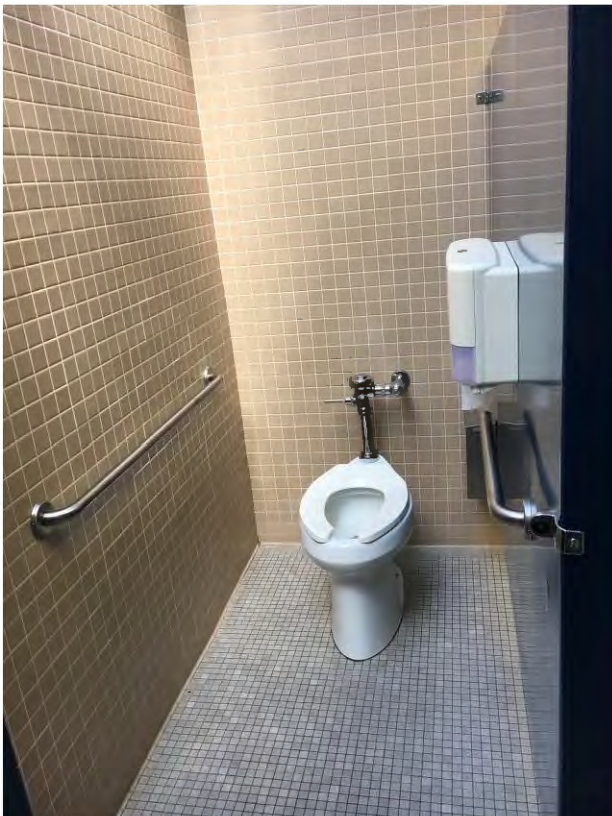
Finding: 9

6 (Medium): Access to goods and services (DOJ level 2) moderately out of compliance. Parking or exterior conditions (DOJ's level 1) – minimally out of compliance. Restrooms (DOJ level 3) – severely out of compliance.

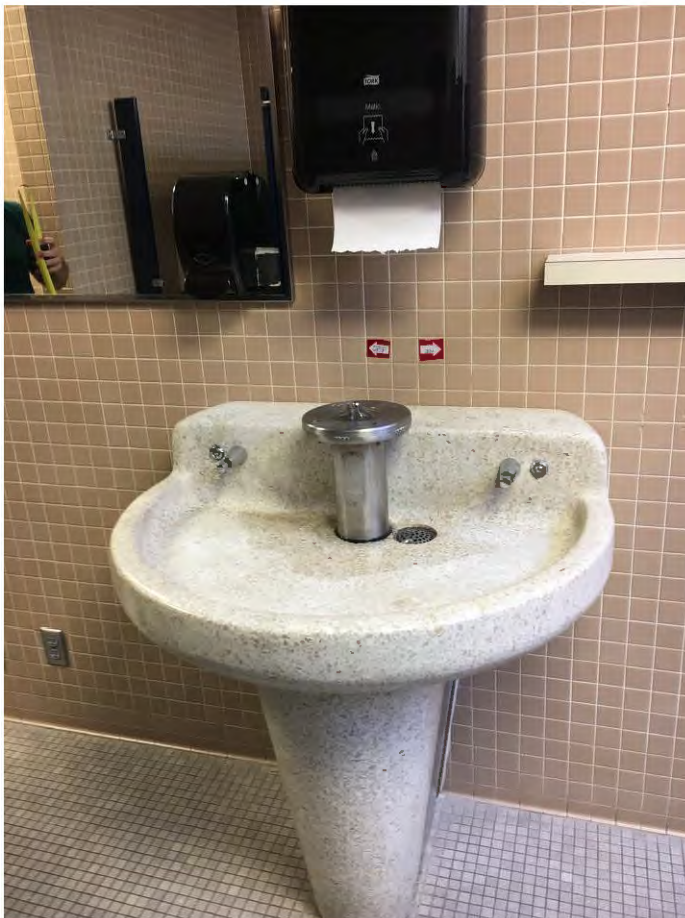
Finding: 10

6 (Medium): Access to goods and services (DOJ level 2) moderately out of compliance. Parking or exterior conditions (DOJ's level 1) – minimally out of compliance. Restrooms (DOJ level 3) – severely out of compliance.

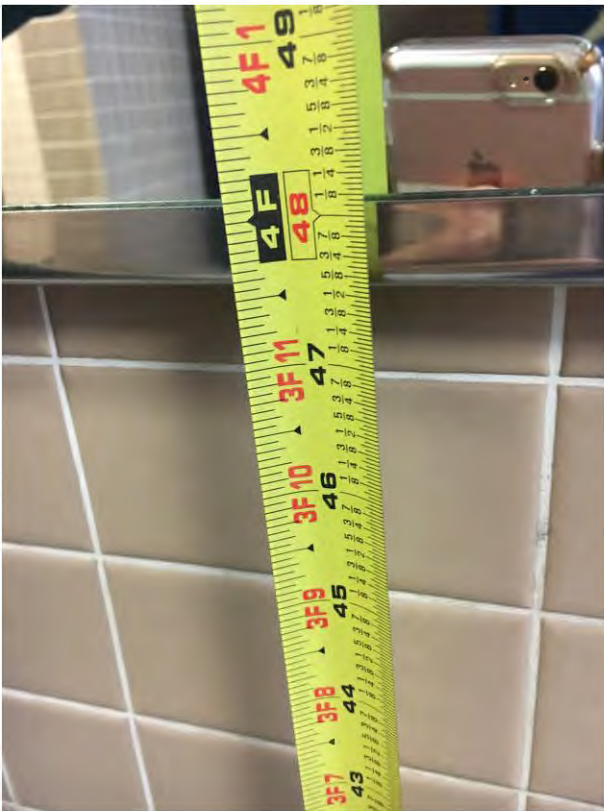
Finding: 11

7 (Medium): Access to goods and services (DOJ level 2) minimally out of compliance. Restrooms (DOJ level 3) – Moderately out of compliance Drinking fountains or public phones (DOJ level 4 & 5) severely out of compliance.

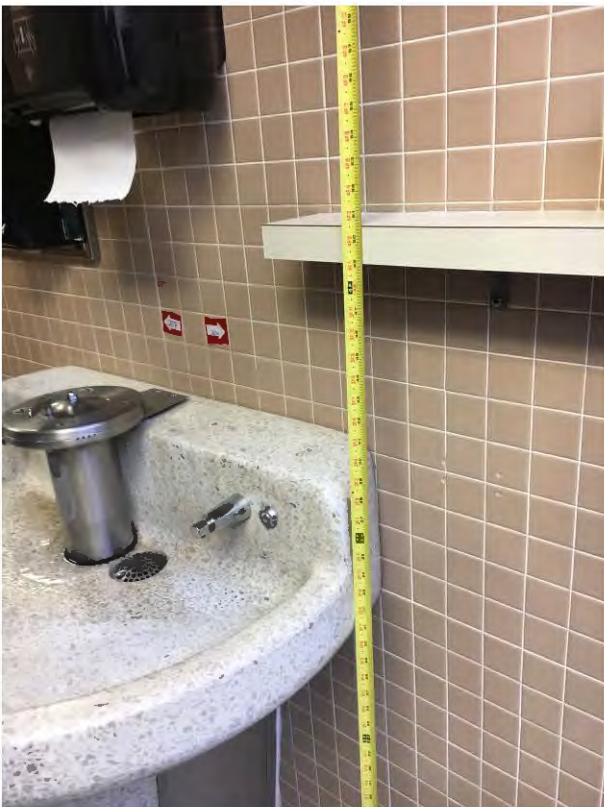
Finding: 12

8 (Medium): Drinking fountains or public phones (DOJ level 4 & 5) - moderately out of compliance.

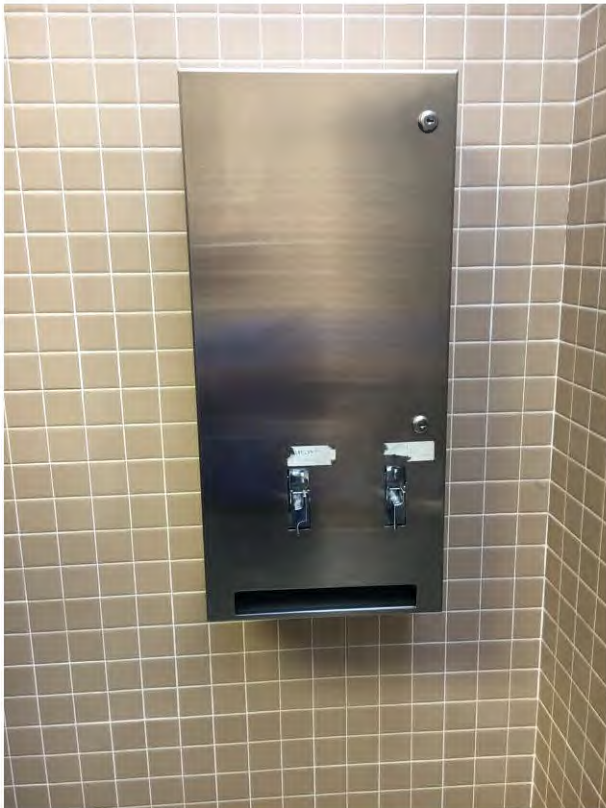
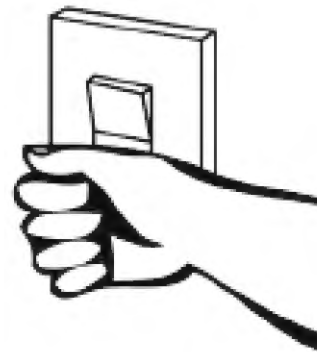
Finding: 13

11 (Low): Client is a Title II agency, elements are out of compliance but may be able to handled programmatically, or do not need to be handled unless or until they hire a person with a disability.

Replace with a dispenser that has controls that do not require grasping and twisting to operate.

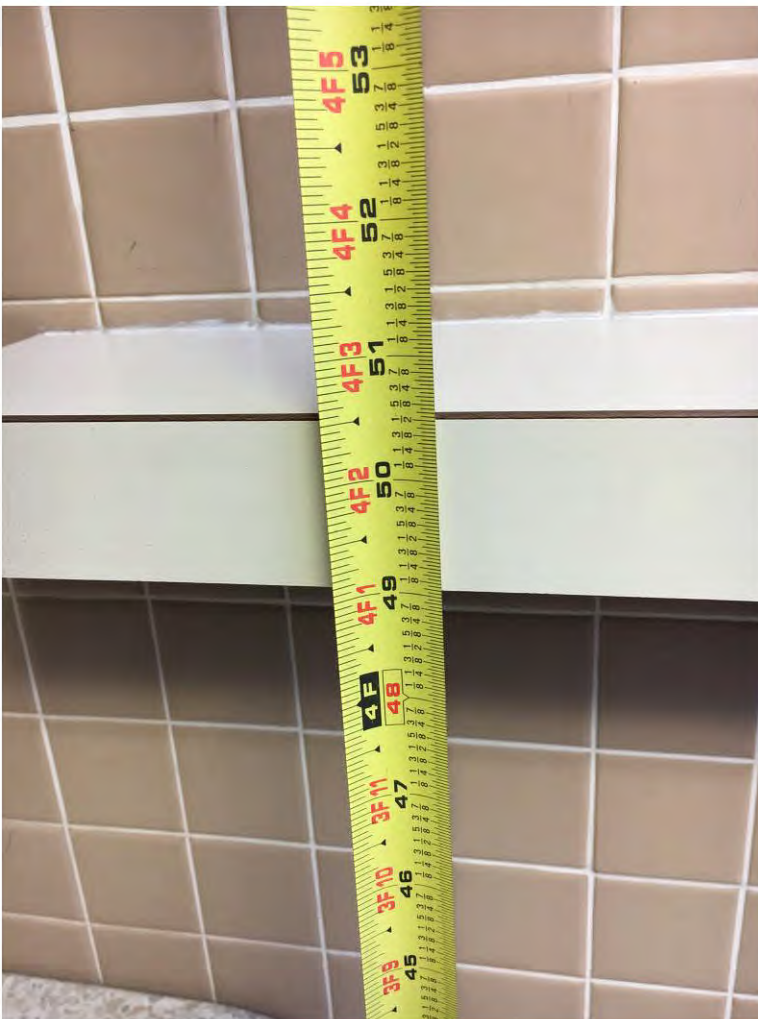
Finding: 14

9 (Low): Restrooms (DOJ level 3) – minimally out of compliance.

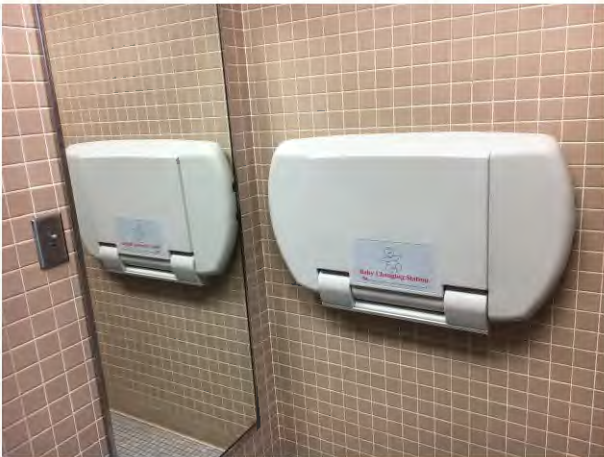
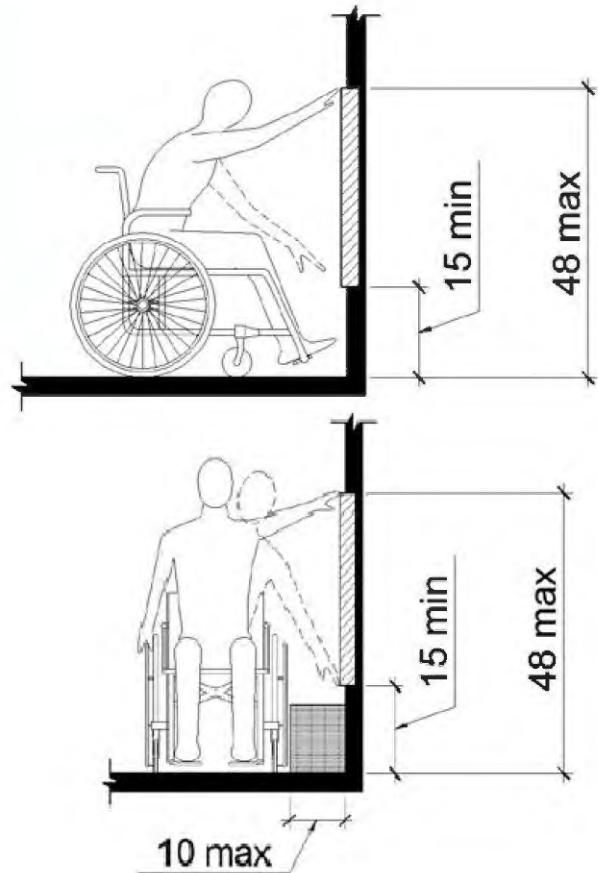
Finding: 15

9 (Low): Restrooms (DOJ level 3) – minimally out of compliance.

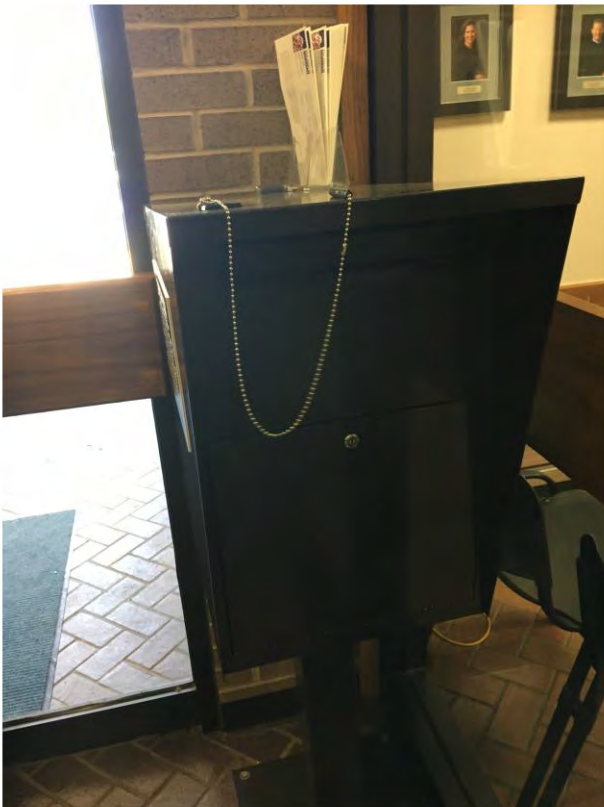
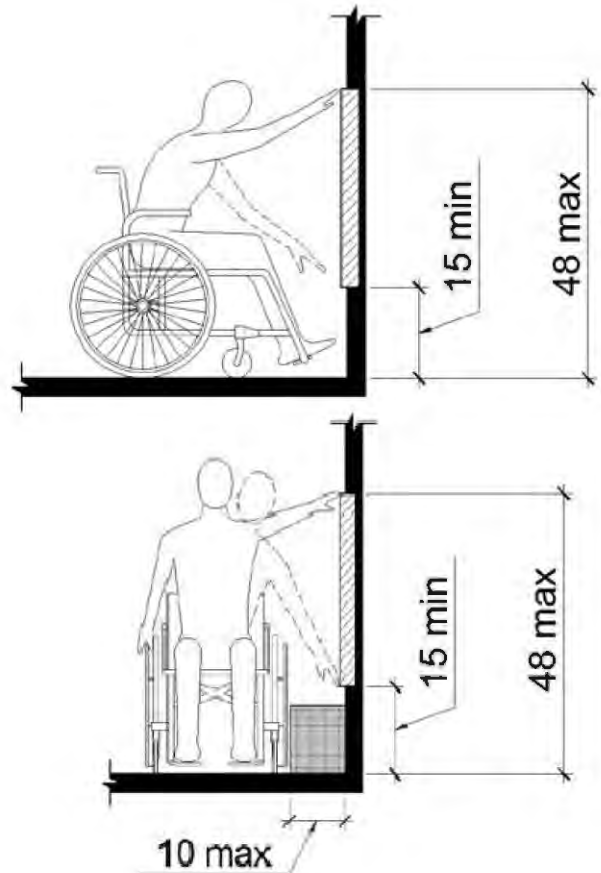
Finding: 16

**Current
Condition:**
50"

7 (Medium): Access to goods and services (DOJ level 2) minimally out of compliance. Restrooms (DOJ level 3) – Moderately out of compliance Drinking fountains or public phones (DOJ level 4 & 5) severely out of compliance.

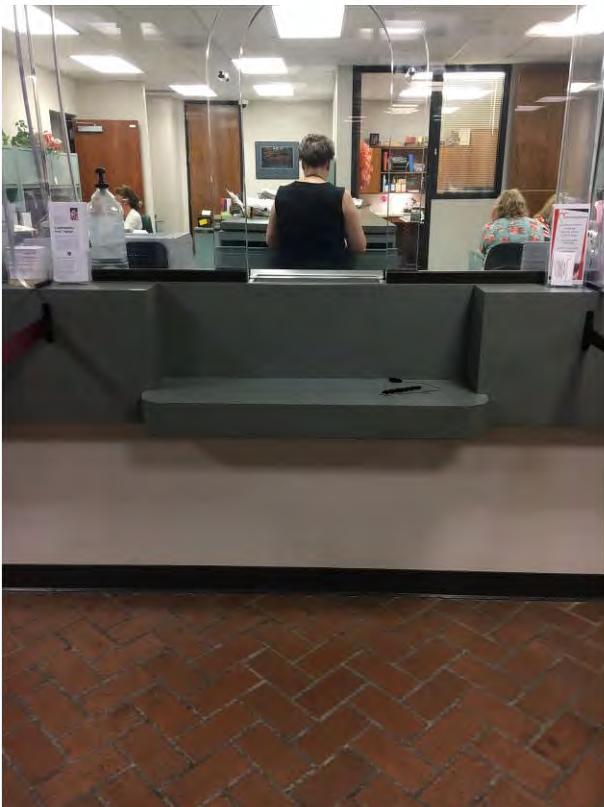
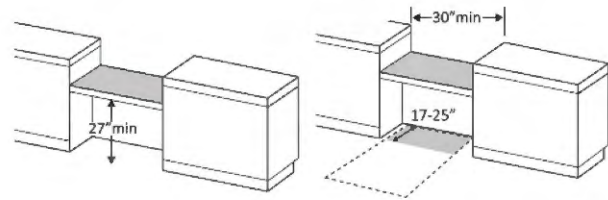
Finding: 17

5 (Medium): Access to goods and services issues (DOJ level 2) - severely out of compliance.

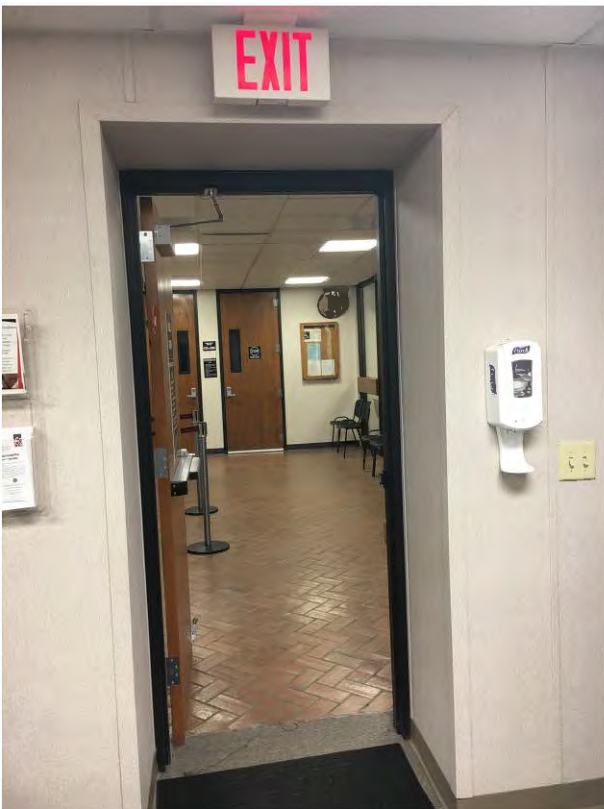
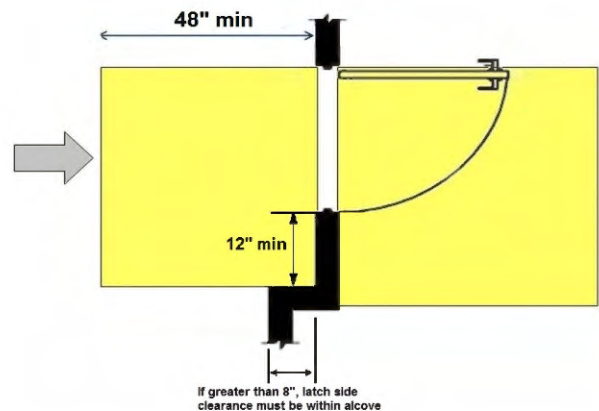
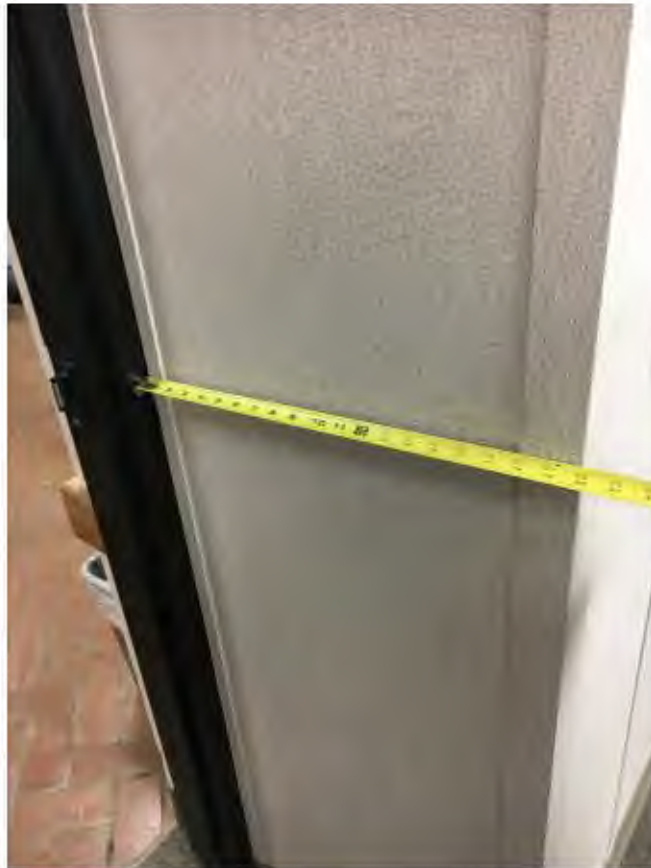
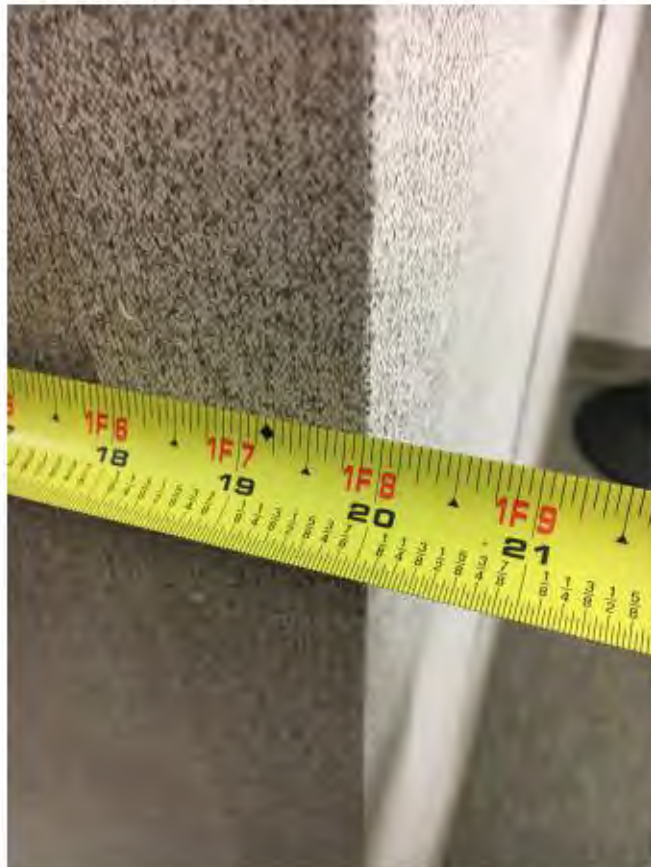
Finding: 18

6 (Medium): Access to goods and services (DOJ level 2) moderately out of compliance. Parking or exterior conditions (DOJ's level 1) – minimally out of compliance. Restrooms (DOJ level 3) – severely out of compliance.

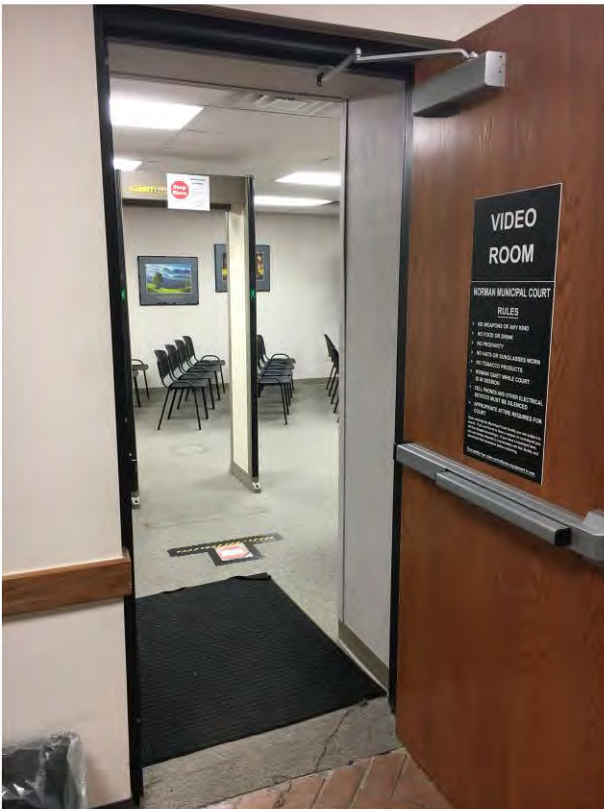
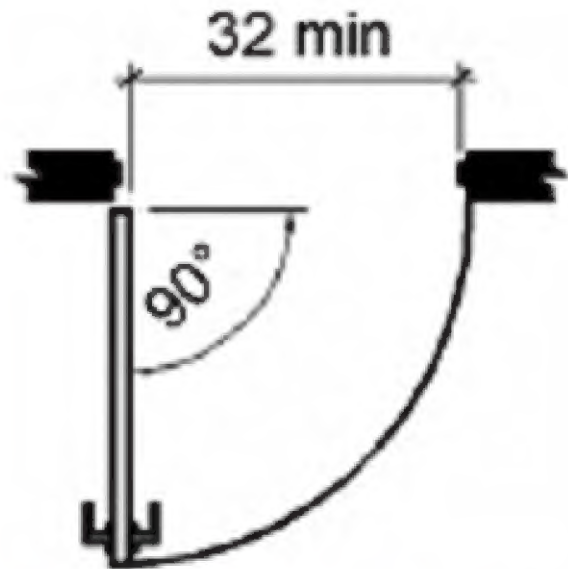
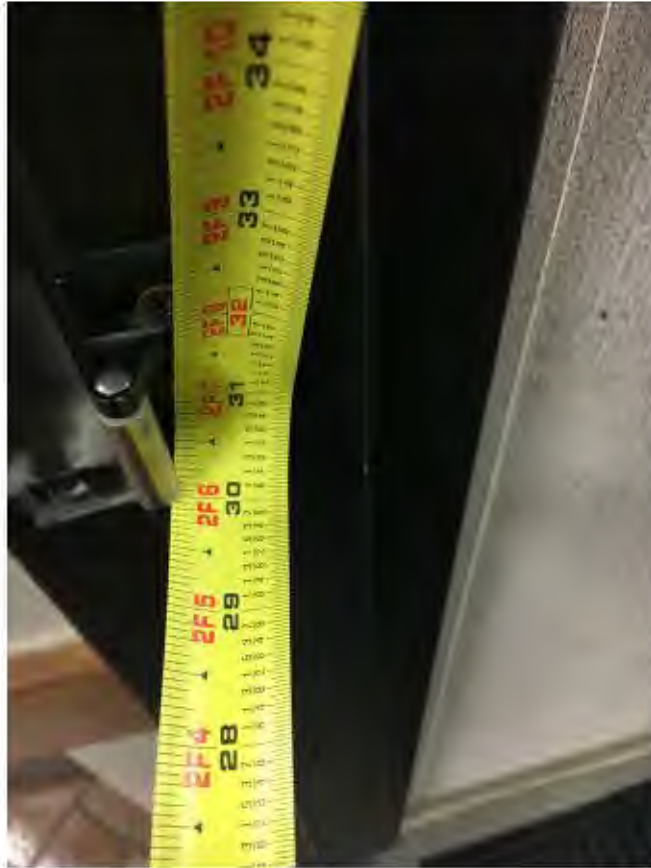
Finding: 19

6 (Medium): Access to goods and services (DOJ level 2) moderately out of compliance. Parking or exterior conditions (DOJ's level 1) – minimally out of compliance. Restrooms (DOJ level 3) – severely out of compliance.

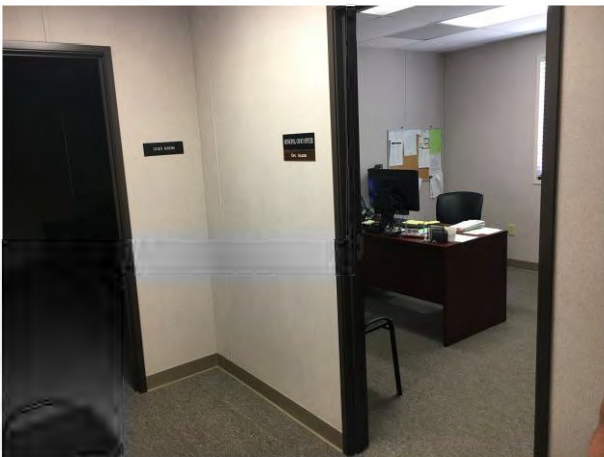
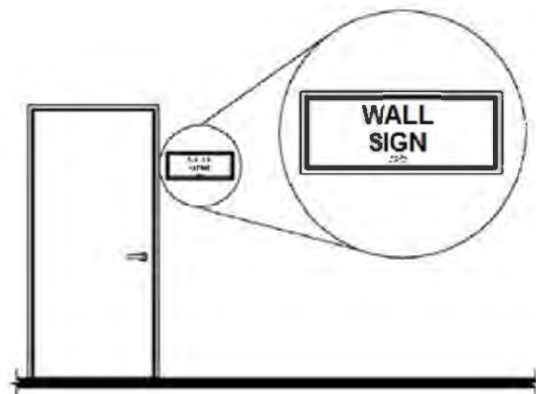
Finding: 20

6 (Medium): Access to goods and services (DOJ level 2) moderately out of compliance. Parking or exterior conditions (DOJ's level 1) – minimally out of compliance. Restrooms (DOJ level 3) – severely out of compliance.

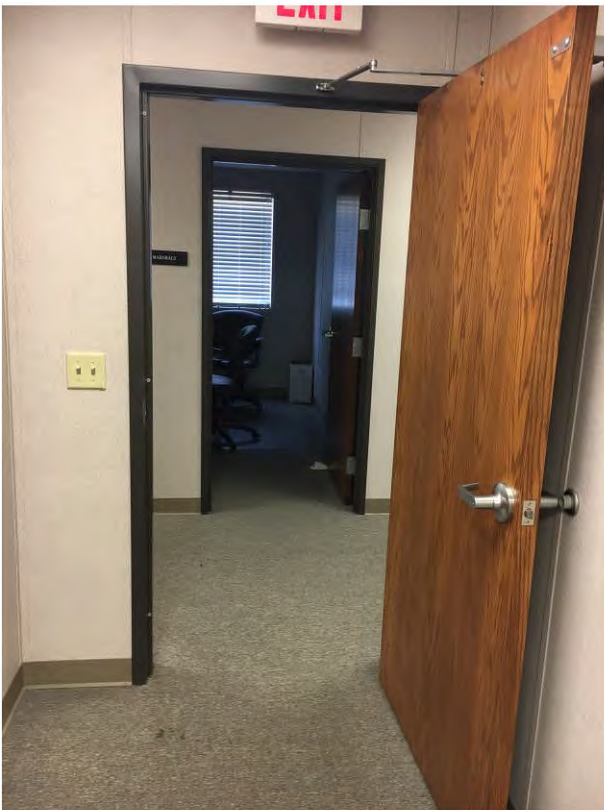
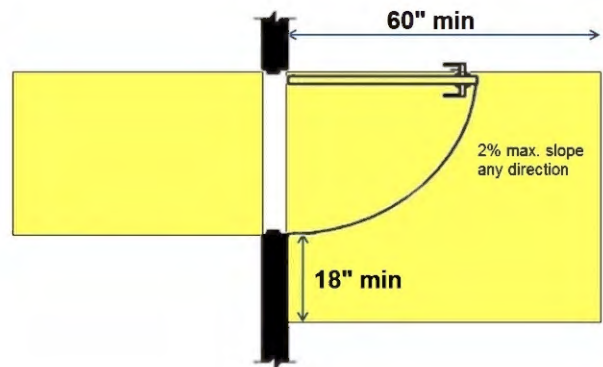
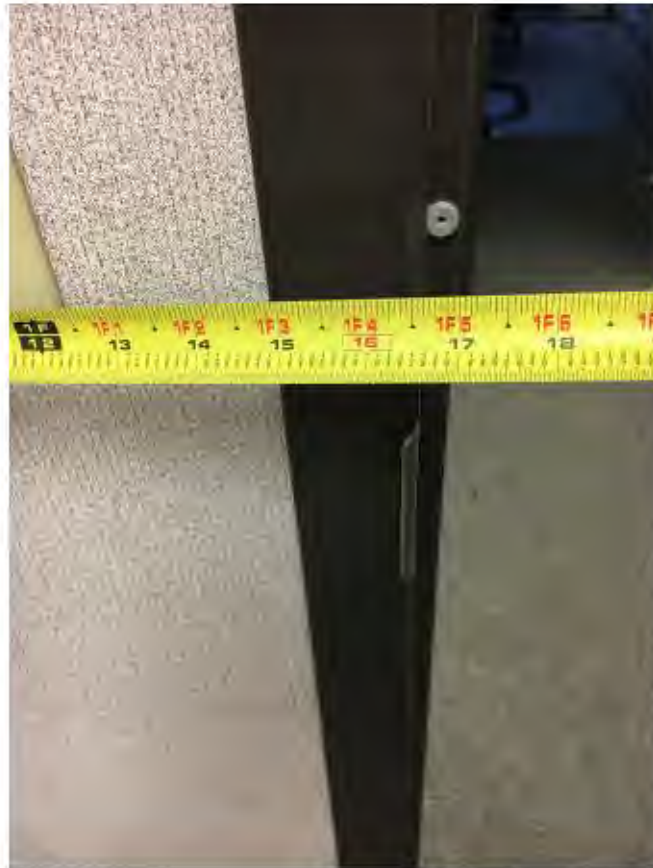
Finding: 21

9 (Low): Restrooms (DOJ level 3) – minimally out of compliance.

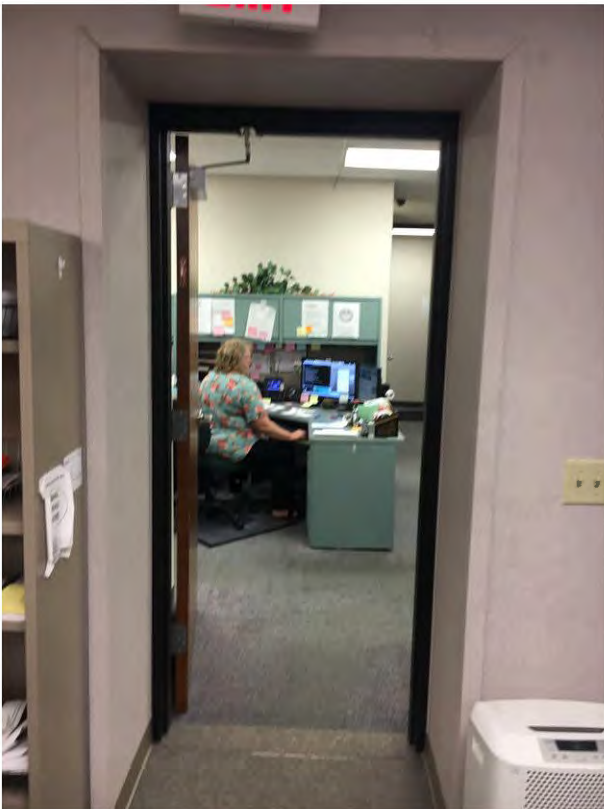
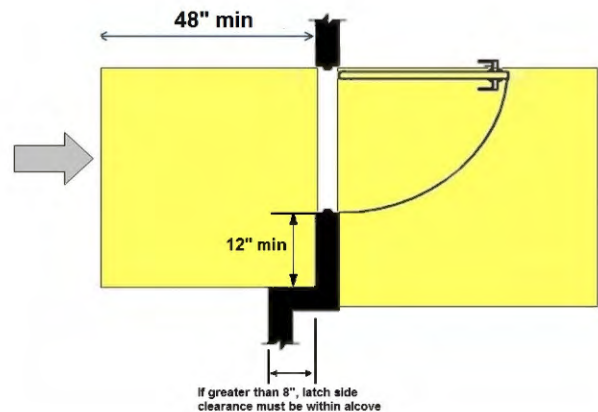
Finding: 22

6 (Medium): Access to goods and services (DOJ level 2) moderately out of compliance. Parking or exterior conditions (DOJ's level 1) – minimally out of compliance. Restrooms (DOJ level 3) – severely out of compliance.

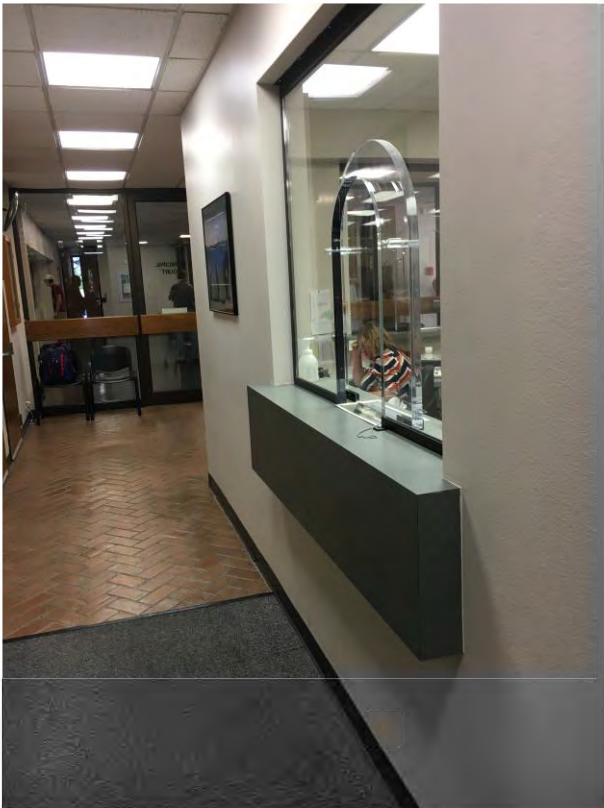
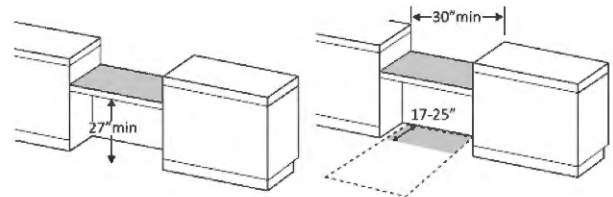
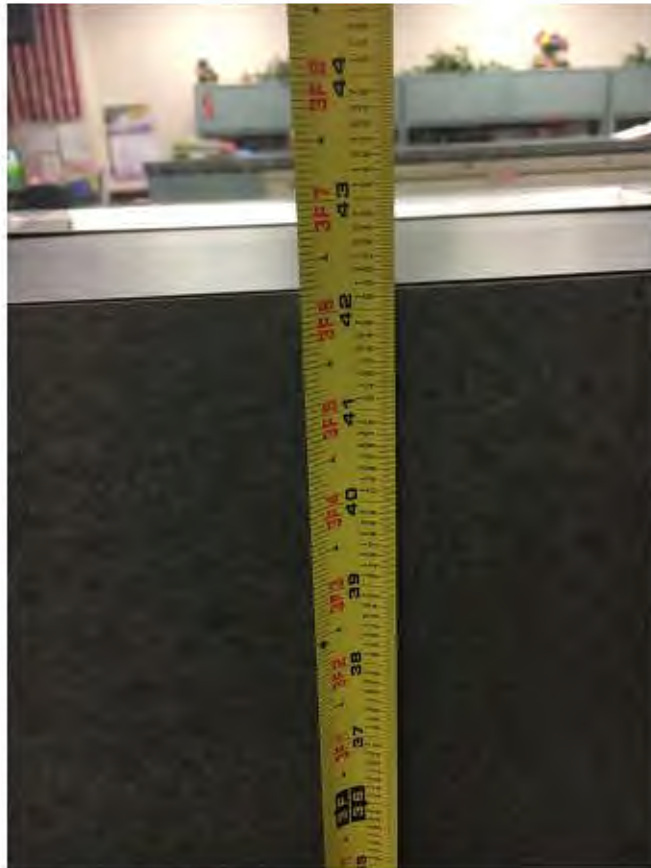
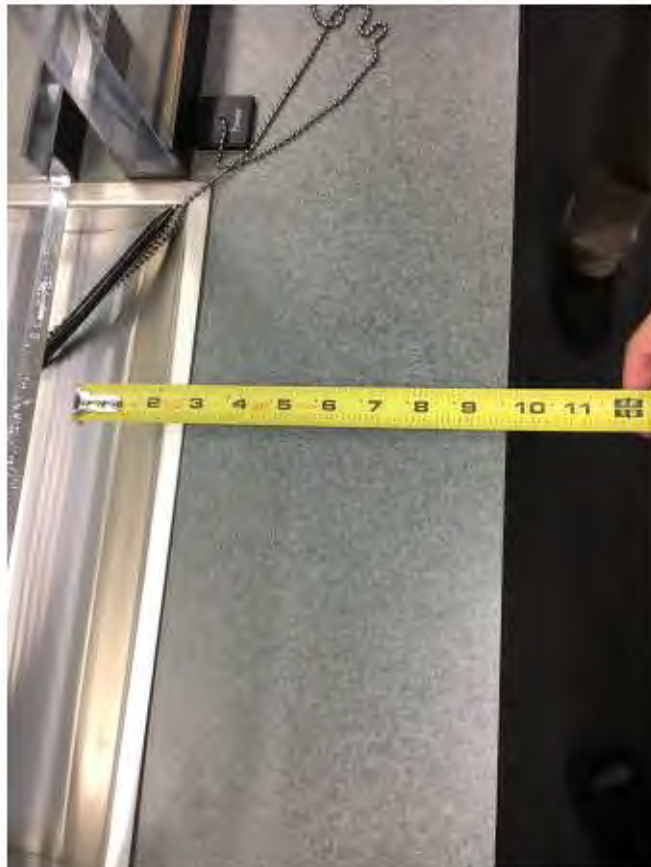
Finding: 23

6 (Medium): Access to goods and services (DOJ level 2) moderately out of compliance. Parking or exterior conditions (DOJ's level 1) – minimally out of compliance. Restrooms (DOJ level 3) – severely out of compliance.

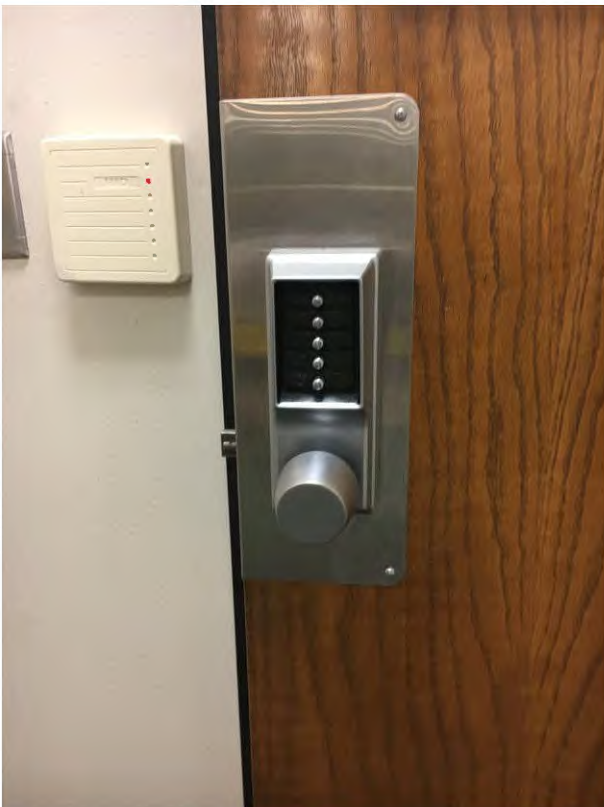
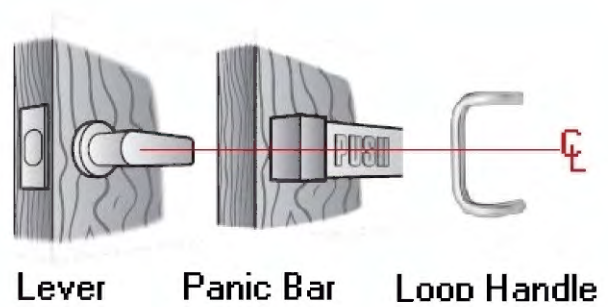
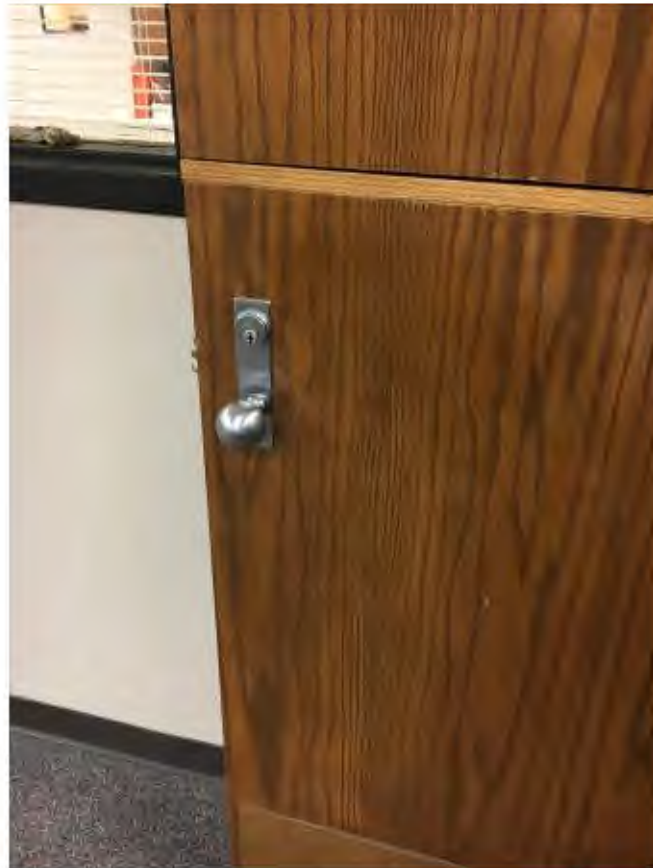
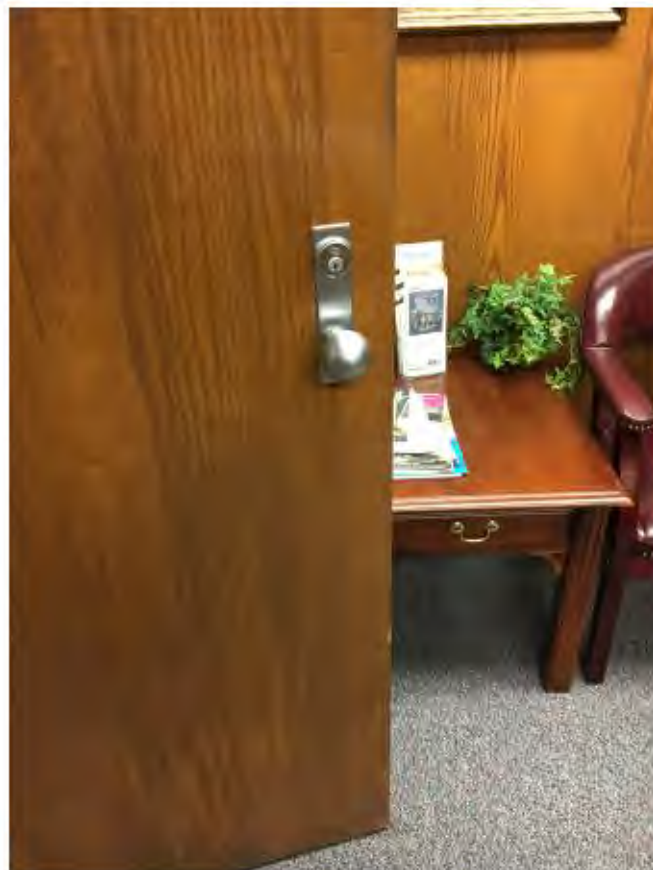
Finding: 24

5 (Medium): Access to goods and services issues (DOJ level 2) - severely out of compliance.

Operating hardware must be centered between 34" and 44" above the floor or ground

Replace with lever style door hardware.

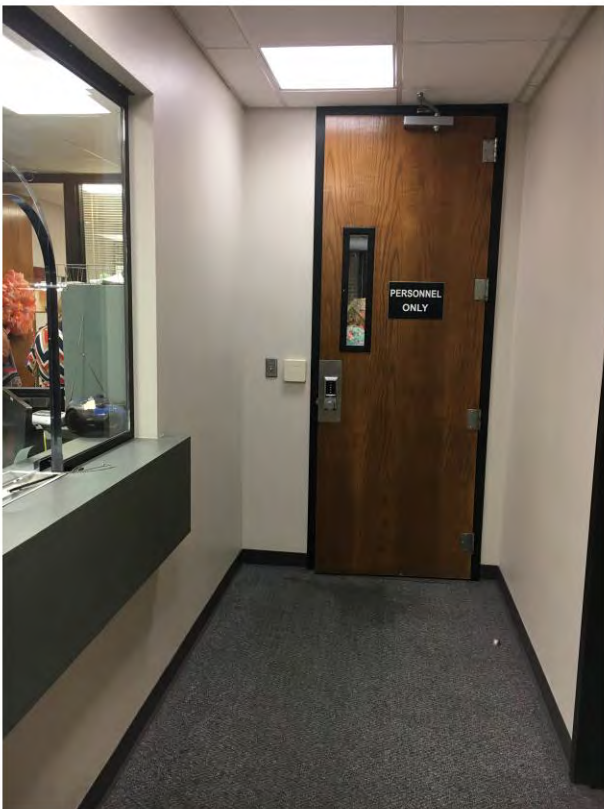
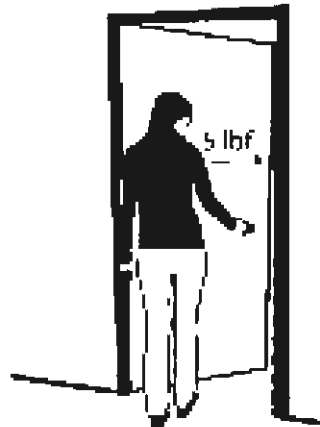
Finding: 25

7 (Medium): Access to goods and services (DOJ level 2) minimally out of compliance. Restrooms (DOJ level 3) – Moderately out of compliance Drinking fountains or public phones (DOJ level 4 & 5) severely out of compliance.

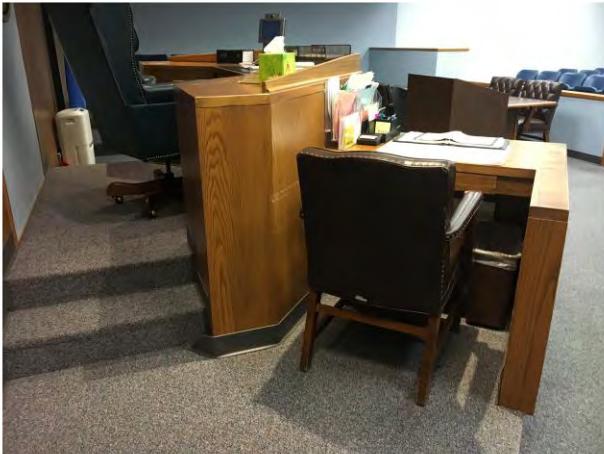
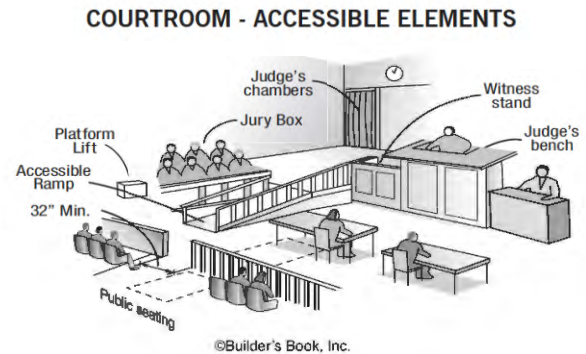
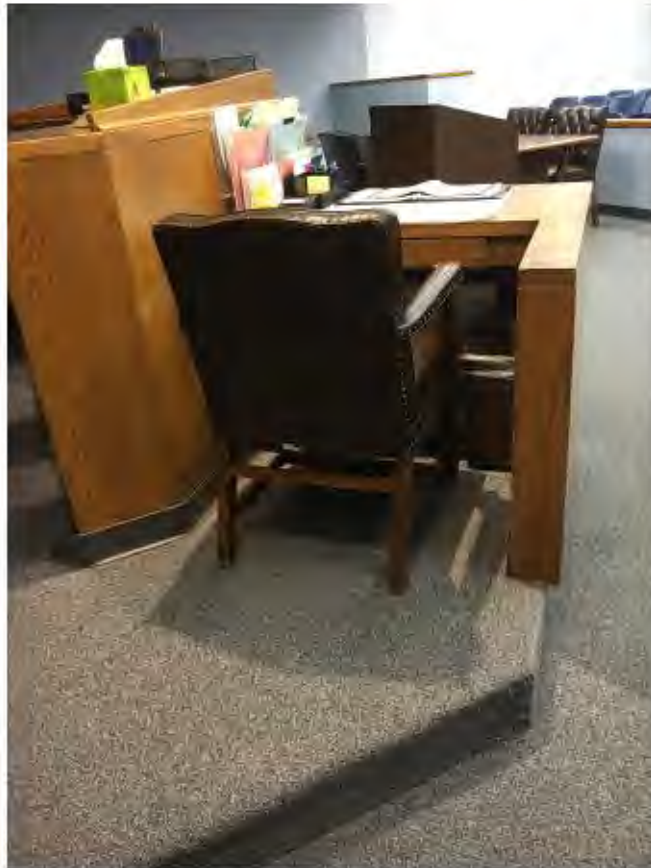
Finding: 26

11 (Low): Client is a Title II agency, elements are out of compliance but may be able to handled programmatically, or do not need to be handled unless or until they hire a person with a disability.

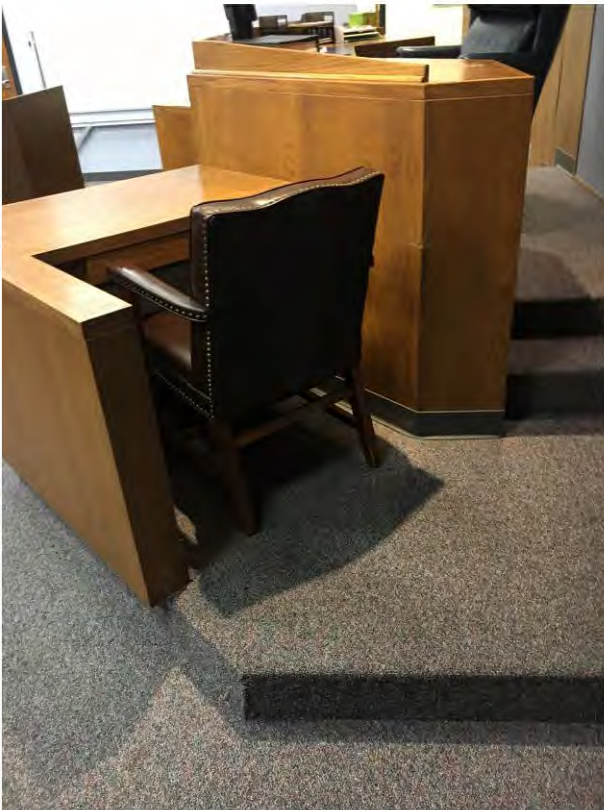
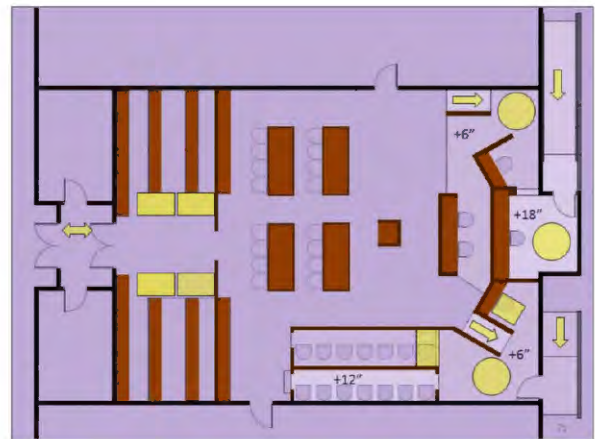
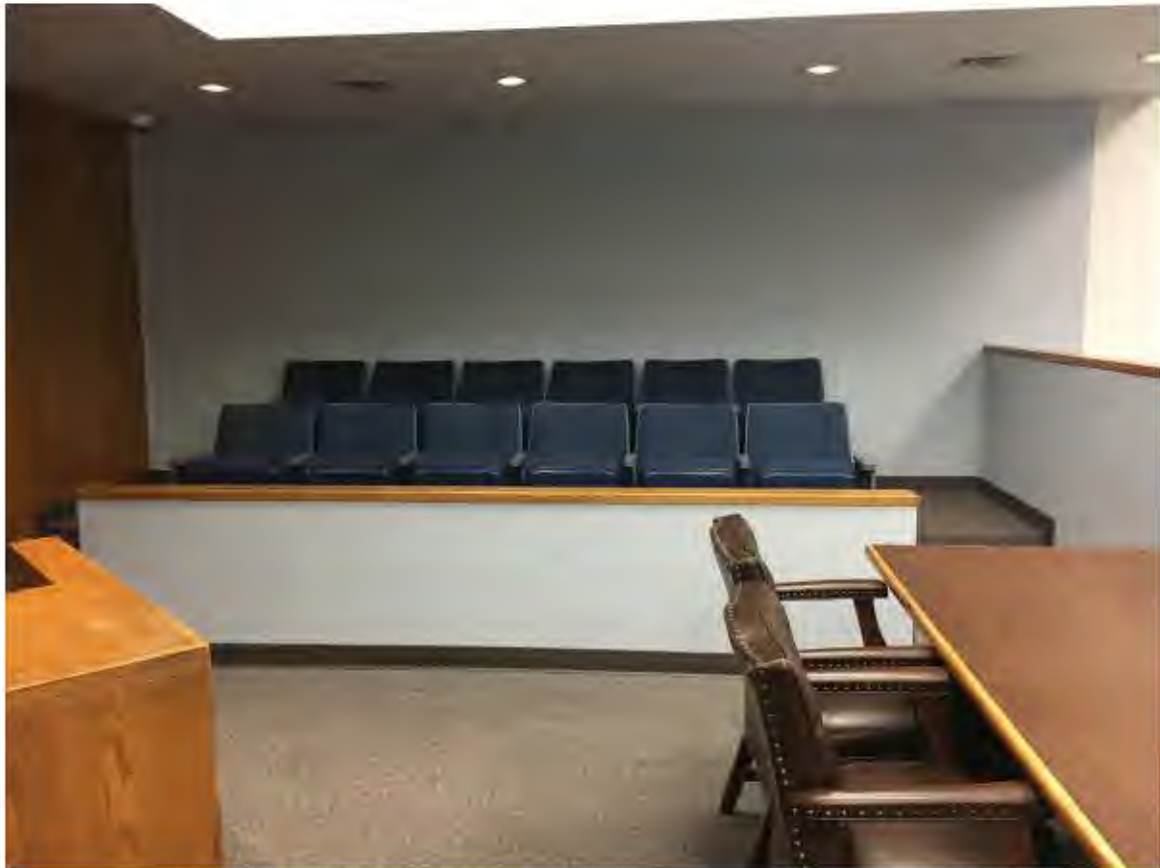
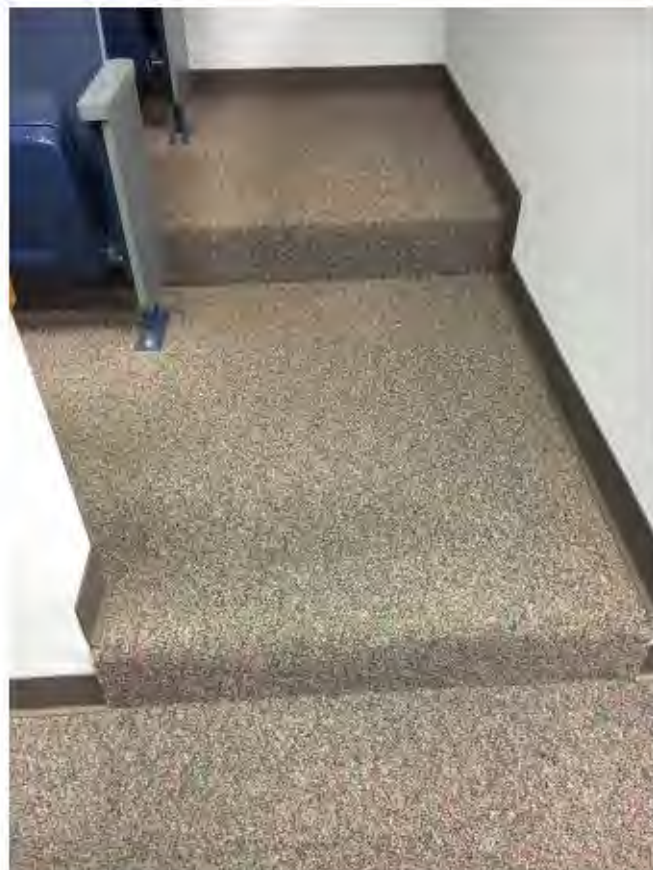
Finding: 27

5 (Medium): Access to goods and services issues (DOJ level 2) - severely out of compliance.

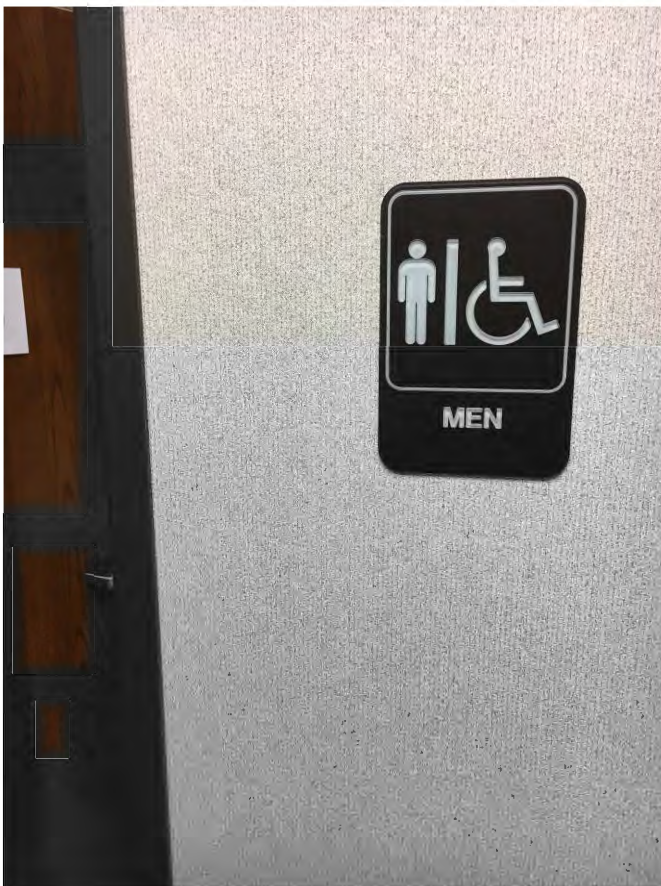
Finding: 28

7 (Medium): Access to goods and services (DOJ level 2) minimally out of compliance. Restrooms (DOJ level 3) – Moderately out of compliance Drinking fountains or public phones (DOJ level 4 & 5) severely out of compliance.
