City of Norman
ADA Self-Evaluation and Transition Plan
Building Cost Projection Summary
5/1/2018

Municipal Complex - Building A

Accessibility Evaluation

Inspection Date: 09/20/2017

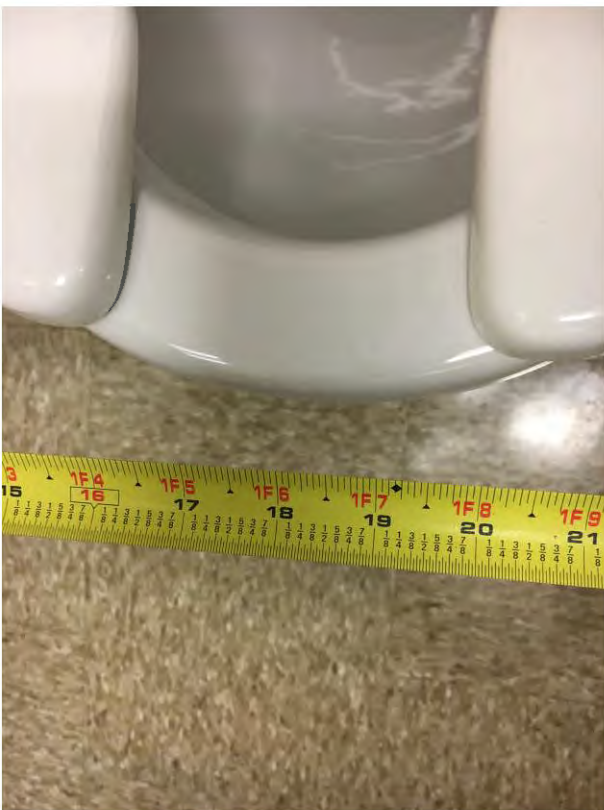
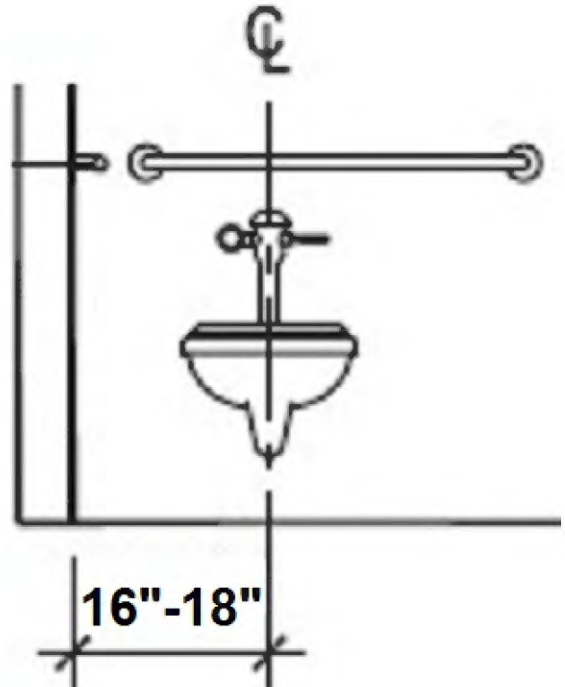
Finding: 29

9 (Low): Restrooms (DOJ level 3) – minimally out of compliance.

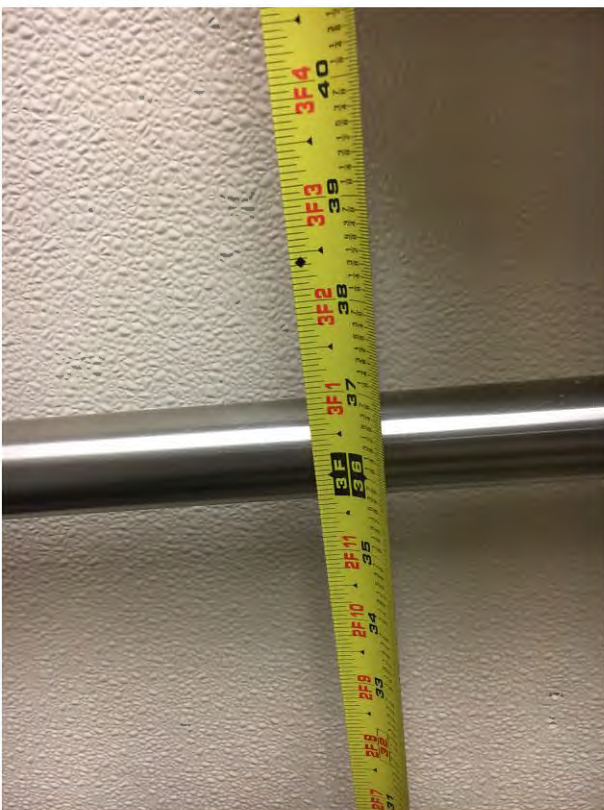
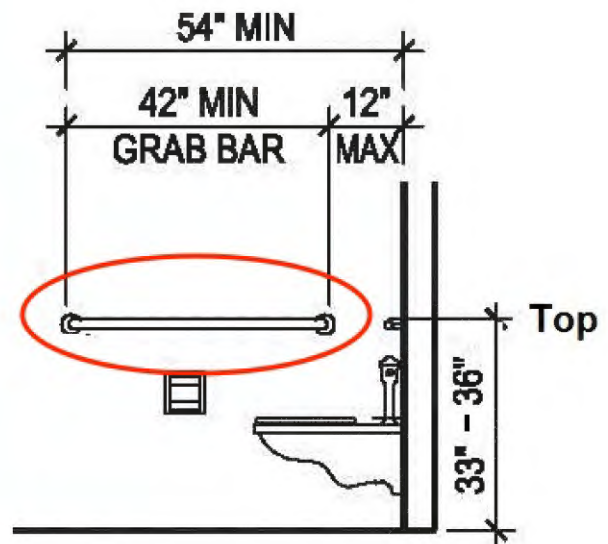
Finding: 30

7 (Medium): Access to goods and services (DOJ level 2) minimally out of compliance. Restrooms (DOJ level 3) – Moderately out of compliance Drinking fountains or public phones (DOJ level 4 & 5) severely out of compliance.

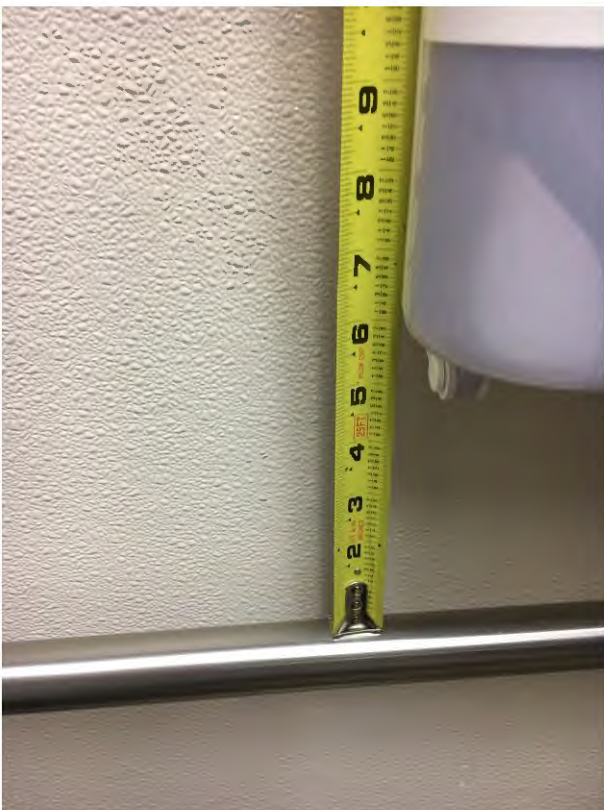
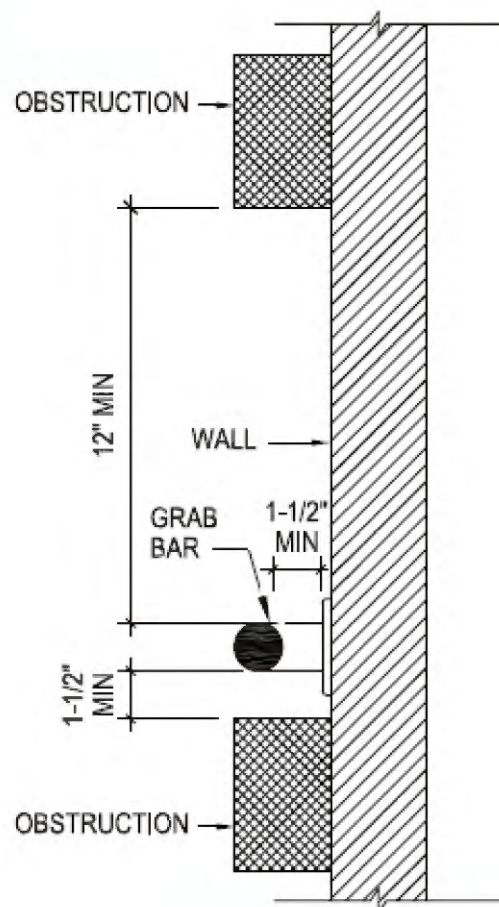
Finding: 31

6 (Medium): Access to goods and services (DOJ level 2) moderately out of compliance. Parking or exterior conditions (DOJ's level 1) – minimally out of compliance. Restrooms (DOJ level 3) – severely out of compliance.

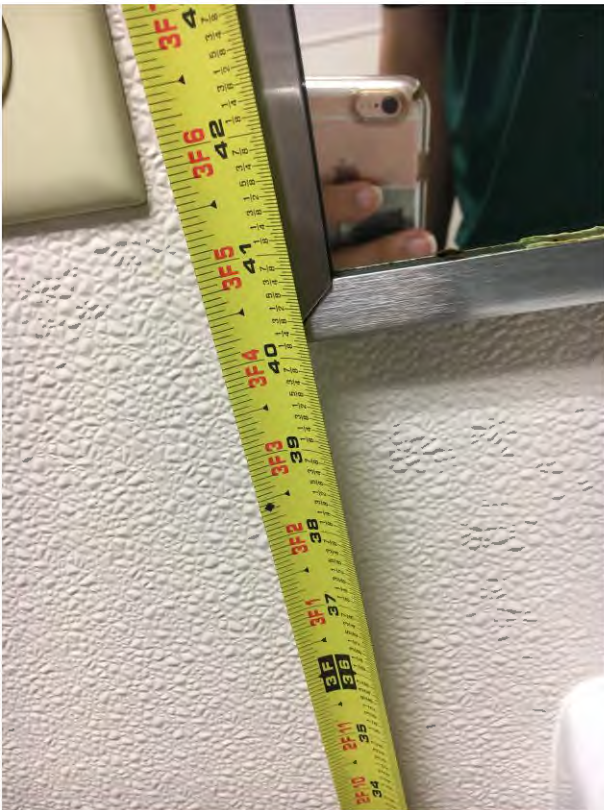
Finding: 33

Municipal Courts - Men's Restroom

7 (Medium): Access to goods and services (DOJ level 2) minimally out of compliance. Restrooms (DOJ level 3) – Moderately out of compliance Drinking fountains or public phones (DOJ level 4 & 5) severely out of compliance.

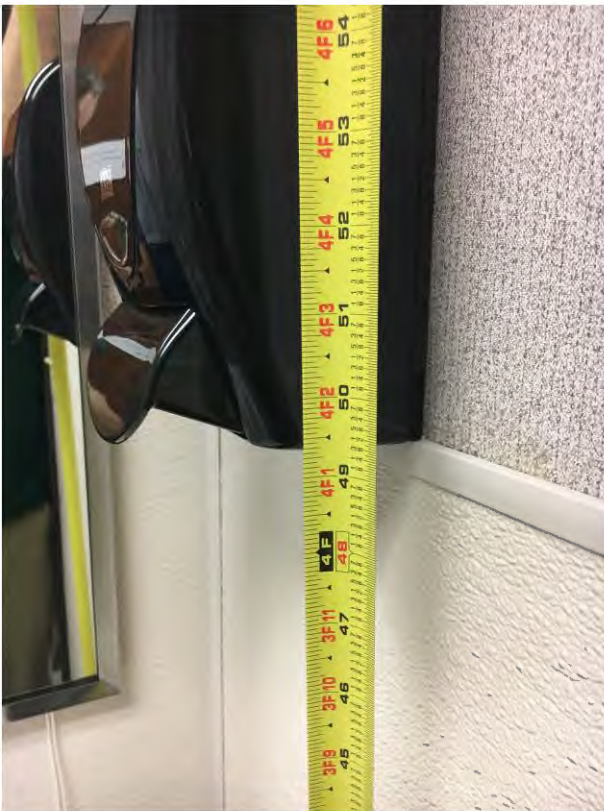
Finding: 34

Municipal Courts - Men's Restroom

9 (Low): Restrooms (DOJ level 3) – minimally out of compliance.

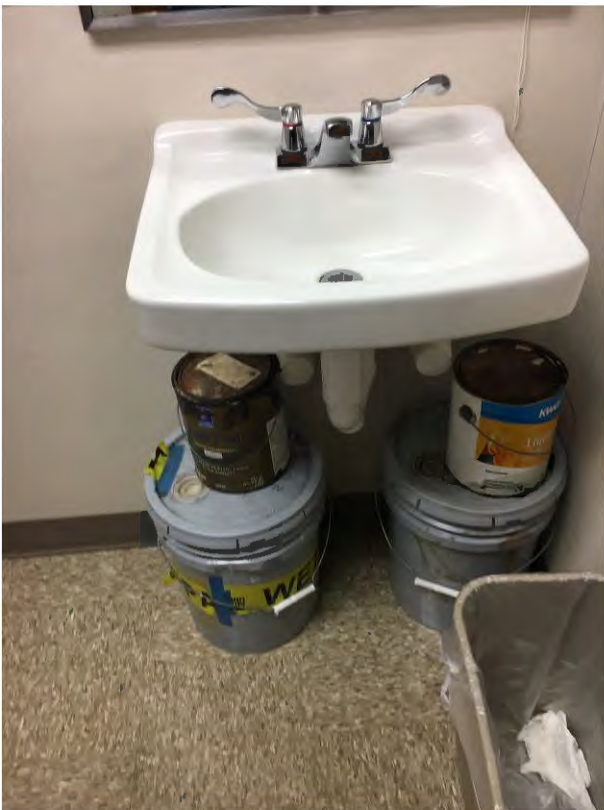
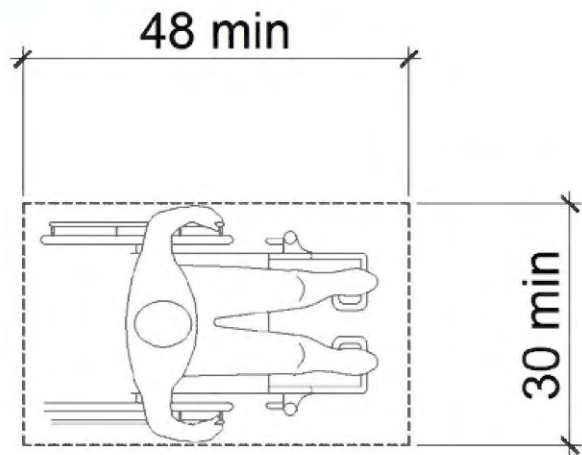
Finding: 35

Municipal Courts - Women's Restroom

7 (Medium): Access to goods and services (DOJ level 2) minimally out of compliance. Restrooms (DOJ level 3) – Moderately out of compliance Drinking fountains or public phones (DOJ level 4 & 5) severely out of compliance.

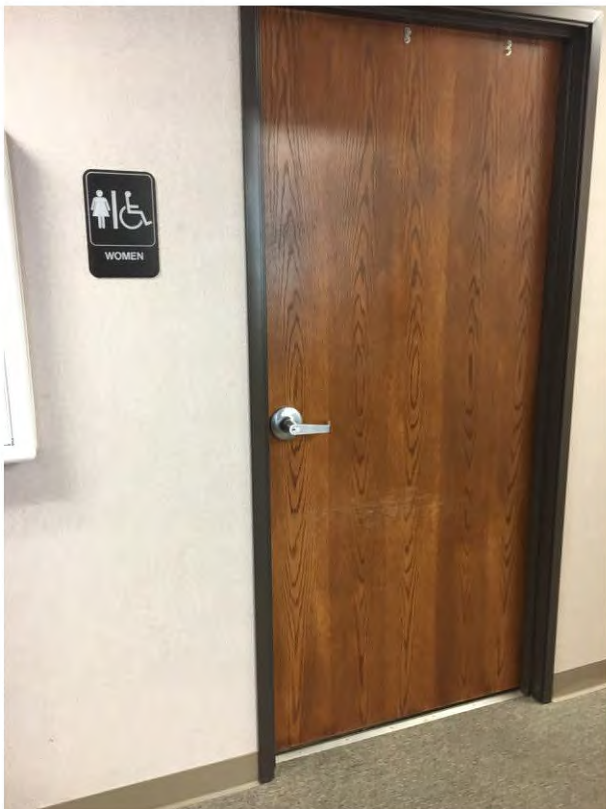
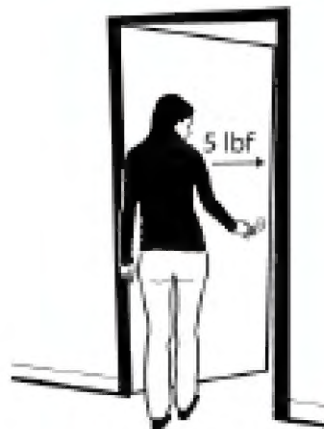
Finding: 36

Municipal Courts - Women's Restroom

9 (Low): Restrooms (DOJ level 3) – minimally out of compliance.

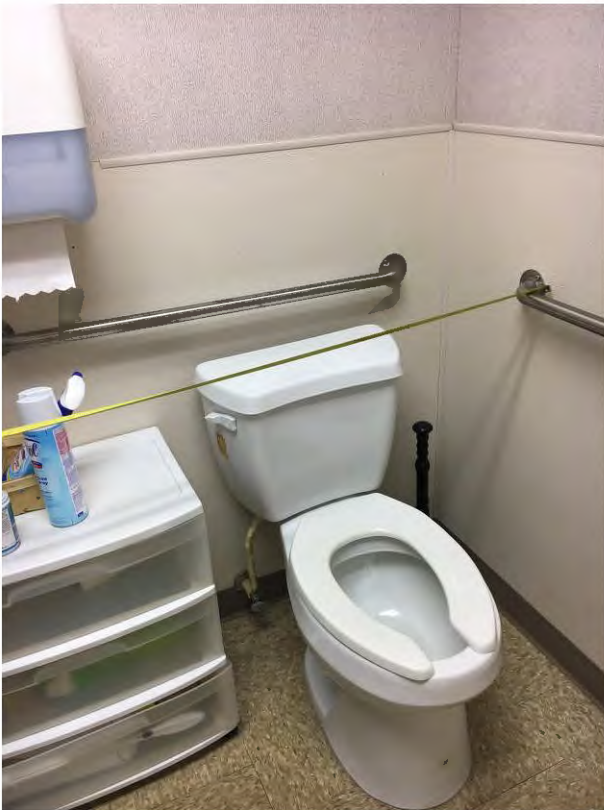
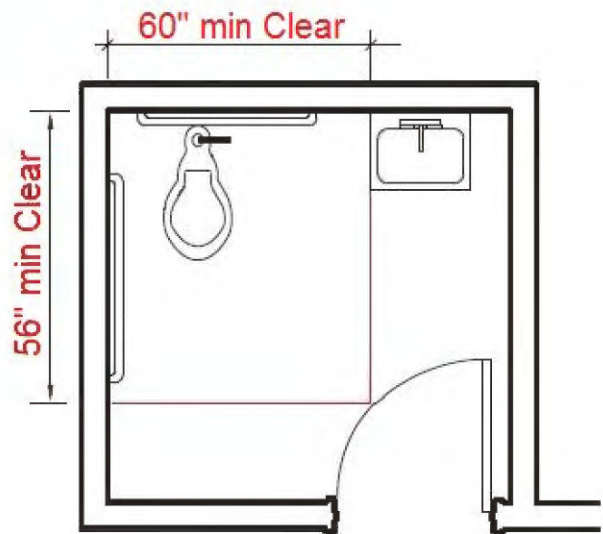
Finding: 37

Municipal Courts - Women's Restroom

7 (Medium): Access to goods and services (DOJ level 2) minimally out of compliance. Restrooms (DOJ level 3) – Moderately out of compliance Drinking fountains or public phones (DOJ level 4 & 5) severely out of compliance.

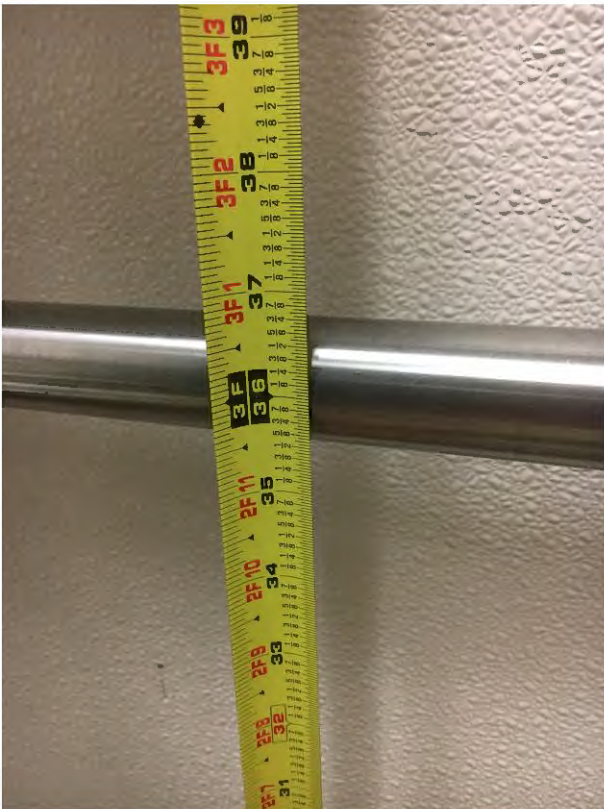
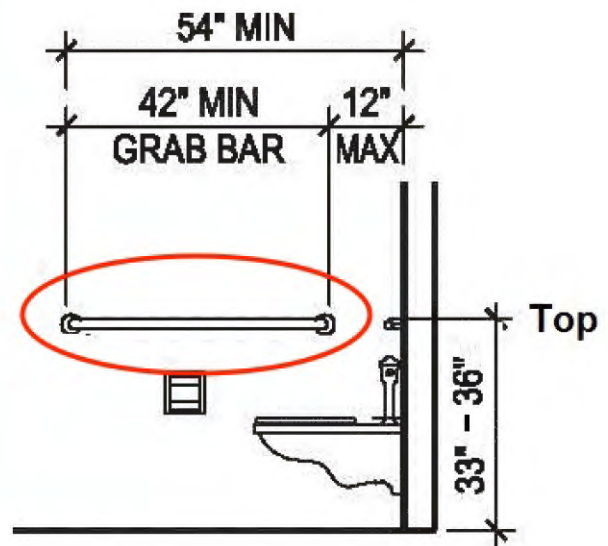
Finding: 38

Municipal Courts - Women's Restroom

6 (Medium): Access to goods and services (DOJ level 2) moderately out of compliance. Parking or exterior conditions (DOJ's level 1) – minimally out of compliance. Restrooms (DOJ level 3) – severely out of compliance.

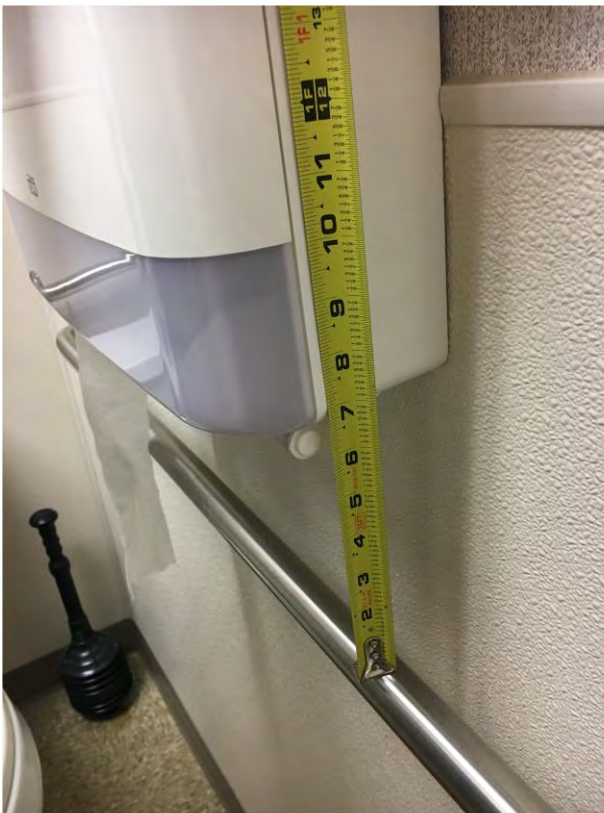
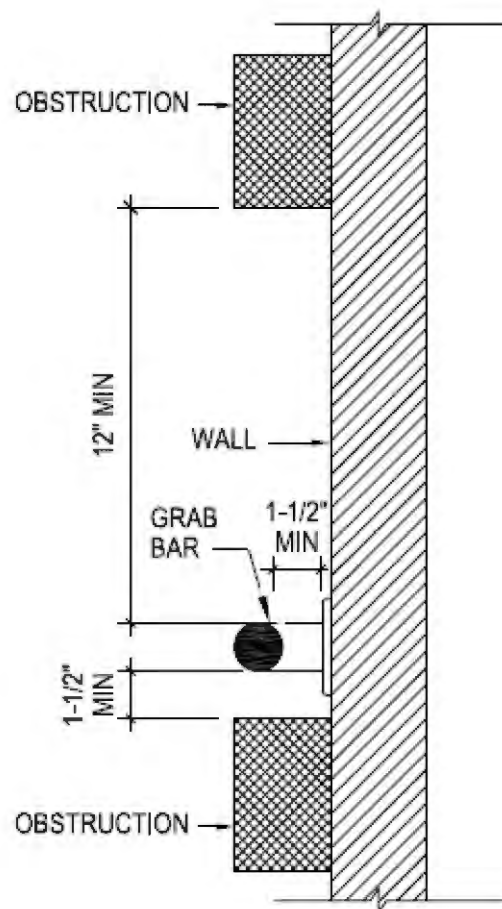
Finding: 39

Municipal Courts - Women's Restroom

6 (Medium): Access to goods and services (DOJ level 2) moderately out of compliance. Parking or exterior conditions (DOJ's level 1) – minimally out of compliance. Restrooms (DOJ level 3) – severely out of compliance.

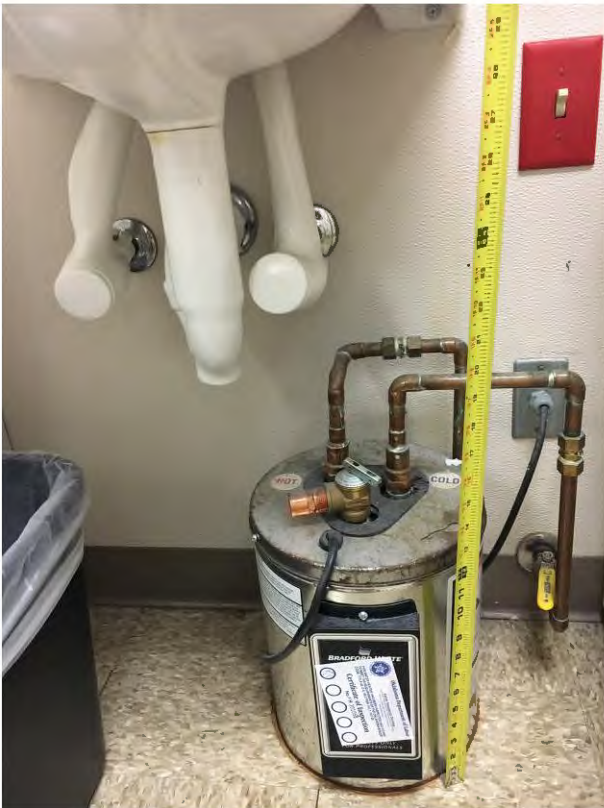
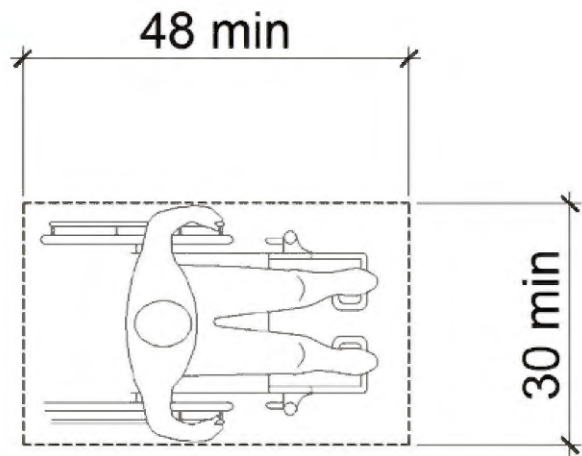
Finding: 40

Municipal Courts - Women's Restroom

7 (Medium): Access to goods and services (DOJ level 2) minimally out of compliance. Restrooms (DOJ level 3) – Moderately out of compliance Drinking fountains or public phones (DOJ level 4 & 5) severely out of compliance.

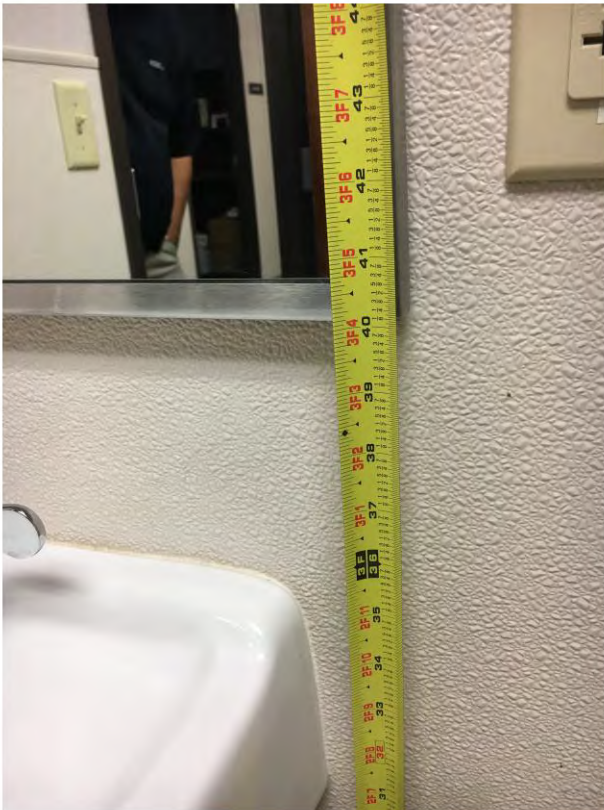
Finding: 41

Municipal Courts - Women's Restroom

9 (Low): Restrooms (DOJ level 3) – minimally out of compliance.

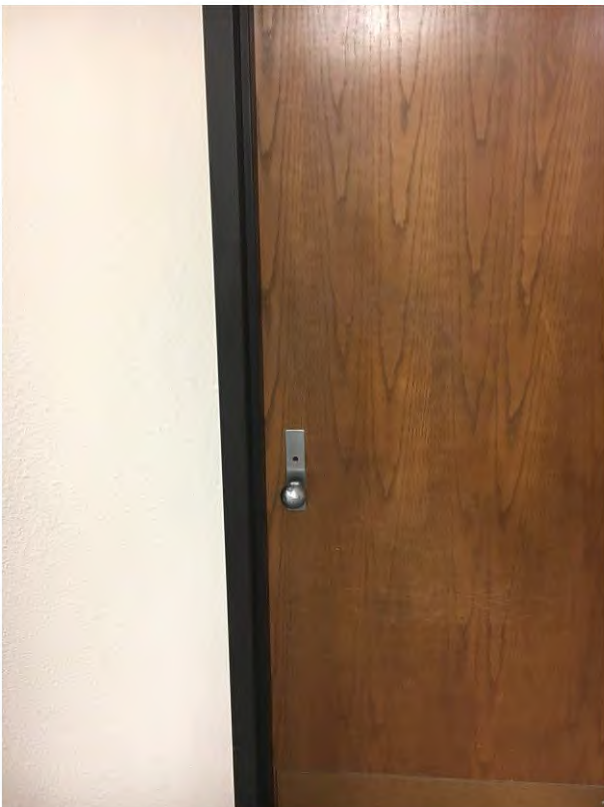
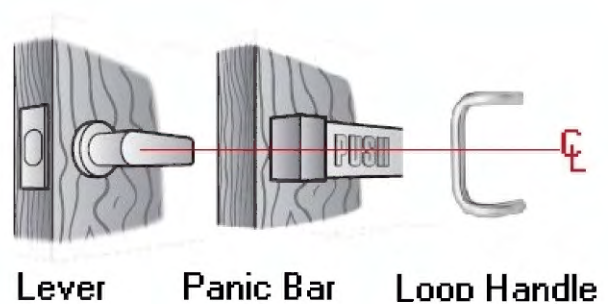
Operating hardware must be centered between 34" and 44" above the floor or ground

Municipal Courts - Judge's Restroom

6 (Medium): Access to goods and services (DOJ level 2) moderately out of compliance. Parking or exterior conditions (DOJ's level 1) – minimally out of compliance. Restrooms (DOJ level 3) – severely out of compliance.

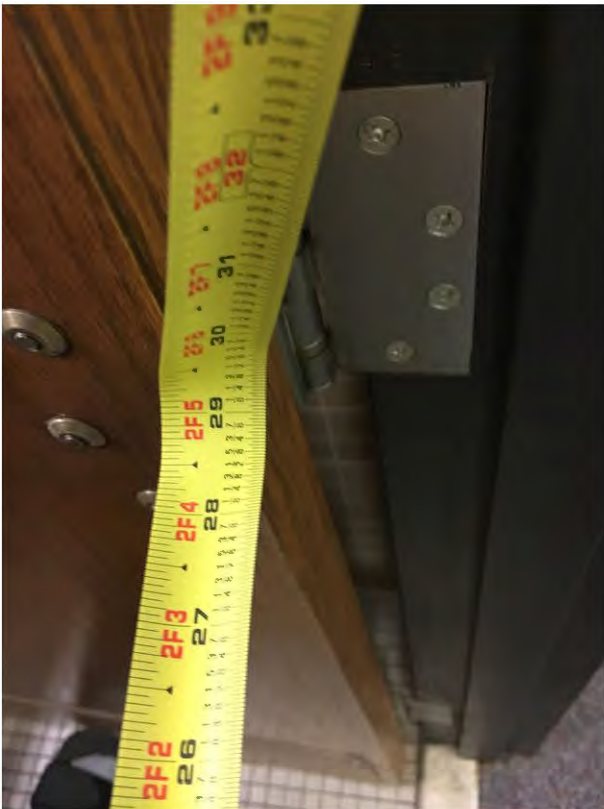
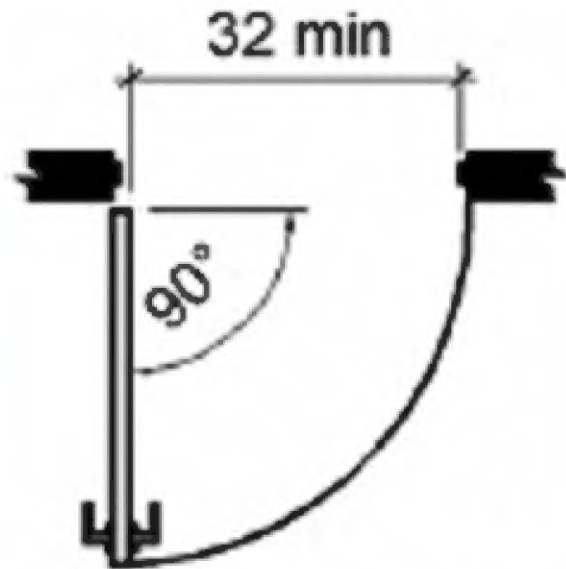
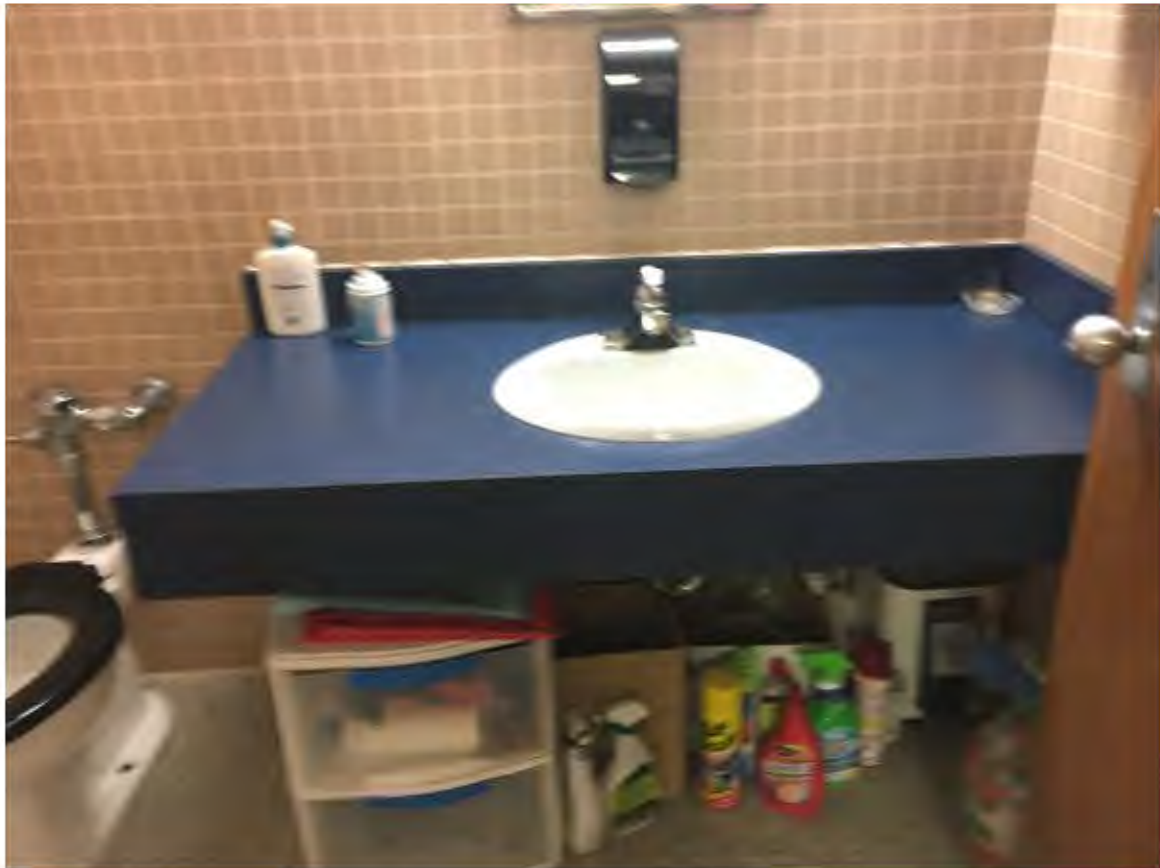
Finding #44 Additional Finding Photos

Hinged Door or Gate

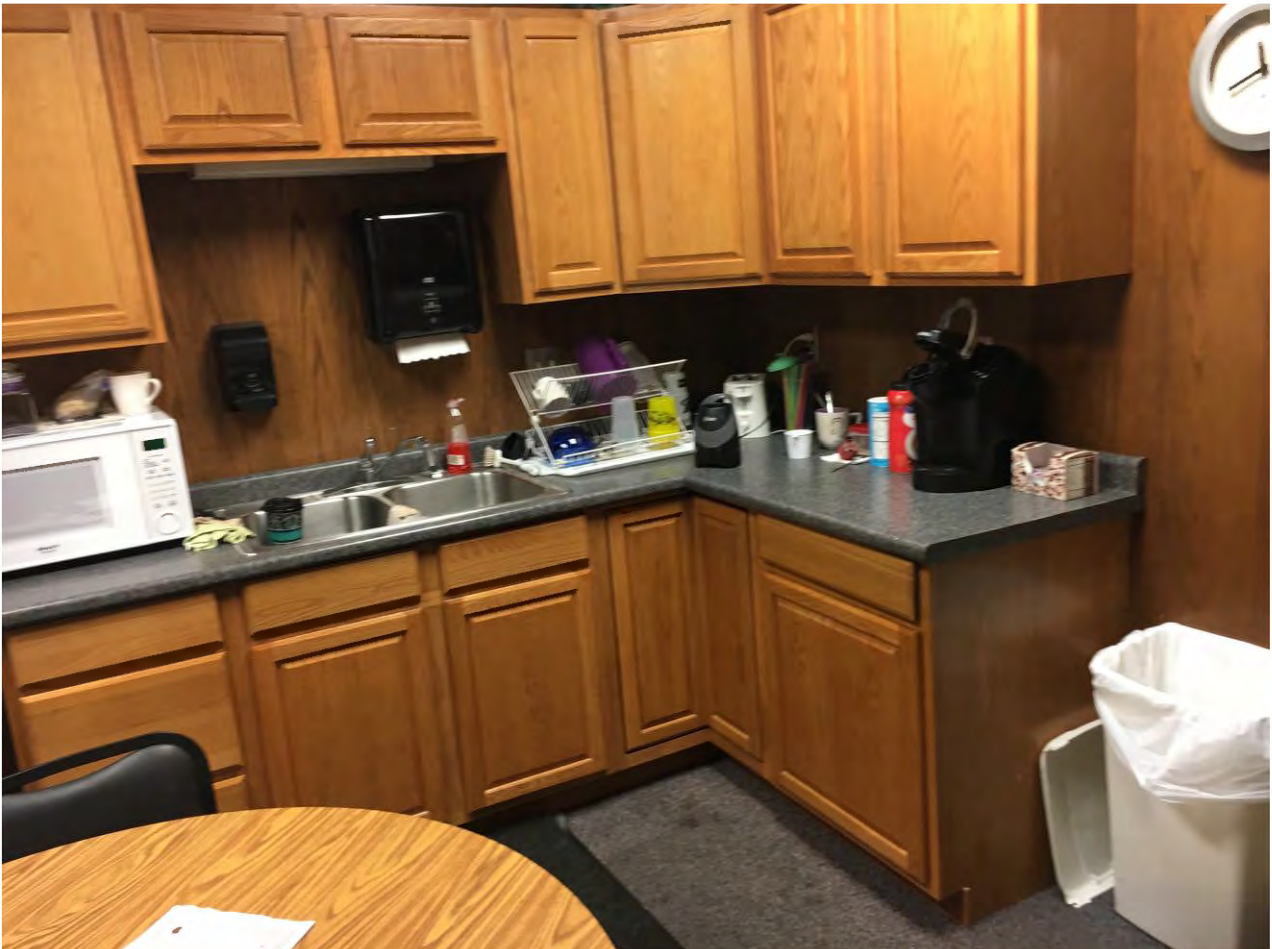
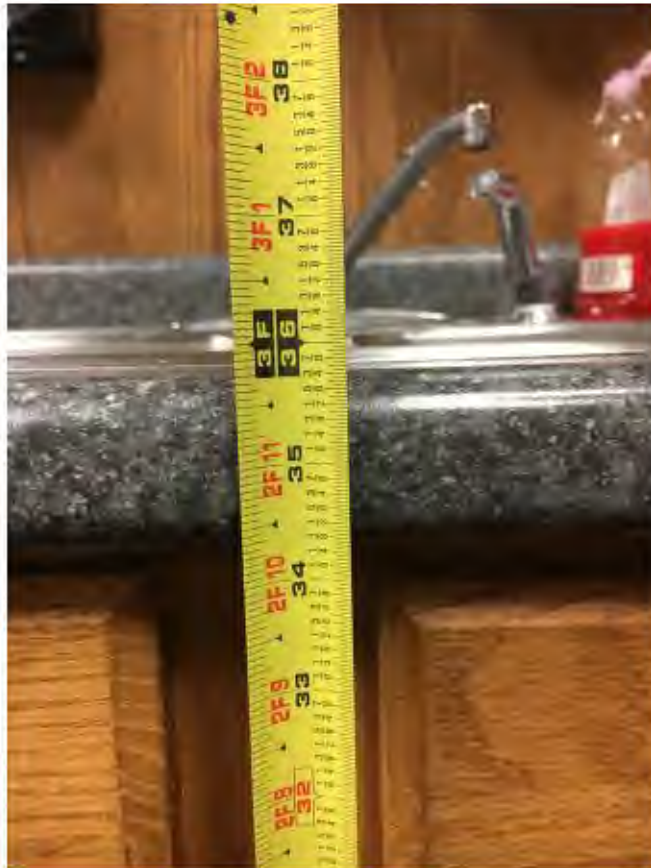
Finding #45 Additional Finding Photos

Municipal Courts - Breakroom

7 (Medium): Access to goods and services (DOJ level 2) minimally out of compliance. Restrooms (DOJ level 3) – Moderately out of compliance Drinking fountains or public phones (DOJ level 4 & 5) severely out of compliance.

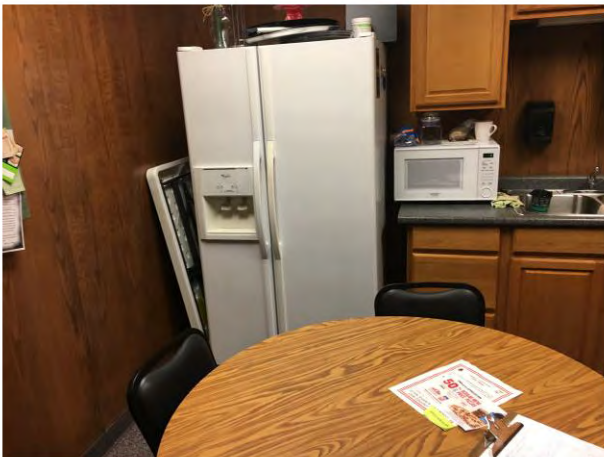
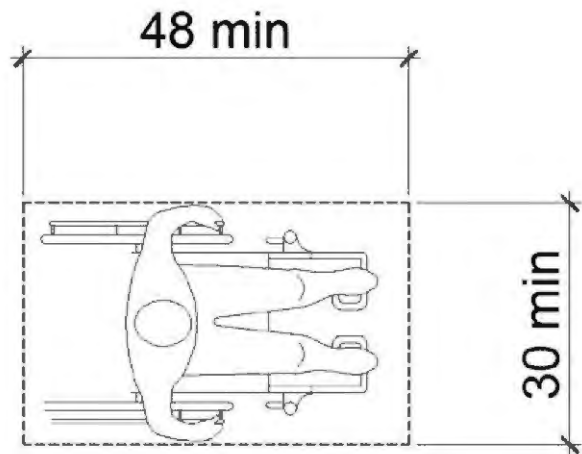
Finding: 46

Municipal Courts - Breakroom

11 (Low): Client is a Title II agency, elements are out of compliance but may be able to handled programmatically, or do not need to be handled unless or until they hire a person with a disability.

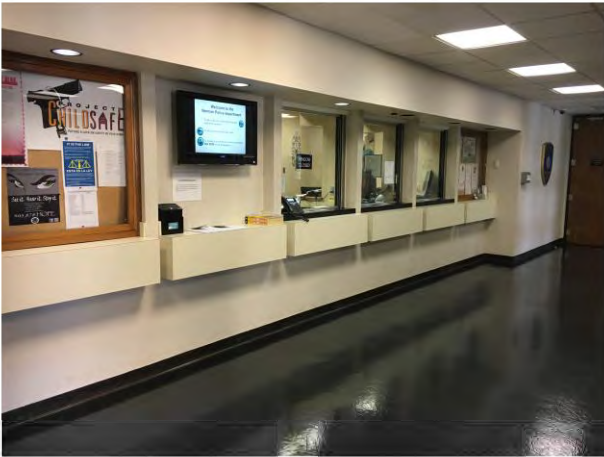
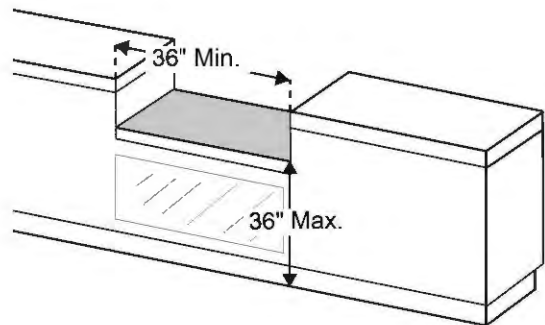
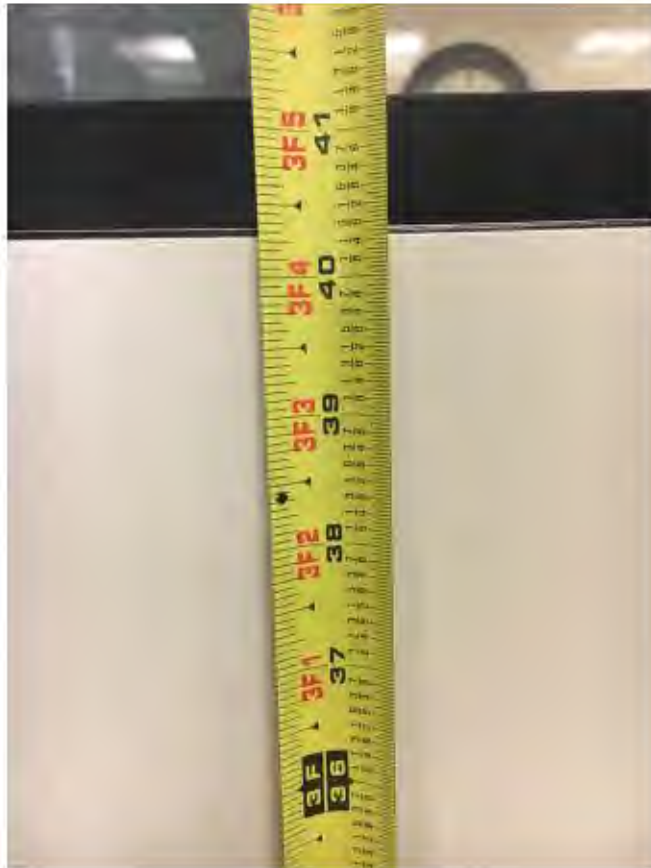
Finding: 47

Police Station - General

5 (Medium): Access to goods and services issues (DOJ level 2) - severely out of compliance.

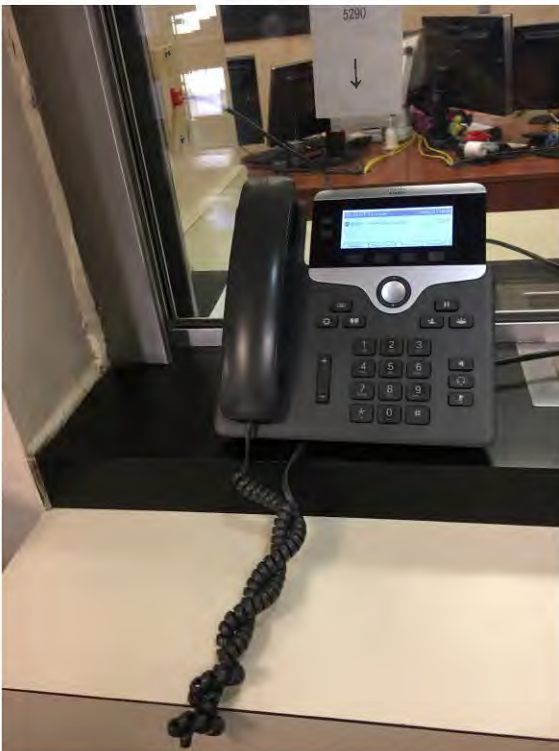
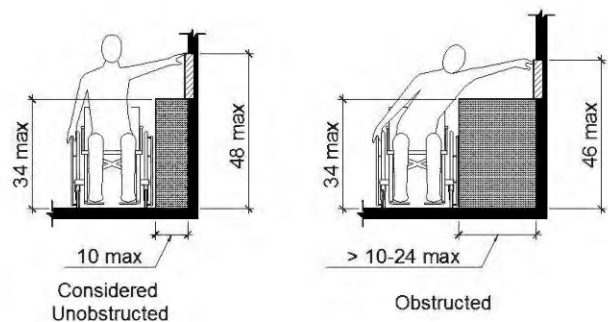
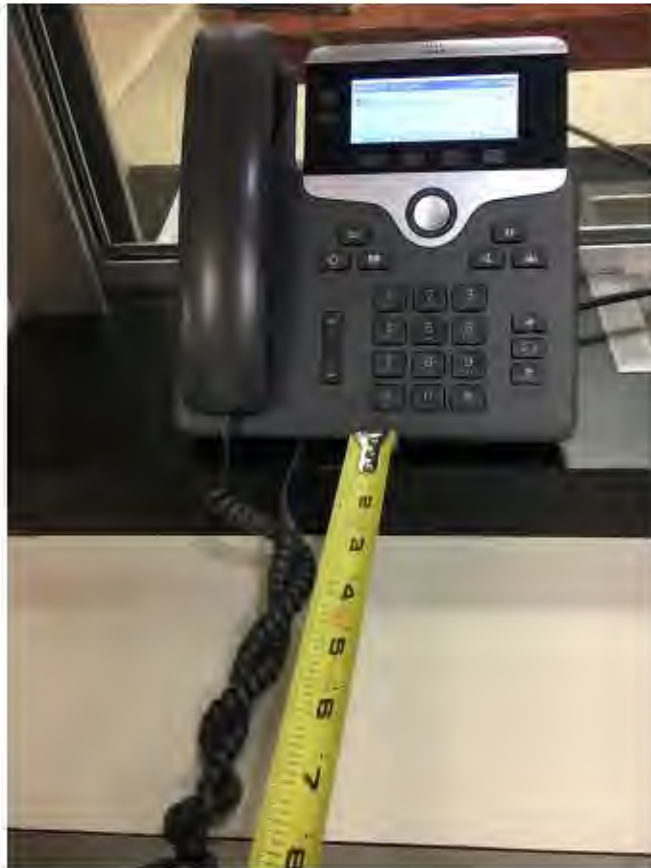
Finding: 48

Police Station - General

7 (Medium): Access to goods and services (DOJ level 2) minimally out of compliance. Restrooms (DOJ level 3) – Moderately out of compliance Drinking fountains or public phones (DOJ level 4 & 5) severely out of compliance.

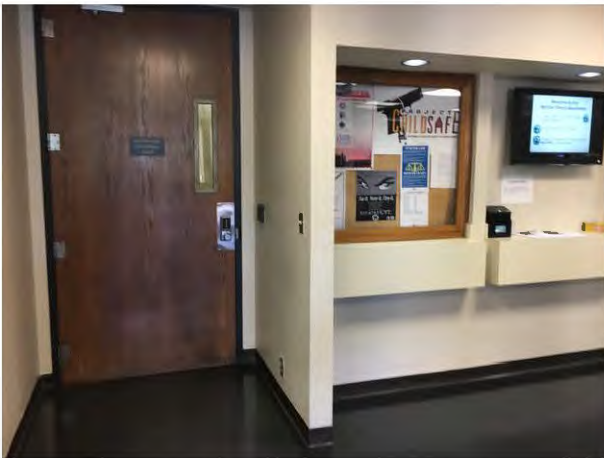
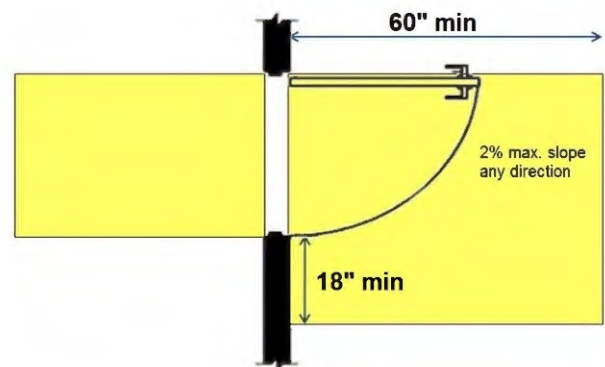
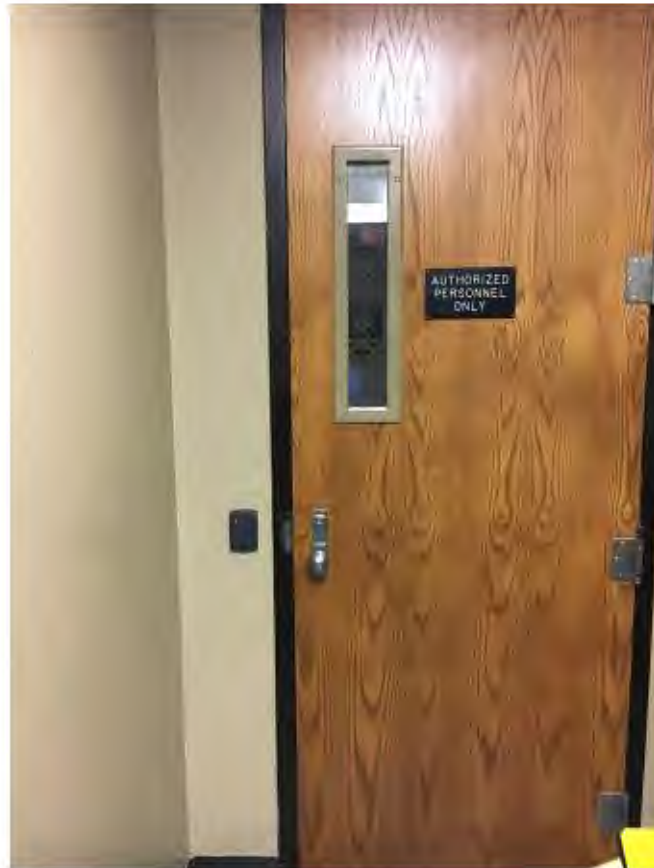
Finding: 49

Police Station - General

6 (Medium): Access to goods and services (DOJ level 2) moderately out of compliance. Parking or exterior conditions (DOJ's level 1) – minimally out of compliance. Restrooms (DOJ level 3) – severely out of compliance.

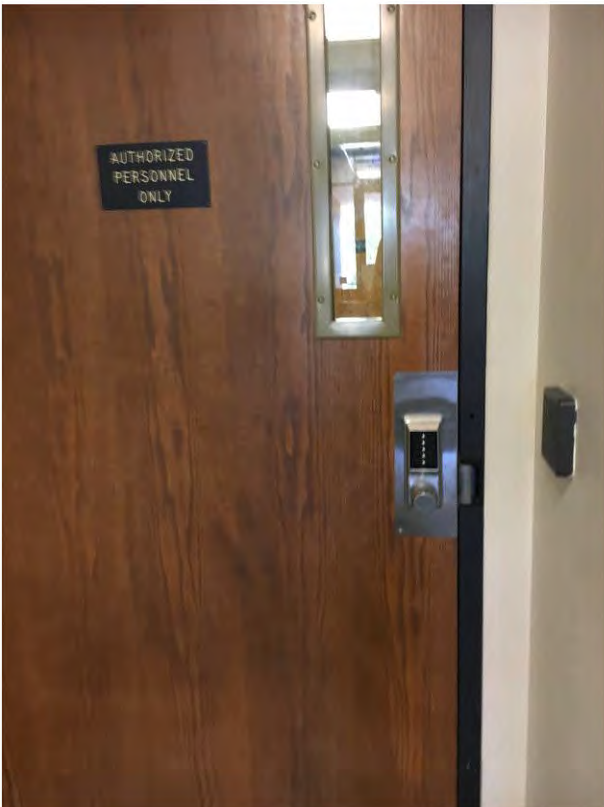
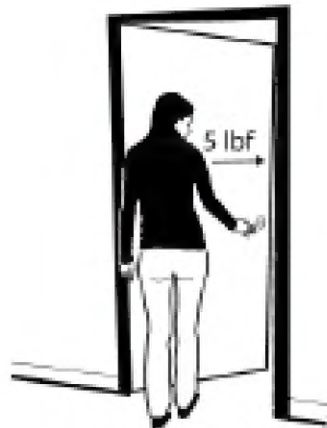
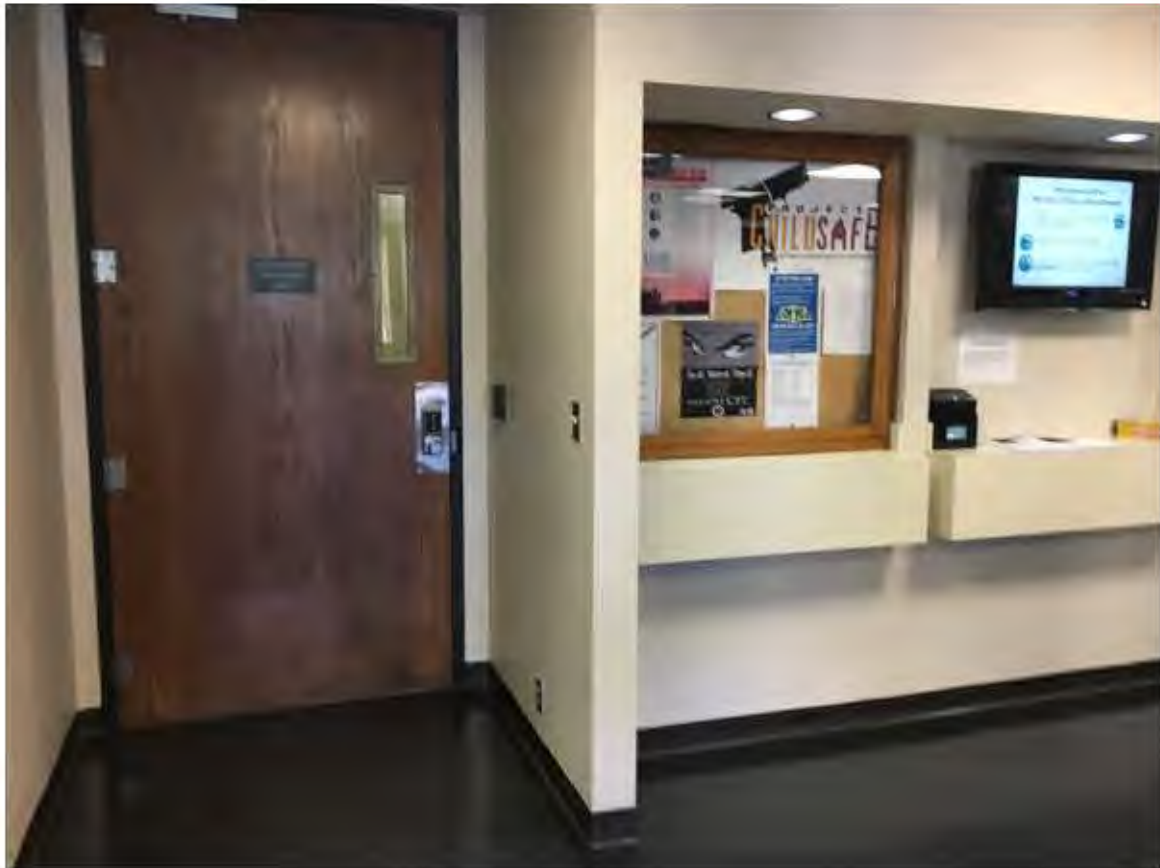
Finding: 50

Police Station - General

7 (Medium): Access to goods and services (DOJ level 2) minimally out of compliance. Restrooms (DOJ level 3) – Moderately out of compliance Drinking fountains or public phones (DOJ level 4 & 5) severely out of compliance.

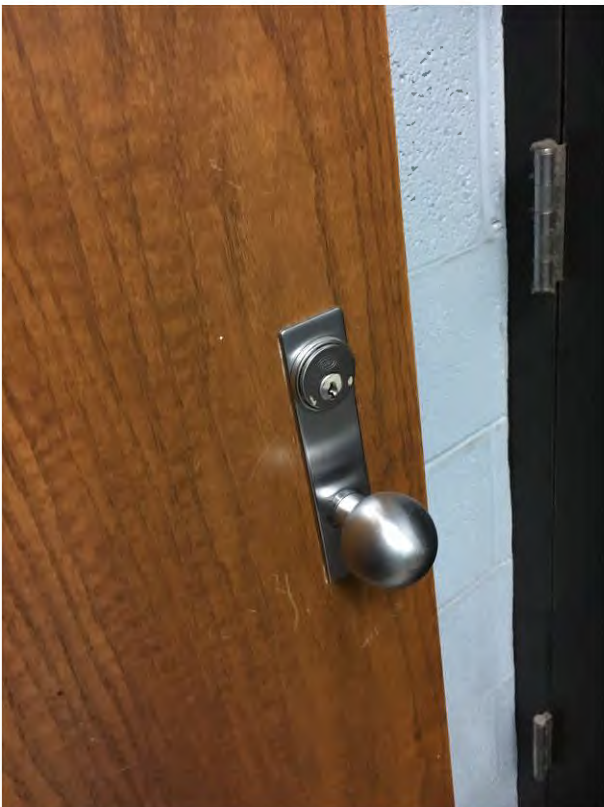
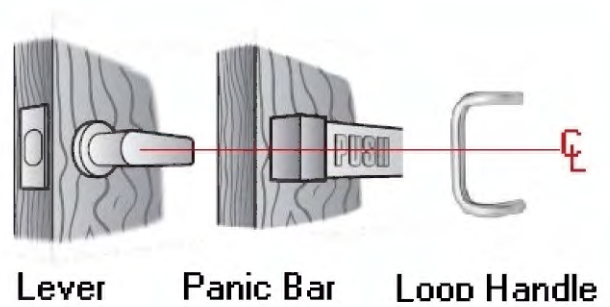
Finding: 51

Police Station - General

5 (Medium): Access to goods and services issues (DOJ level 2) - severely out of compliance.

Operating hardware must be centered between 34" and 44" above the floor or ground

Replace with lever style door hardware.

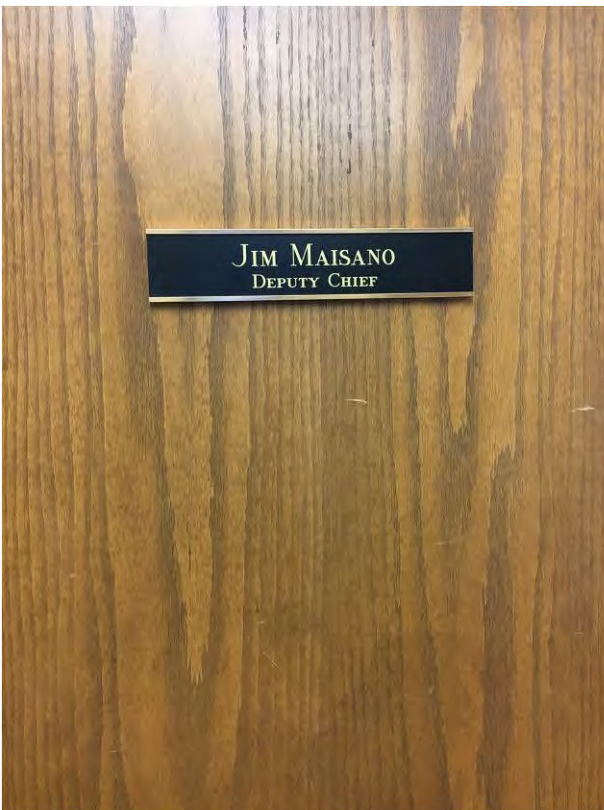
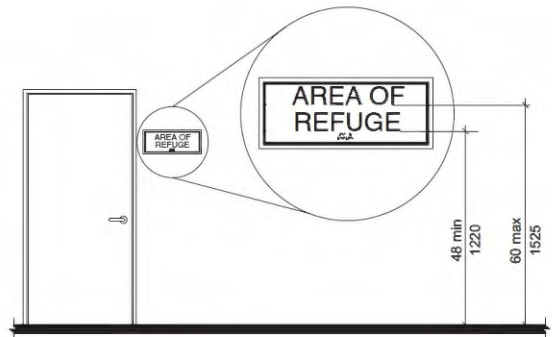
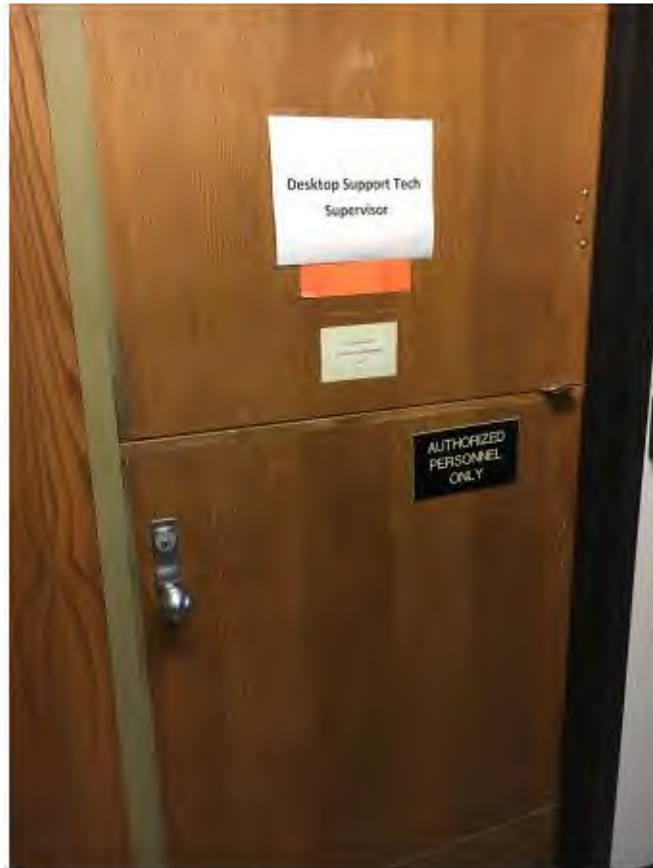
Finding #52 Additional Finding Photos

6 (Medium): Access to goods and services (DOJ level 2) moderately out of compliance. Parking or exterior conditions (DOJ's level 1) – minimally out of compliance. Restrooms (DOJ level 3) – severely out of compliance.

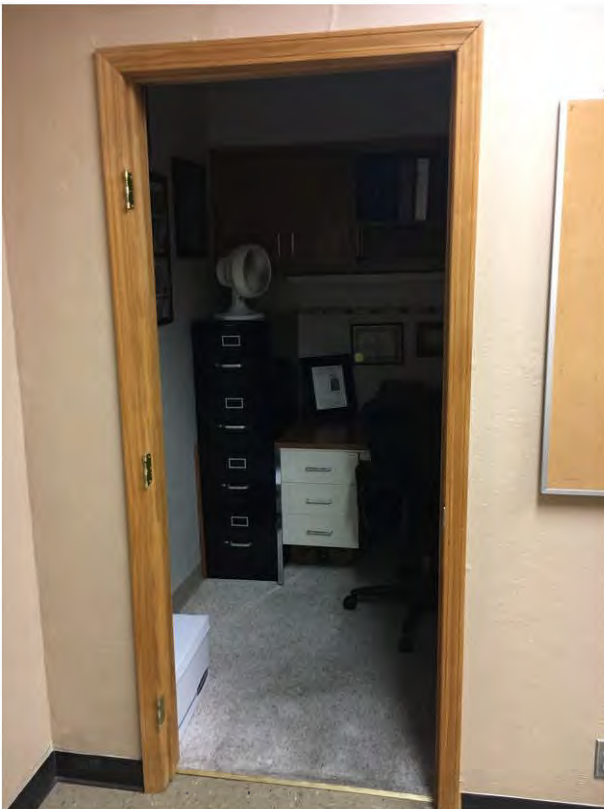
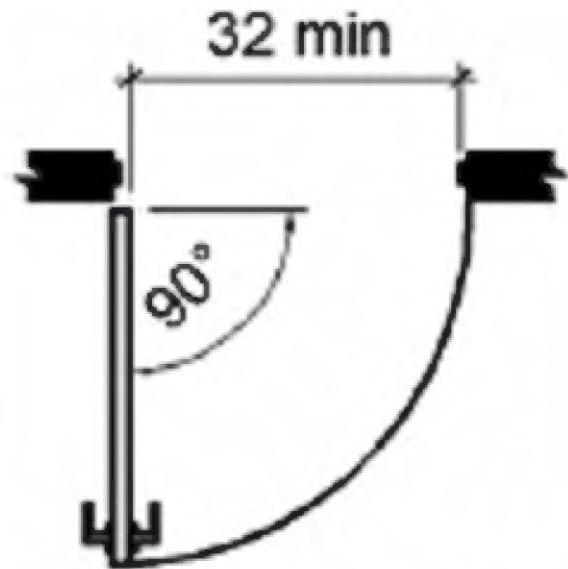
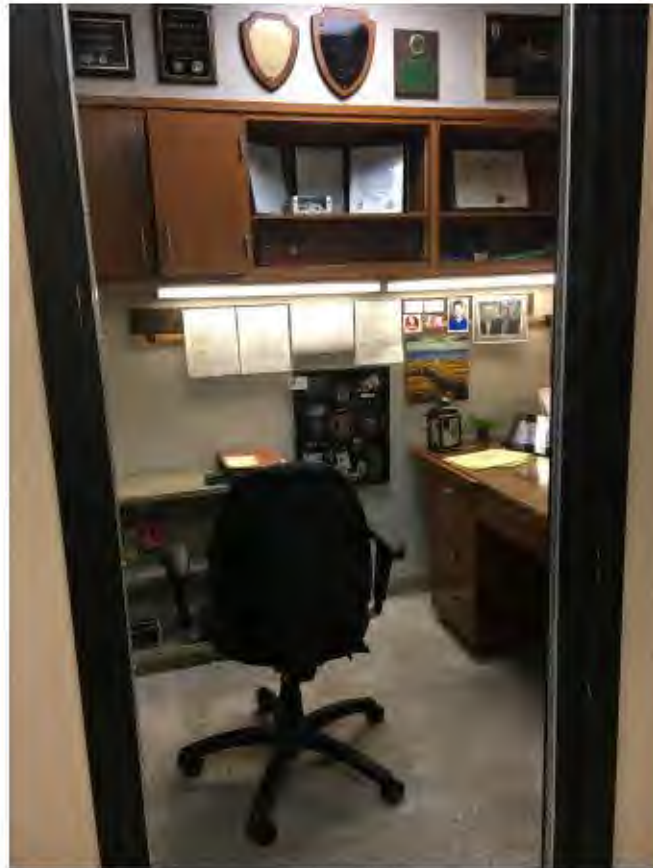
Finding #53 Additional Finding Photos

11 (Low): Client is a Title II agency, elements are out of compliance but may be able to handled programmatically, or do not need to be handled unless or until they hire a person with a disability.
