City of Norman
ADA Self-Evaluation and Transition Plan
Building Cost Projection Summary
5/1/2018

Municipal Complex - Building A

Accessibility Evaluation

Inspection Date: 09/20/2017

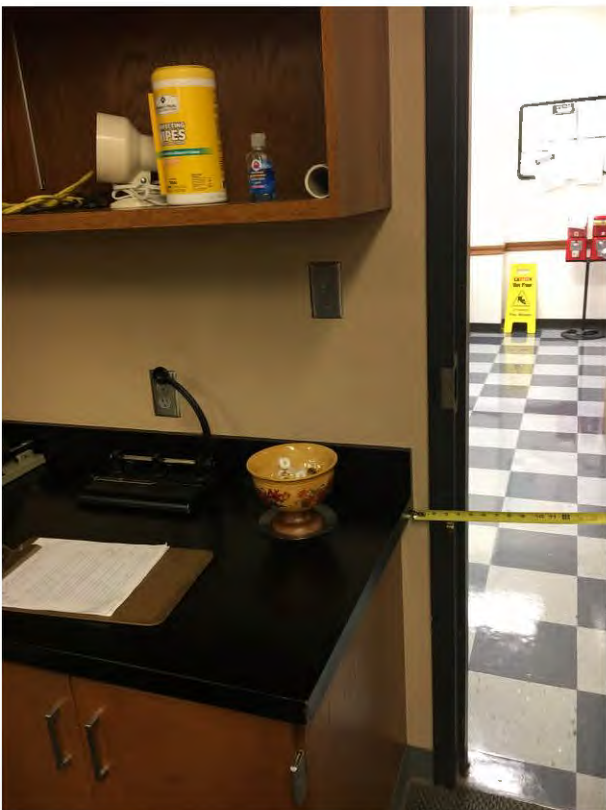
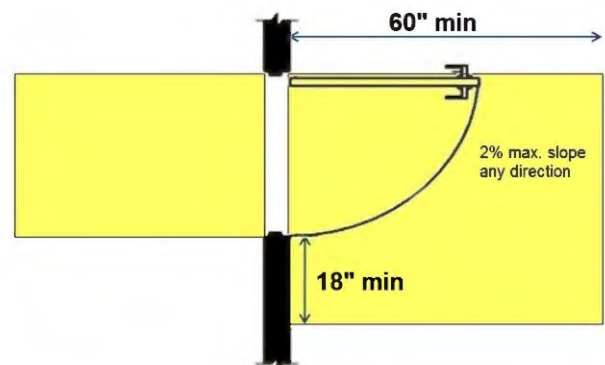
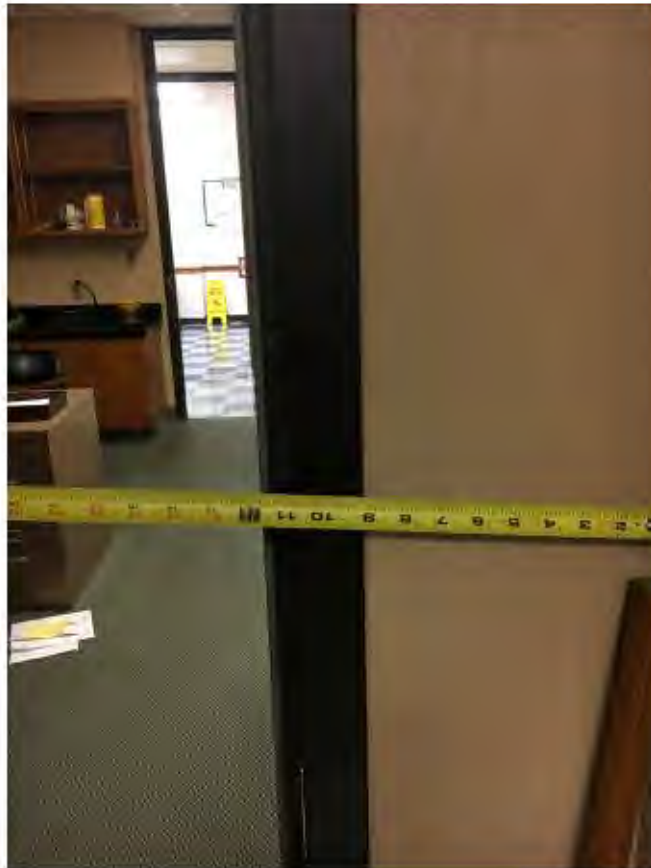
Finding #54 Additional Finding Photos

7 (Medium): Access to goods and services (DOJ level 2) minimally out of compliance. Restrooms (DOJ level 3) – Moderately out of compliance Drinking fountains or public phones (DOJ level 4 & 5) severely out of compliance.

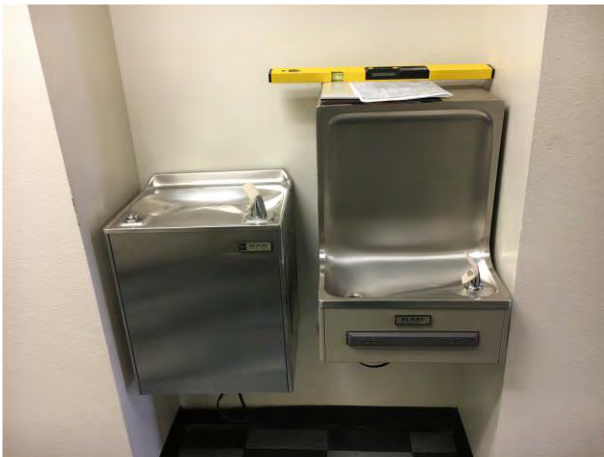
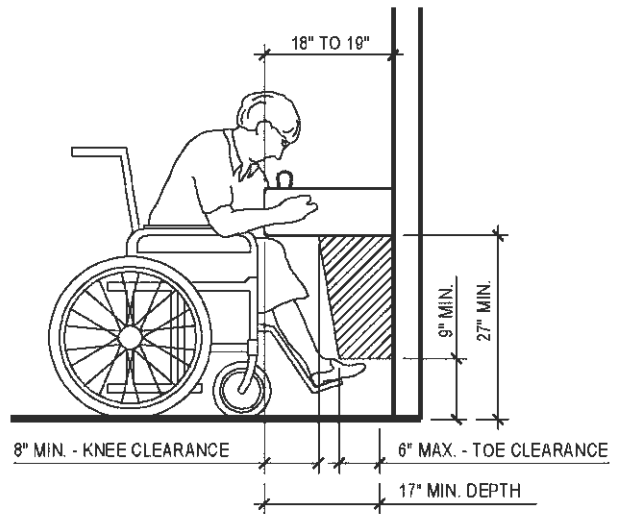
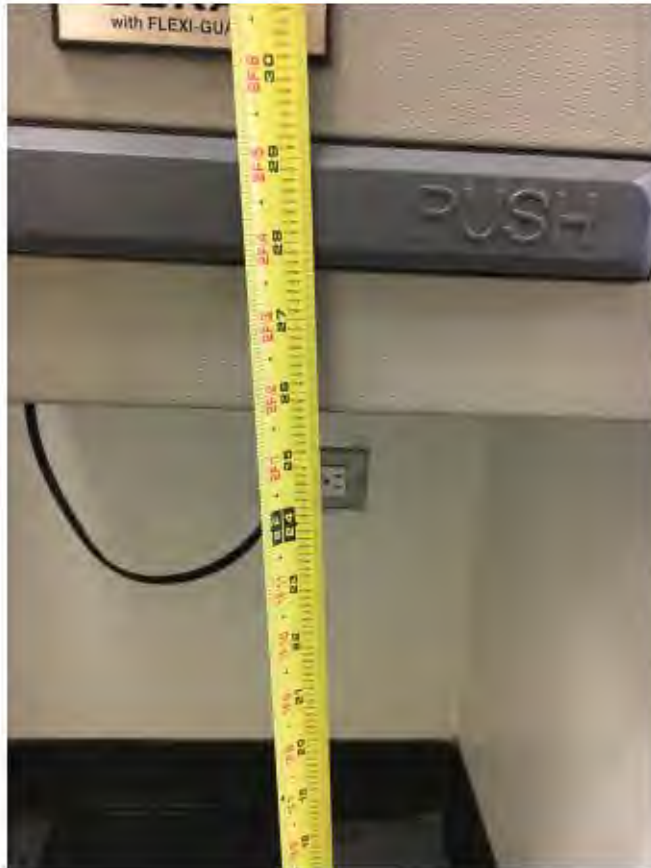
Finding #55 Additional Finding Photos

5 (Medium): Access to goods and services issues (DOJ level 2) - severely out of compliance.

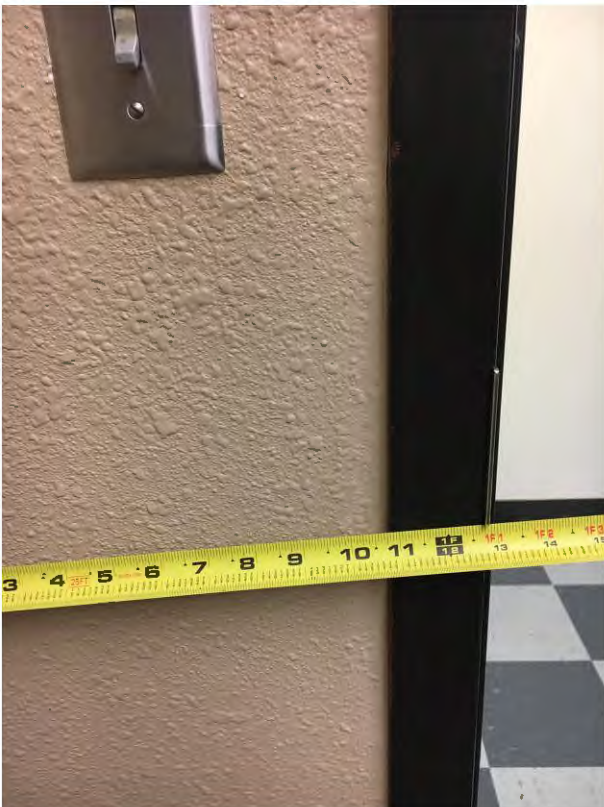
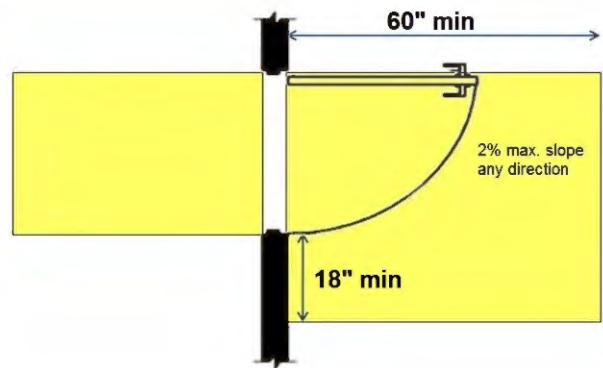
Finding: 57

11 (Low): Client is a Title II agency, elements are out of compliance but may be able to handled programmatically, or do not need to be handled unless or until they hire a person with a disability.

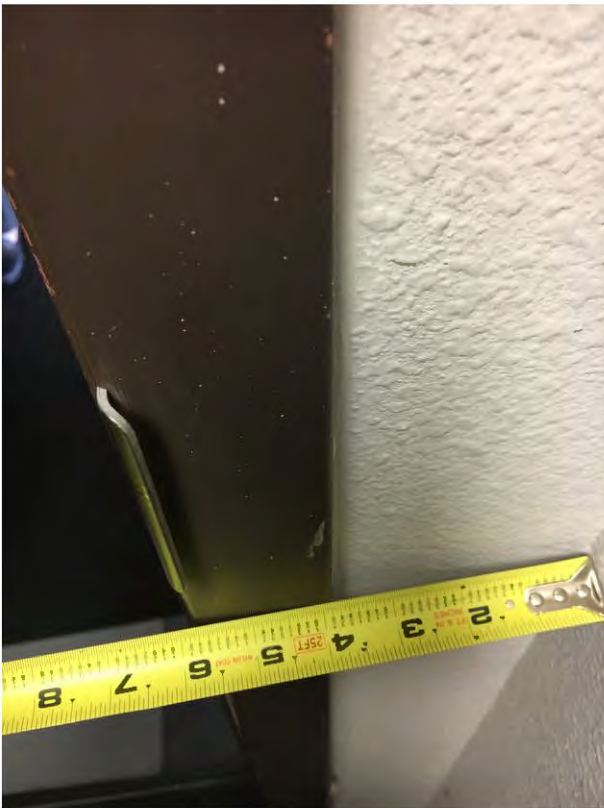
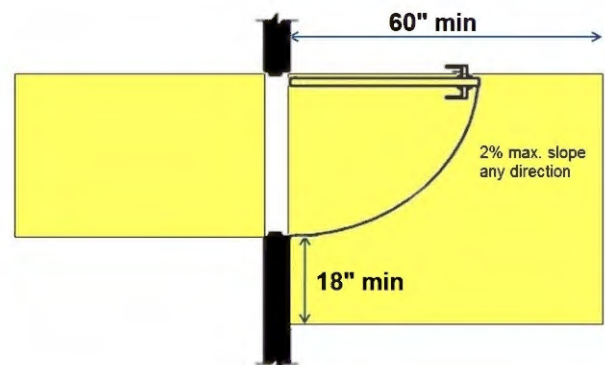
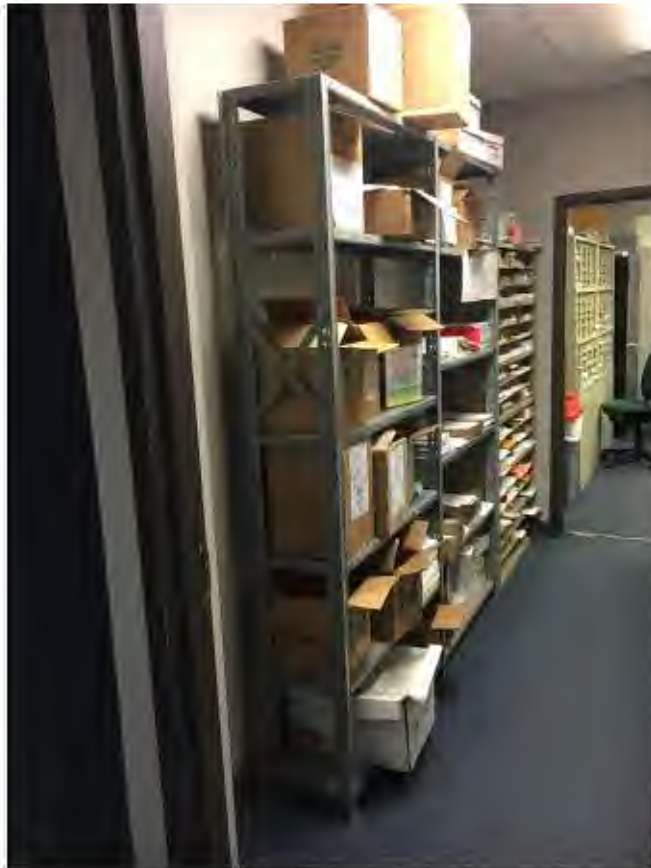
Finding #57 Additional Finding Photos

7 (Medium): Access to goods and services (DOJ level 2) minimally out of compliance. Restrooms (DOJ level 3) – Moderately out of compliance Drinking fountains or public phones (DOJ level 4 & 5) severely out of compliance.

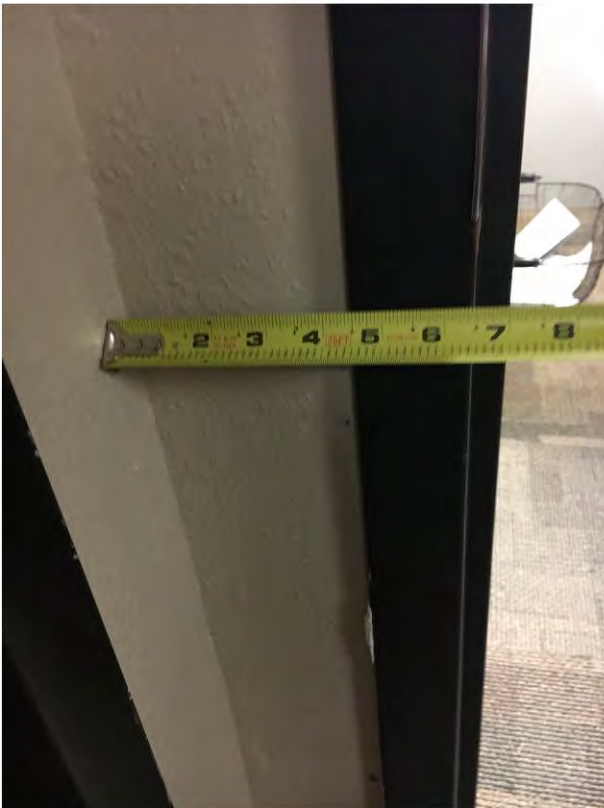
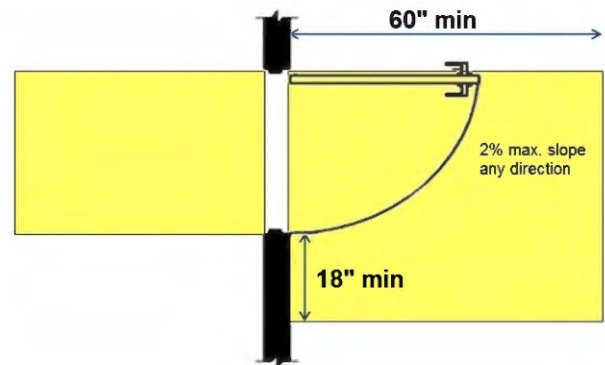
7 (Medium): Access to goods and services (DOJ level 2) minimally out of compliance. Restrooms (DOJ level 3) – Moderately out of compliance Drinking fountains or public phones (DOJ level 4 & 5) severely out of compliance.

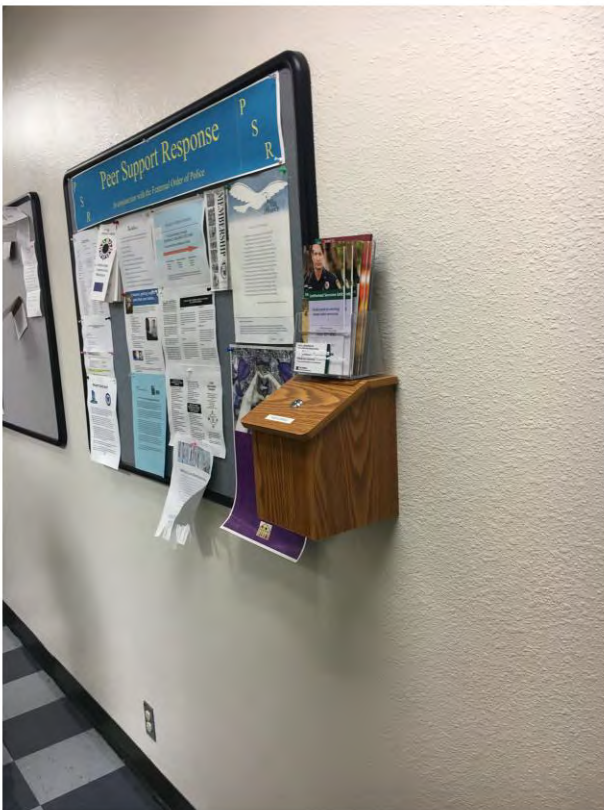
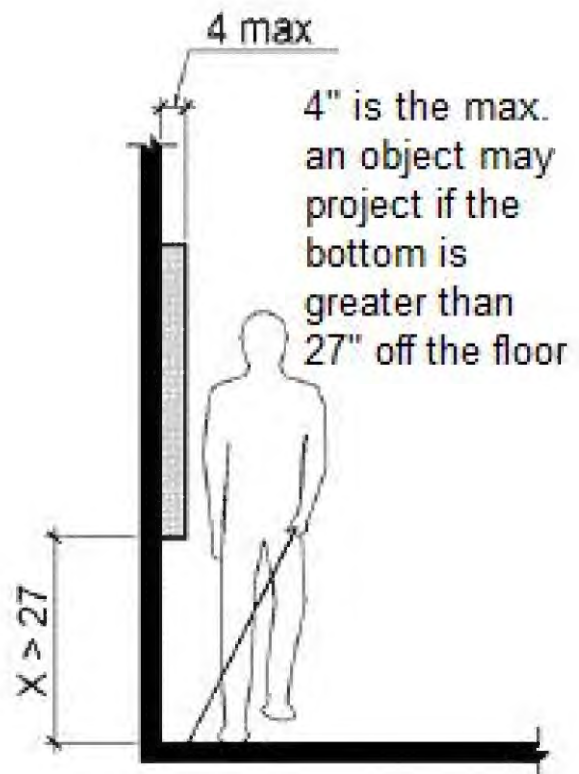
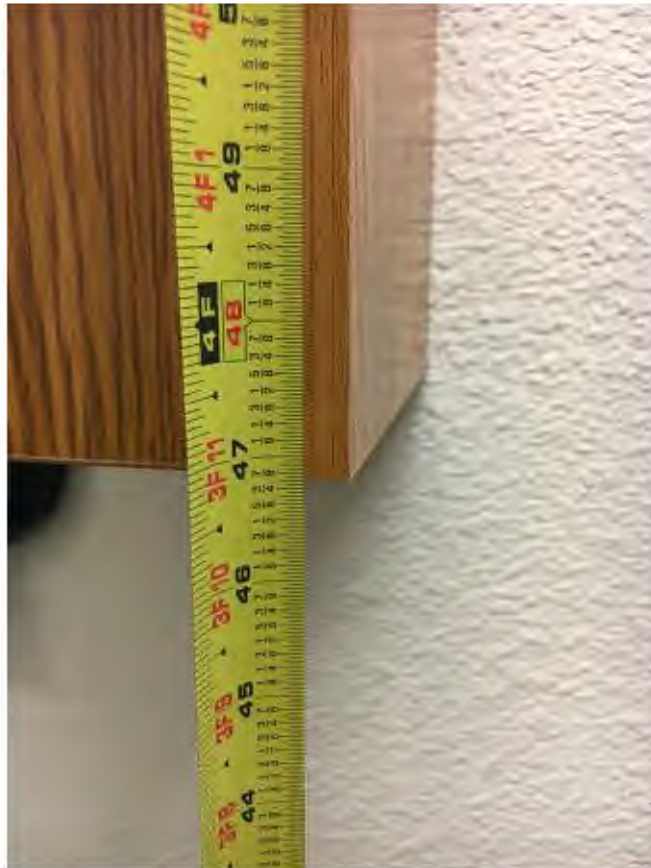
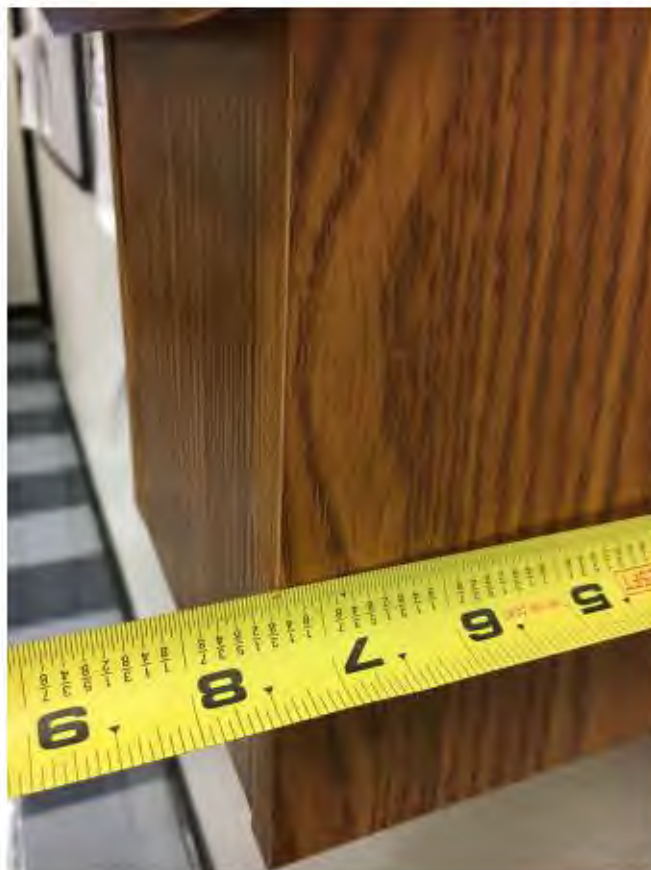
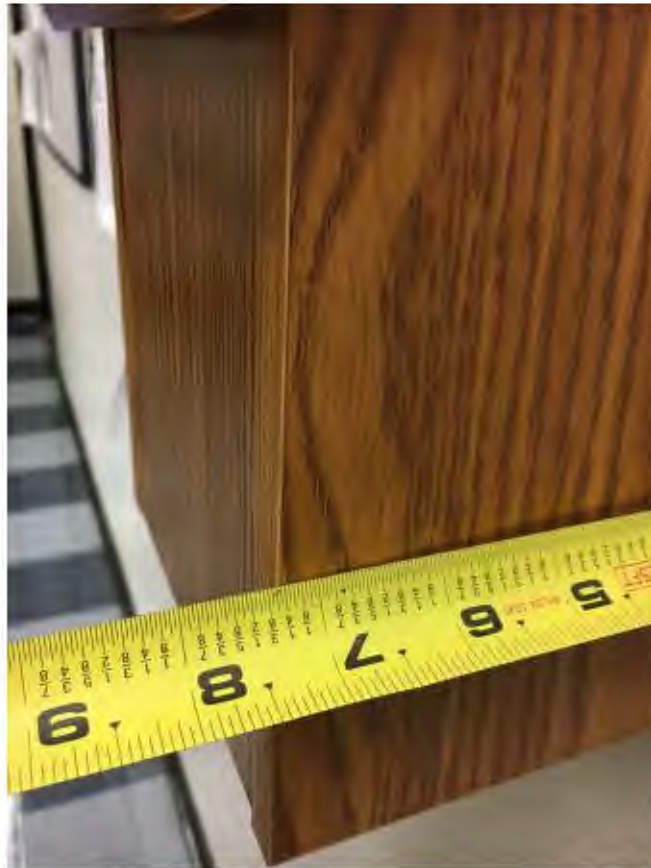
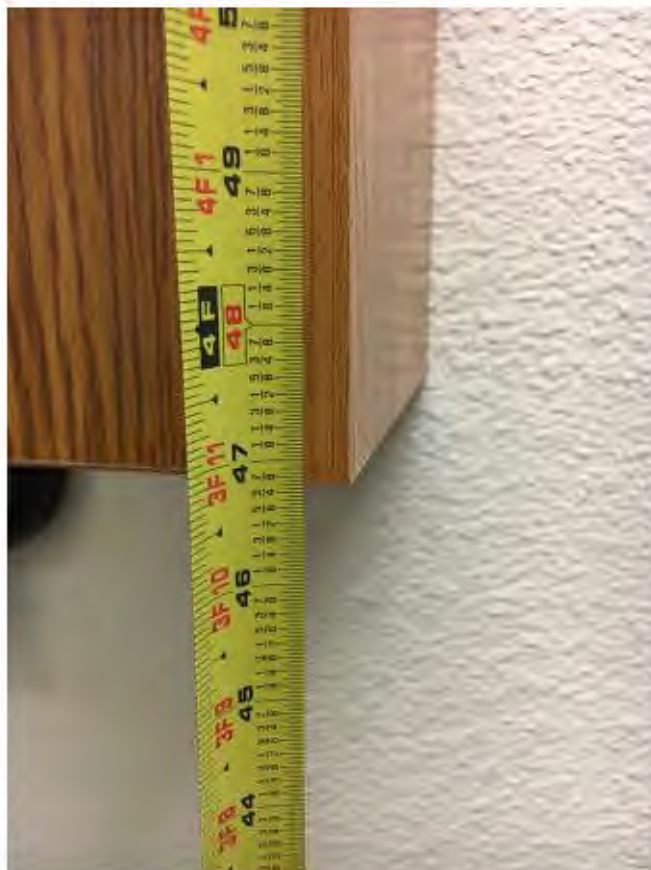
Finding #59 Additional Finding Photos

7 (Medium): Access to goods and services (DOJ level 2) minimally out of compliance. Restrooms (DOJ level 3) – Moderately out of compliance Drinking fountains or public phones (DOJ level 4 & 5) severely out of compliance.

Relocate box to a location that is not in the circulation path or replace the box with a unit that only extends 4" from the wall.

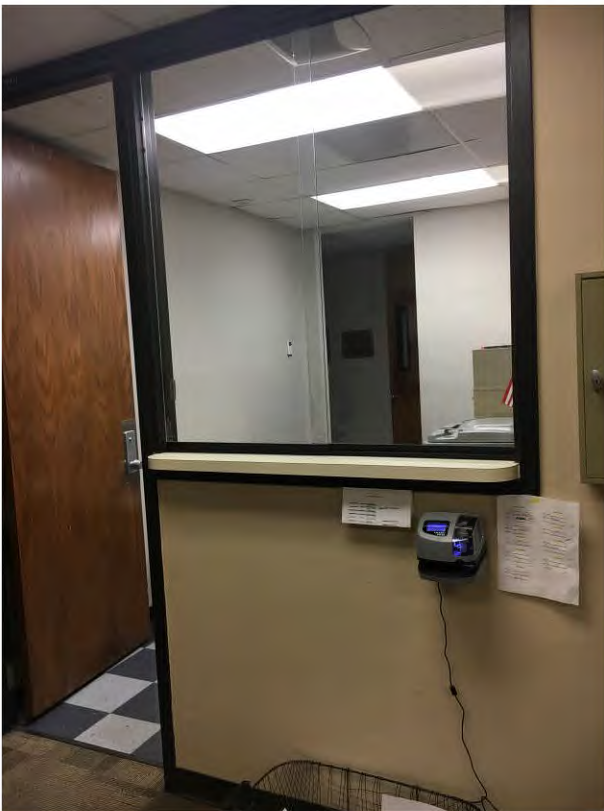
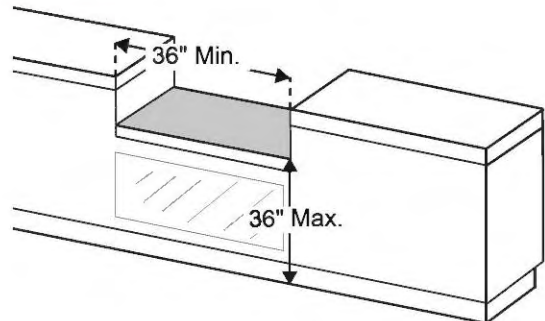
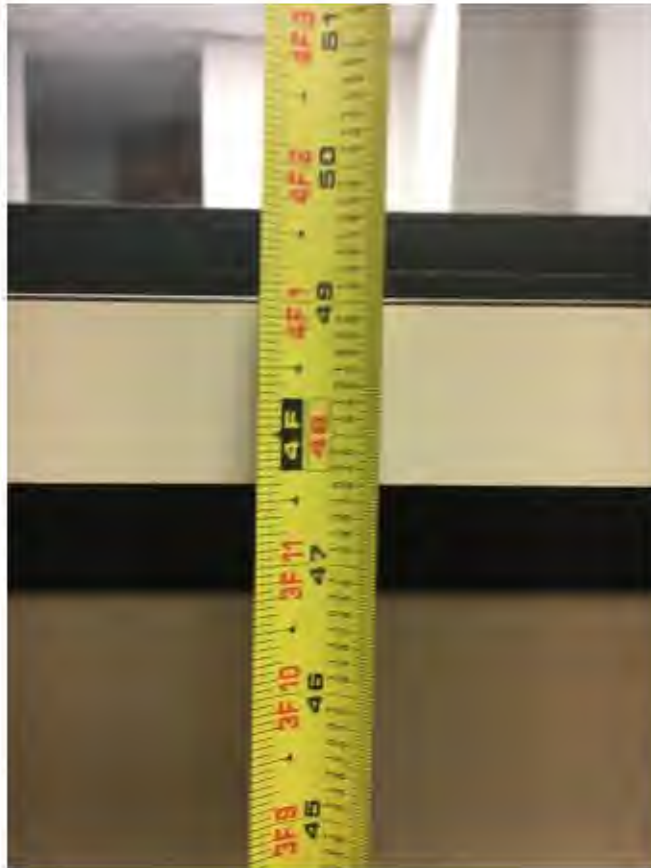
Finding #60 Additional Finding Photos

11 (Low): Client is a Title II agency, elements are out of compliance but may be able to handled programmatically, or do not need to be handled unless or until they hire a person with a disability.

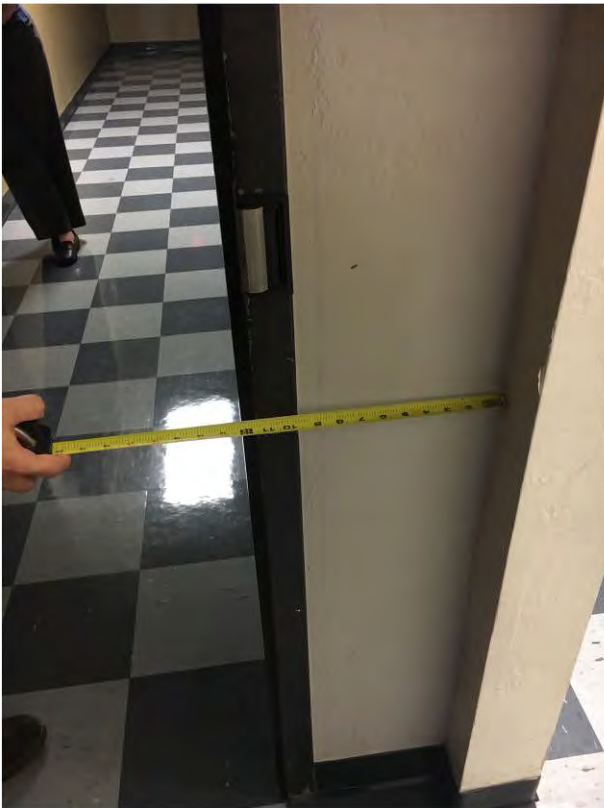
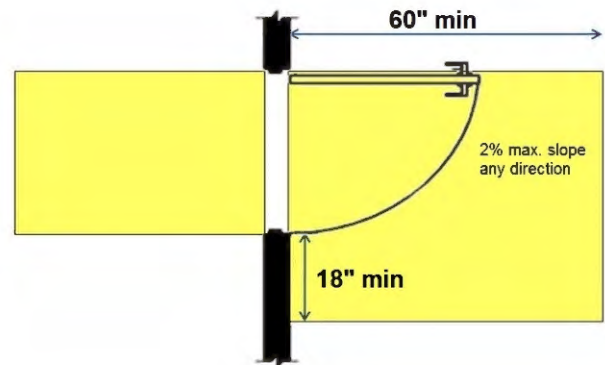
7 (Medium): Access to goods and services (DOJ level 2) minimally out of compliance. Restrooms (DOJ level 3) – Moderately out of compliance Drinking fountains or public phones (DOJ level 4 & 5) severely out of compliance.

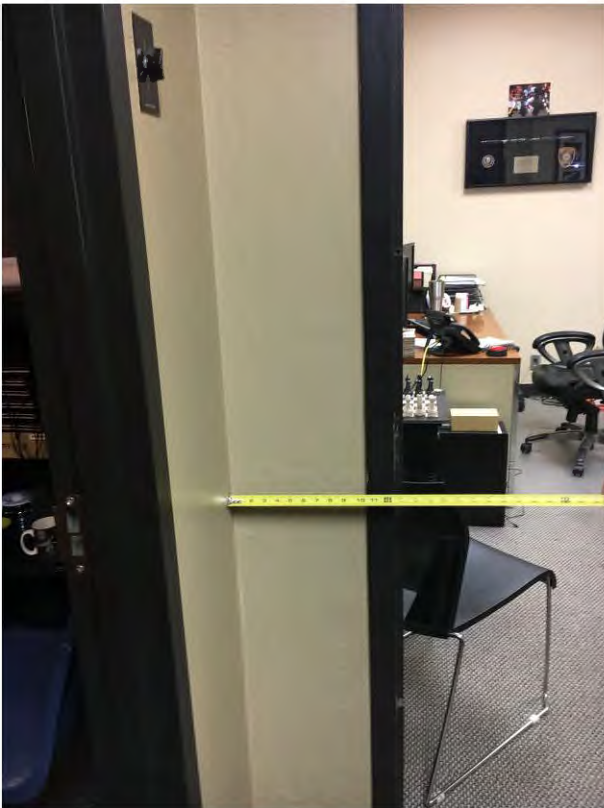
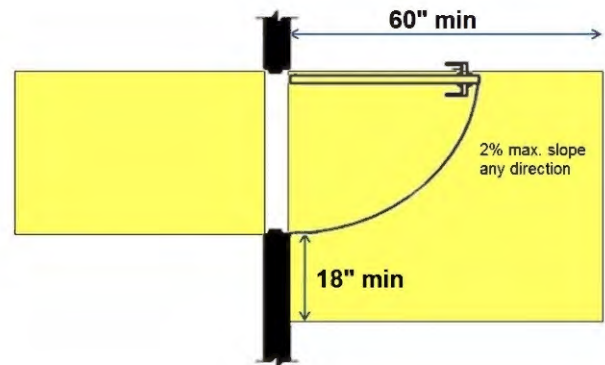
7 (Medium): Access to goods and services (DOJ level 2) minimally out of compliance. Restrooms (DOJ level 3) – Moderately out of compliance Drinking fountains or public phones (DOJ level 4 & 5) severely out of compliance.

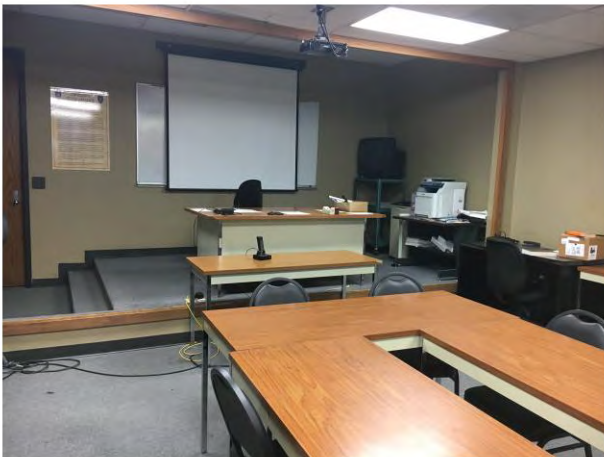
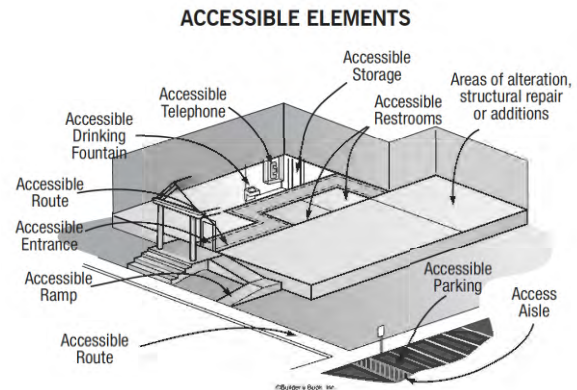
11 (Low): Client is a Title II agency, elements are out of compliance but may be able to handled programmatically, or do not need to be handled unless or until they hire a person with a disability.

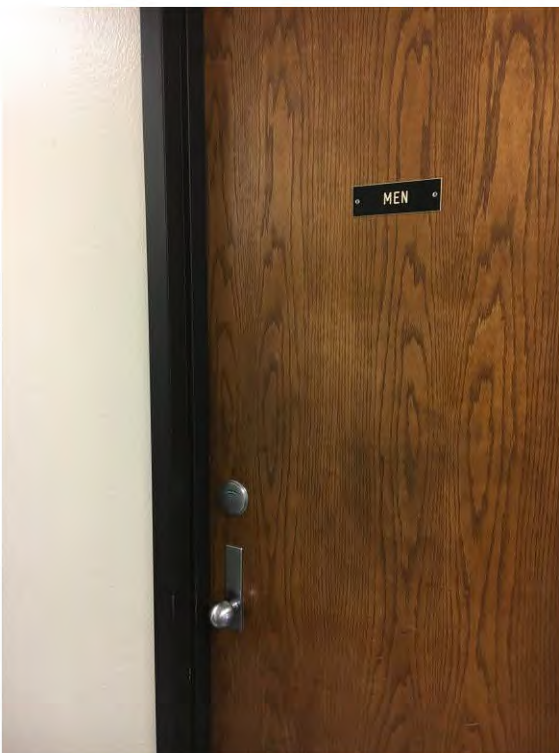
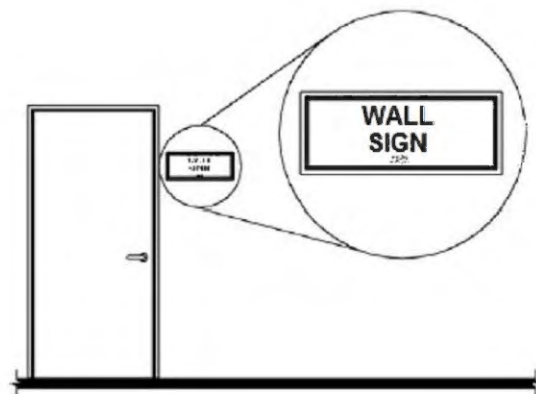
6 (Medium): Access to goods and services (DOJ level 2) moderately out of compliance. Parking or exterior conditions (DOJ's level 1) – minimally out of compliance. Restrooms (DOJ level 3) – severely out of compliance.

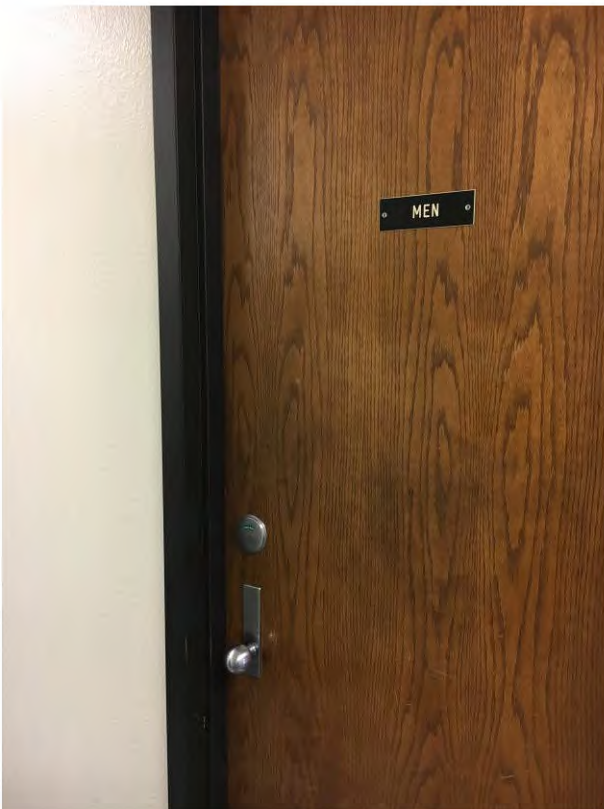
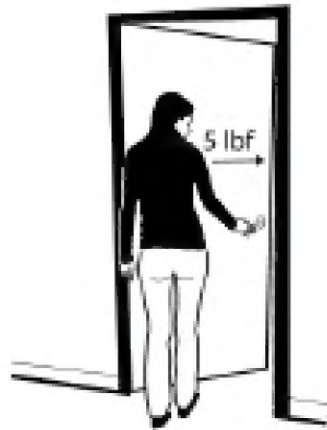
7 (Medium): Access to goods and services (DOJ level 2) minimally out of compliance. Restrooms (DOJ level 3) – Moderately out of compliance Drinking fountains or public phones (DOJ level 4 & 5) severely out of compliance.

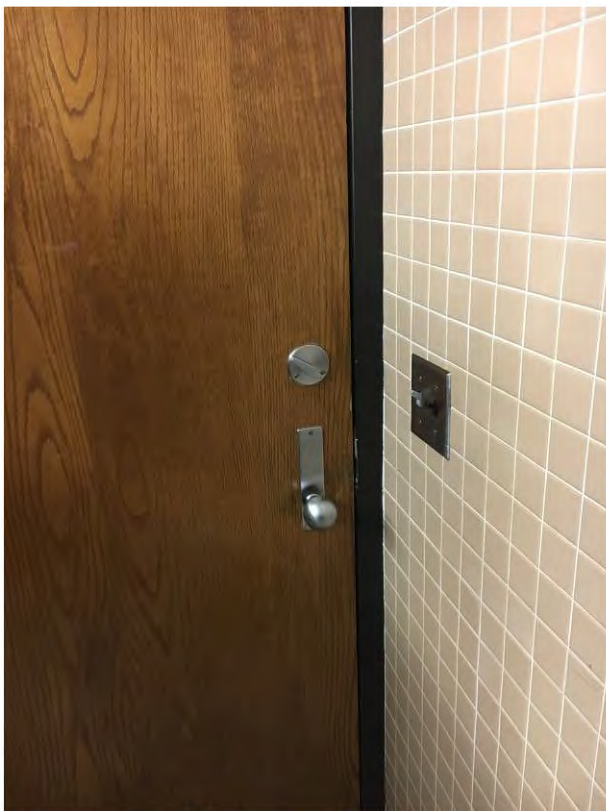
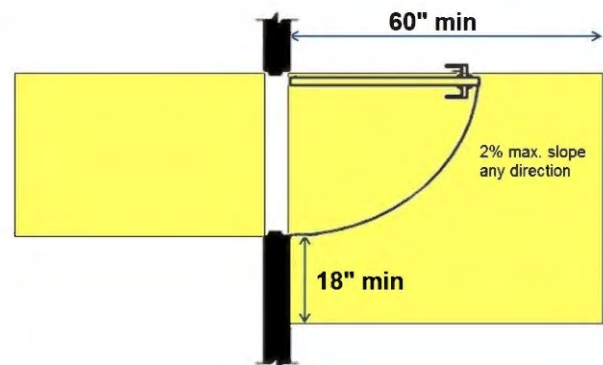
Finding #66 Additional Finding Photos

7 (Medium): Access to goods and services (DOJ level 2) minimally out of compliance. Restrooms (DOJ level 3) – Moderately out of compliance Drinking fountains or public phones (DOJ level 4 & 5) severely out of compliance.

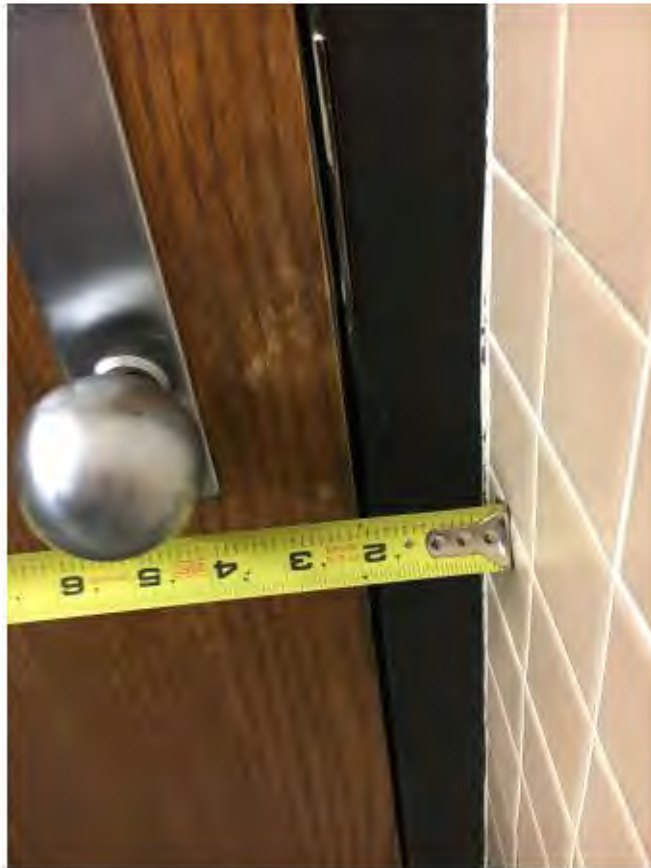
Finding: 67

6 (Medium): Access to goods and services (DOJ level 2) moderately out of compliance. Parking or exterior conditions (DOJ's level 1) – minimally out of compliance. Restrooms (DOJ level 3) – severely out of compliance.

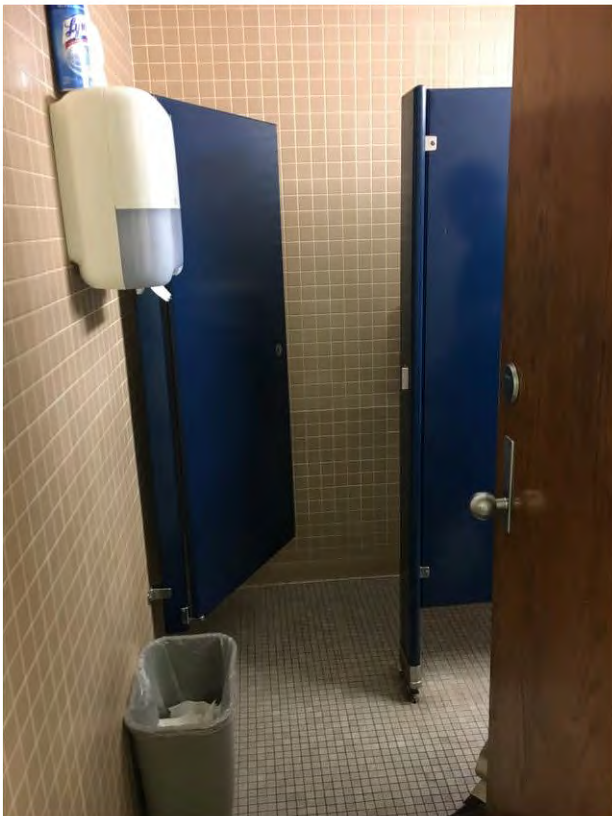
Finding: 68

6 (Medium): Access to goods and services (DOJ level 2) moderately out of compliance. Parking or exterior conditions (DOJ's level 1) – minimally out of compliance. Restrooms (DOJ level 3) – severely out of compliance.

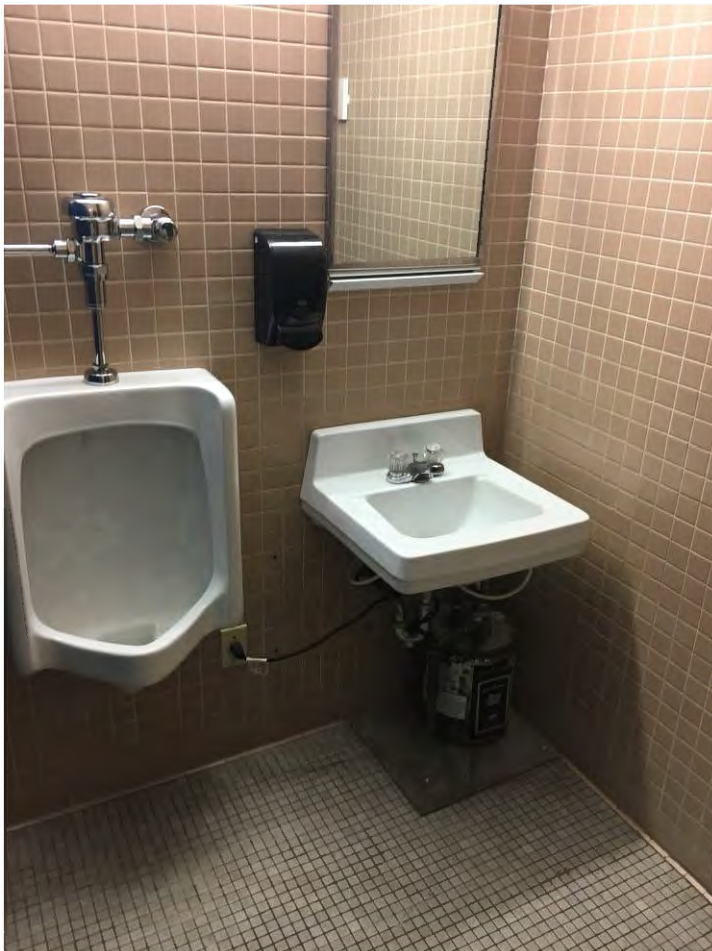
Finding: 69

6 (Medium): Access to goods and services (DOJ level 2) moderately out of compliance. Parking or exterior conditions (DOJ's level 1) – minimally out of compliance. Restrooms (DOJ level 3) – severely out of compliance.

Replace faucet controls with lever style controls.

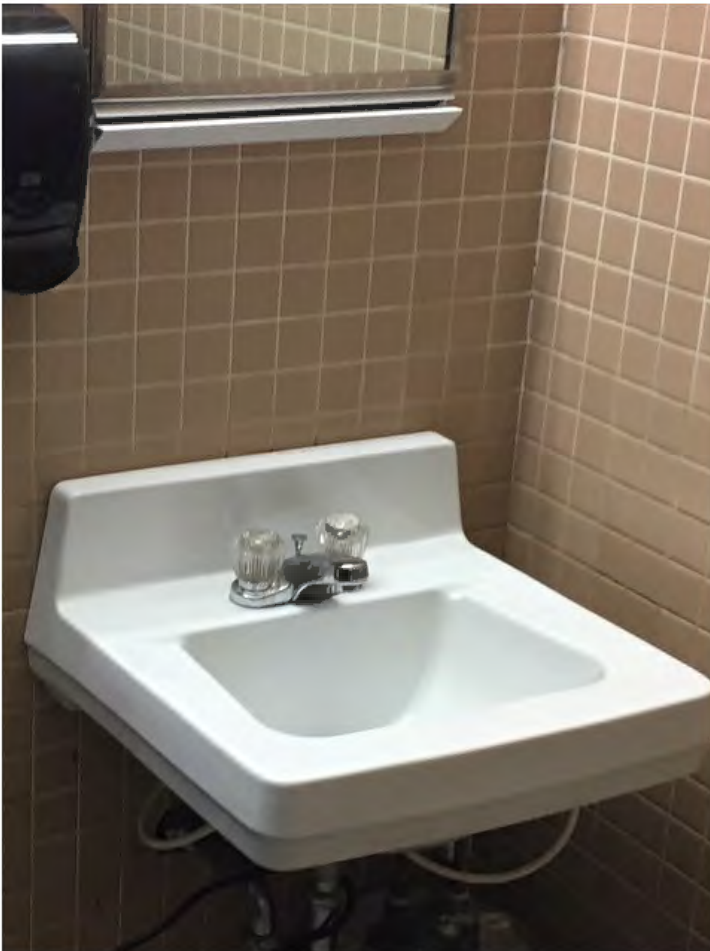
Finding: 70

6 (Medium): Access to goods and services (DOJ level 2) moderately out of compliance. Parking or exterior conditions (DOJ's level 1) – minimally out of compliance. Restrooms (DOJ level 3) – severely out of compliance.

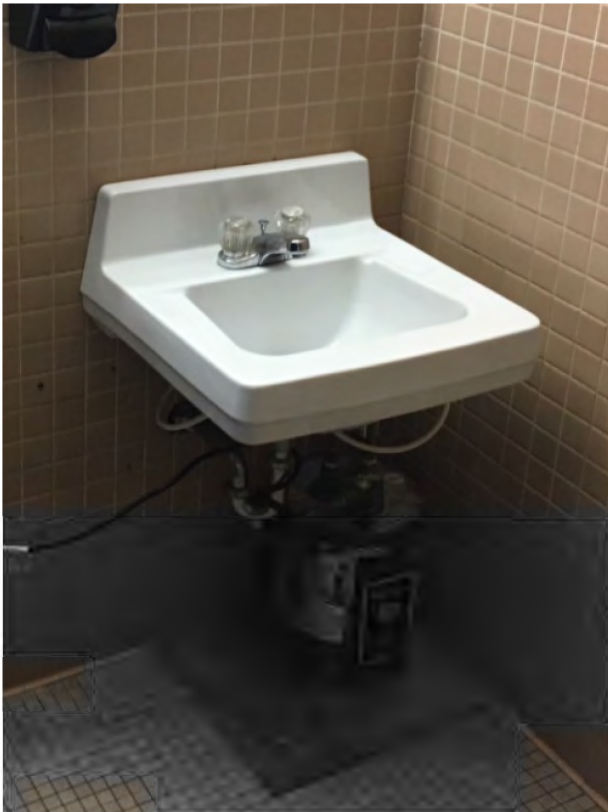
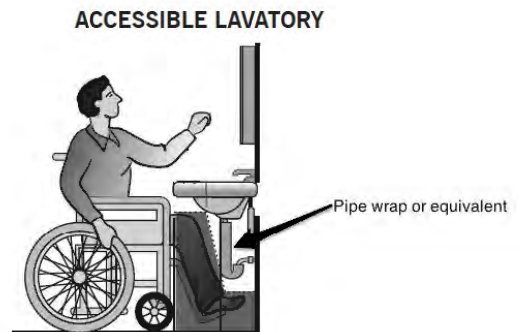
Finding: 71

7 (Medium): Access to goods and services (DOJ level 2) minimally out of compliance. Restrooms (DOJ level 3) – Moderately out of compliance Drinking fountains or public phones (DOJ level 4 & 5) severely out of compliance.

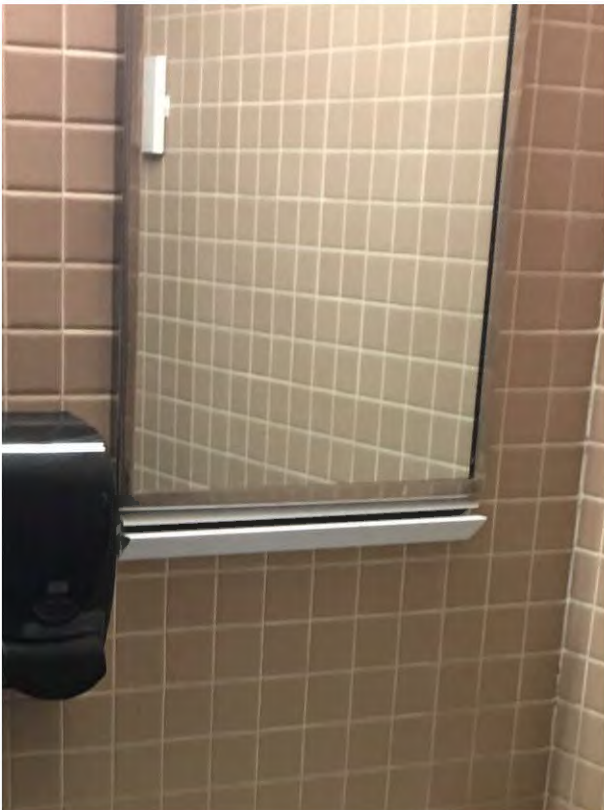
Finding: 72

6 (Medium): Access to goods and services (DOJ level 2) moderately out of compliance. Parking or exterior conditions (DOJ's level 1) – minimally out of compliance. Restrooms (DOJ level 3) – severely out of compliance.

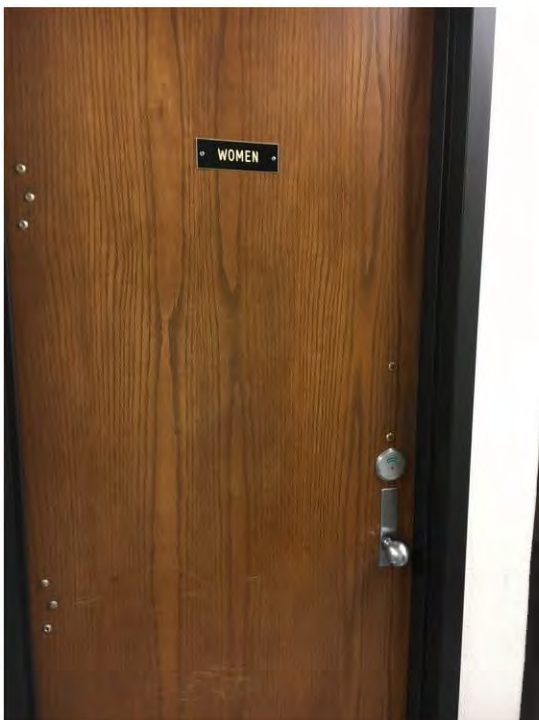
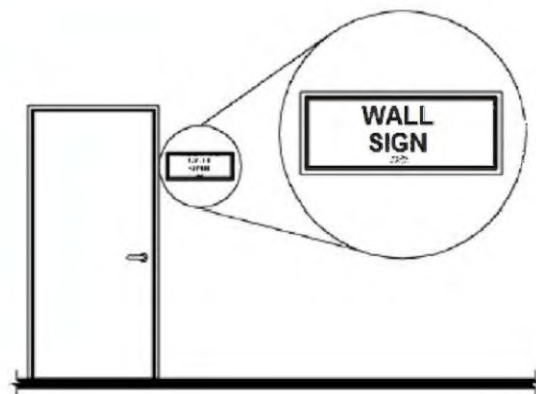
Finding: 73

7 (Medium): Access to goods and services (DOJ level 2) minimally out of compliance. Restrooms (DOJ level 3) – Moderately out of compliance Drinking fountains or public phones (DOJ level 4 & 5) severely out of compliance.

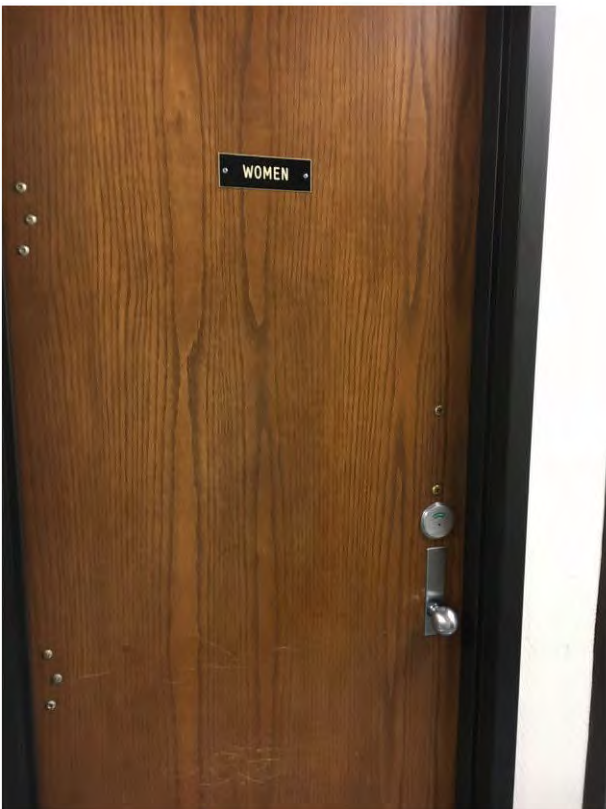
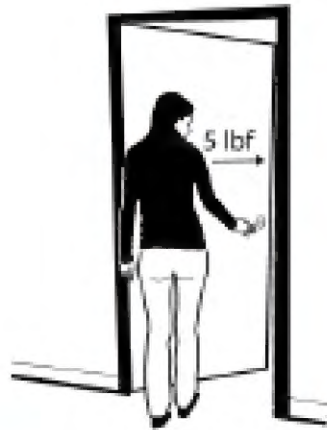
Finding: 74

7 (Medium): Access to goods and services (DOJ level 2) minimally out of compliance. Restrooms (DOJ level 3) – Moderately out of compliance Drinking fountains or public phones (DOJ level 4 & 5) severely out of compliance.

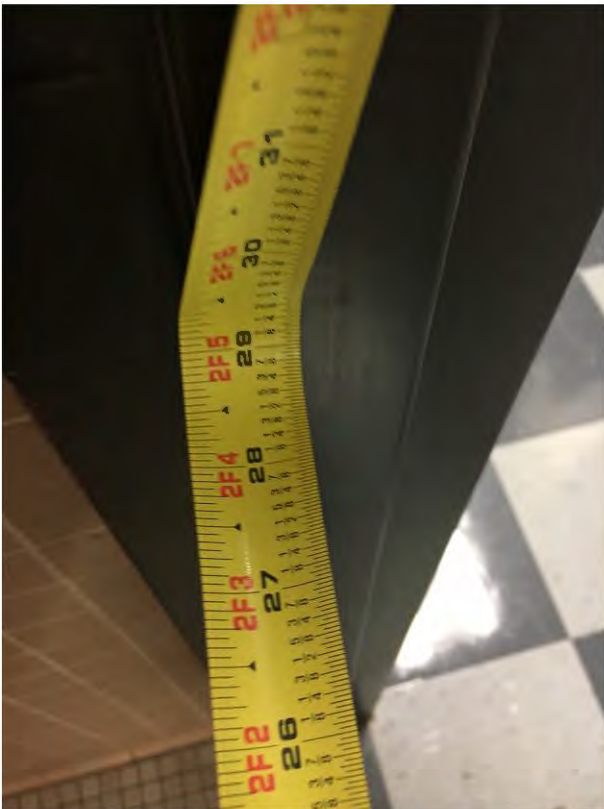
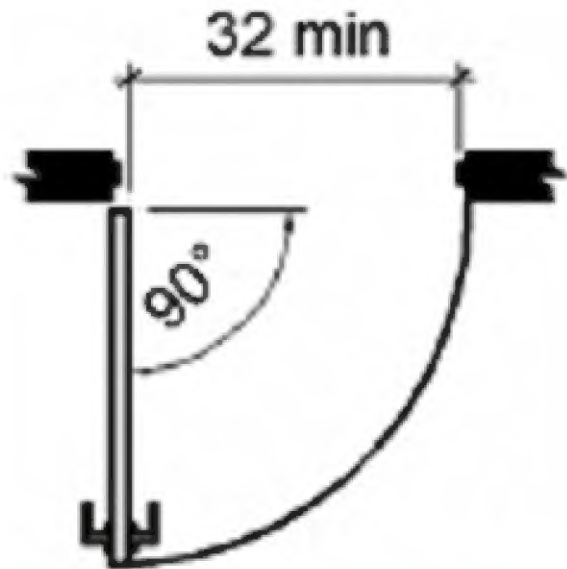
7 (Medium): Access to goods and services (DOJ level 2) minimally out of compliance. Restrooms (DOJ level 3) – Moderately out of compliance Drinking fountains or public phones (DOJ level 4 & 5) severely out of compliance.

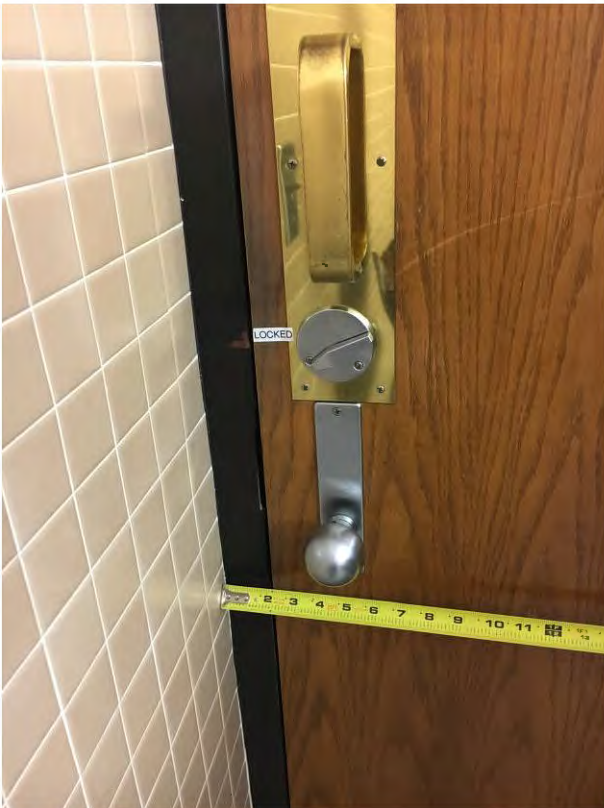
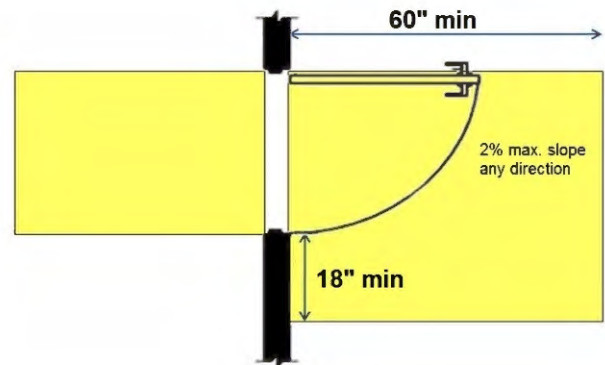
Finding: 76

6 (Medium): Access to goods and services (DOJ level 2) moderately out of compliance. Parking or exterior conditions (DOJ's level 1) – minimally out of compliance. Restrooms (DOJ level 3) – severely out of compliance.

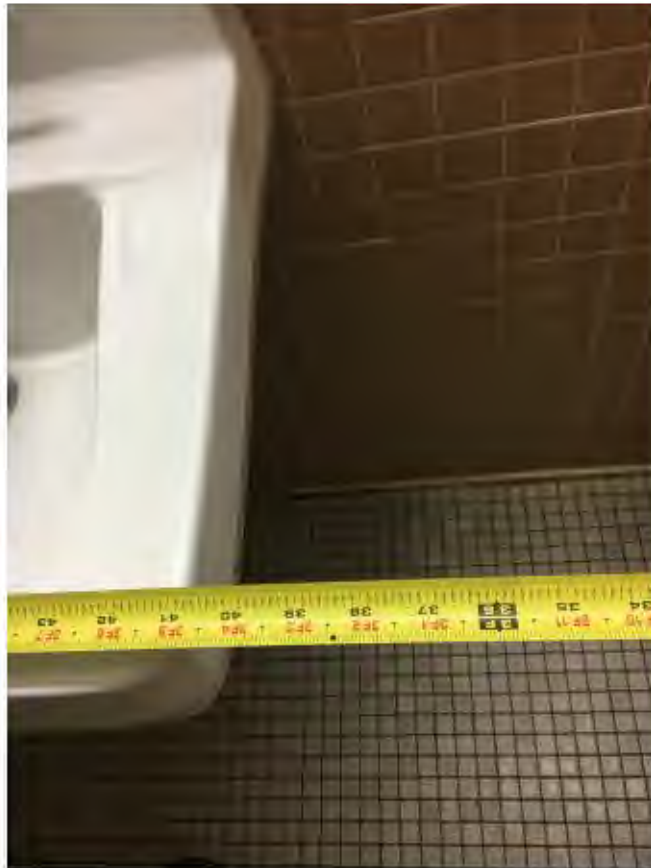
Finding: 77

6 (Medium): Access to goods and services (DOJ level 2) moderately out of compliance. Parking or exterior conditions (DOJ's level 1) – minimally out of compliance. Restrooms (DOJ level 3) – severely out of compliance.

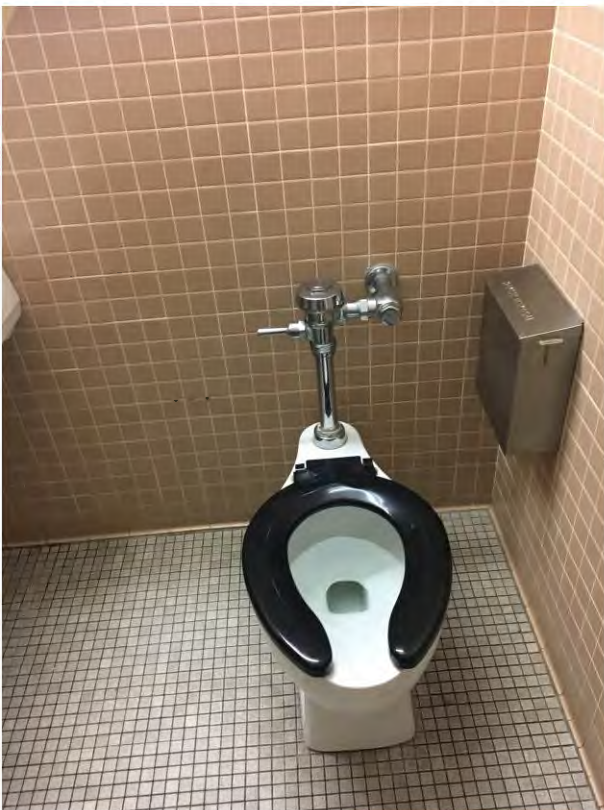
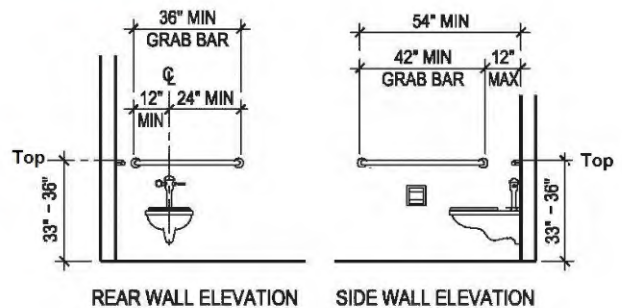
Finding: 78

7 (Medium): Access to goods and services (DOJ level 2) minimally out of compliance. Restrooms (DOJ level 3) – Moderately out of compliance Drinking fountains or public phones (DOJ level 4 & 5) severely out of compliance.
