City of Norman
ADA Self-Evaluation and Transition Plan
Building Cost Projection Summary
5/1/2018

Municipal Complex - Building A

Accessibility Evaluation

Inspection Date: 09/20/2017

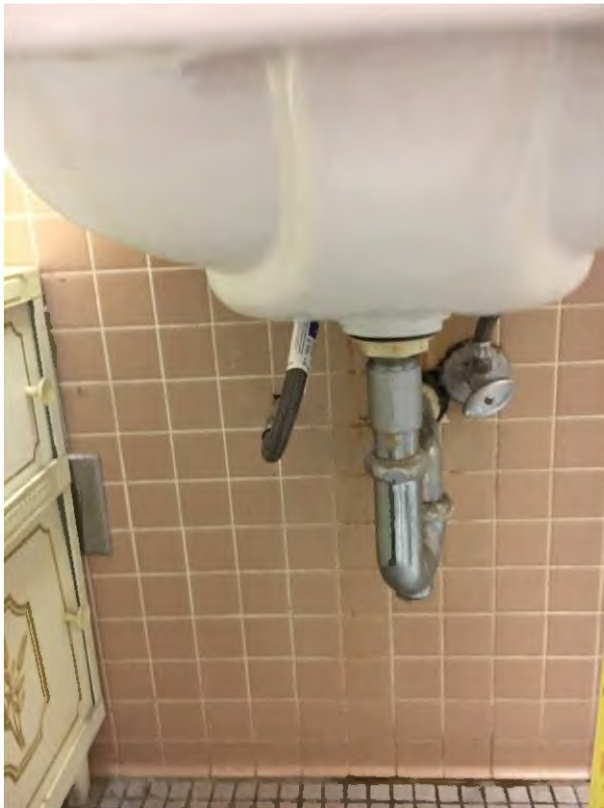
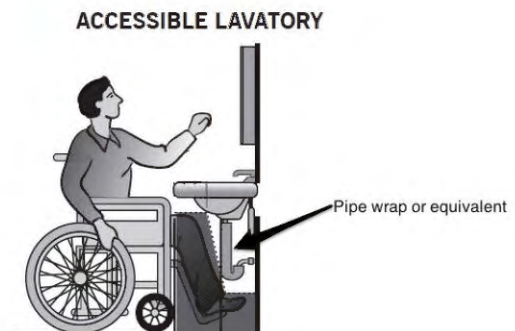
Finding: 79

7 (Medium): Access to goods and services (DOJ level 2) minimally out of compliance. Restrooms (DOJ level 3) – Moderately out of compliance Drinking fountains or public phones (DOJ level 4 & 5) severely out of compliance.

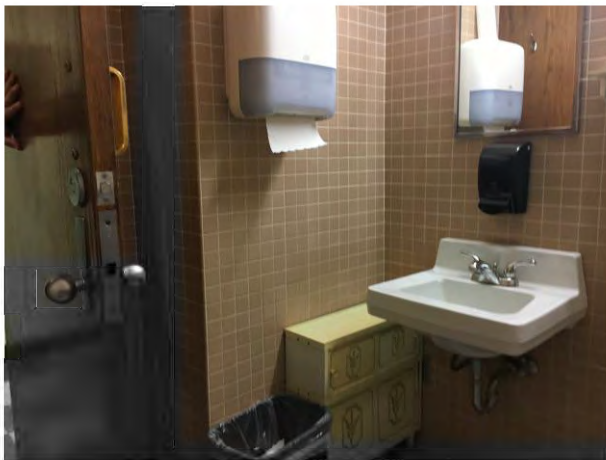
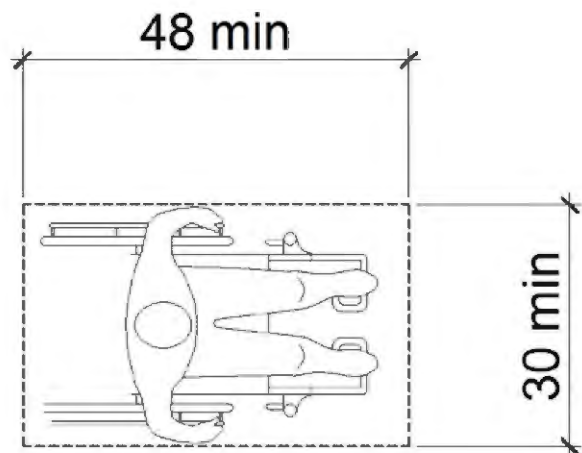
Finding: 80

7 (Medium): Access to goods and services (DOJ level 2) minimally out of compliance. Restrooms (DOJ level 3) – Moderately out of compliance Drinking fountains or public phones (DOJ level 4 & 5) severely out of compliance.

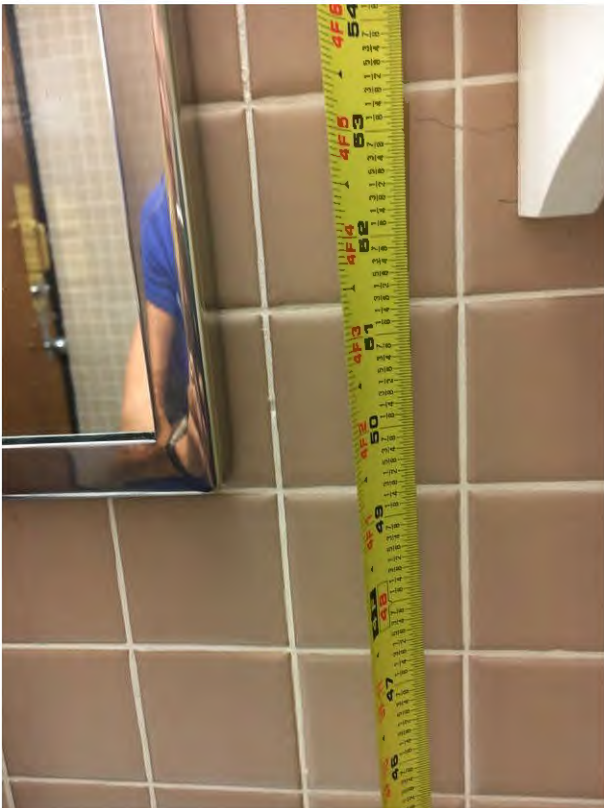
Finding: 81

7 (Medium): Access to goods and services (DOJ level 2) minimally out of compliance. Restrooms (DOJ level 3) – Moderately out of compliance Drinking fountains or public phones (DOJ level 4 & 5) severely out of compliance.

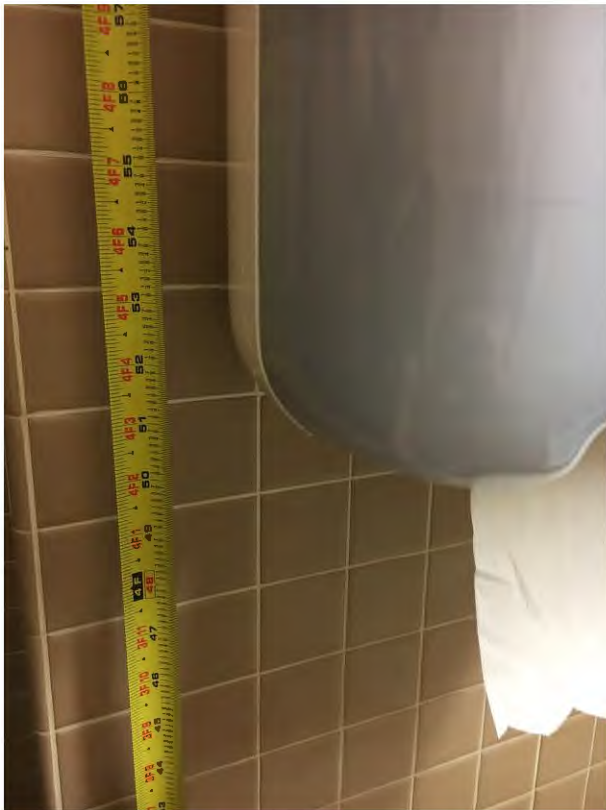
Finding: 82

7 (Medium): Access to goods and services (DOJ level 2) minimally out of compliance. Restrooms (DOJ level 3) – Moderately out of compliance Drinking fountains or public phones (DOJ level 4 & 5) severely out of compliance.

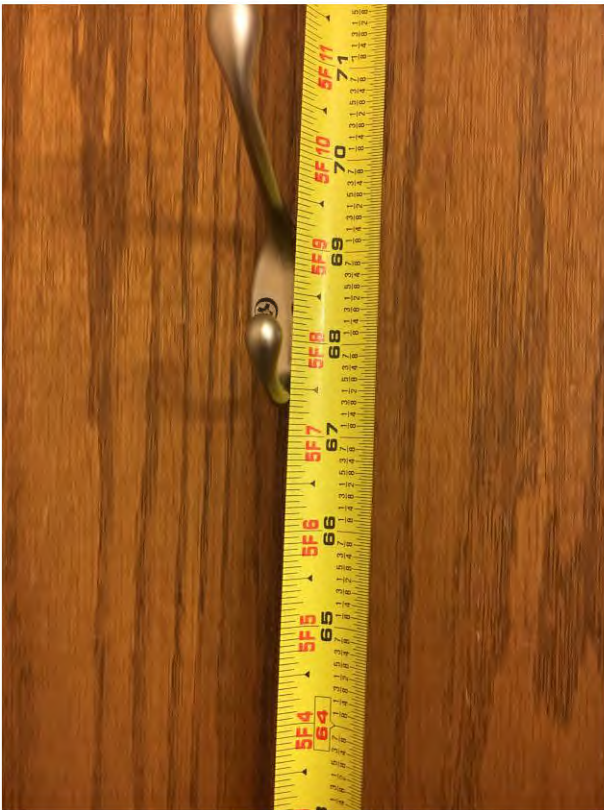
Finding: 83

6 (Medium): Access to goods and services (DOJ level 2) moderately out of compliance. Parking or exterior conditions (DOJ's level 1) – minimally out of compliance. Restrooms (DOJ level 3) – severely out of compliance.

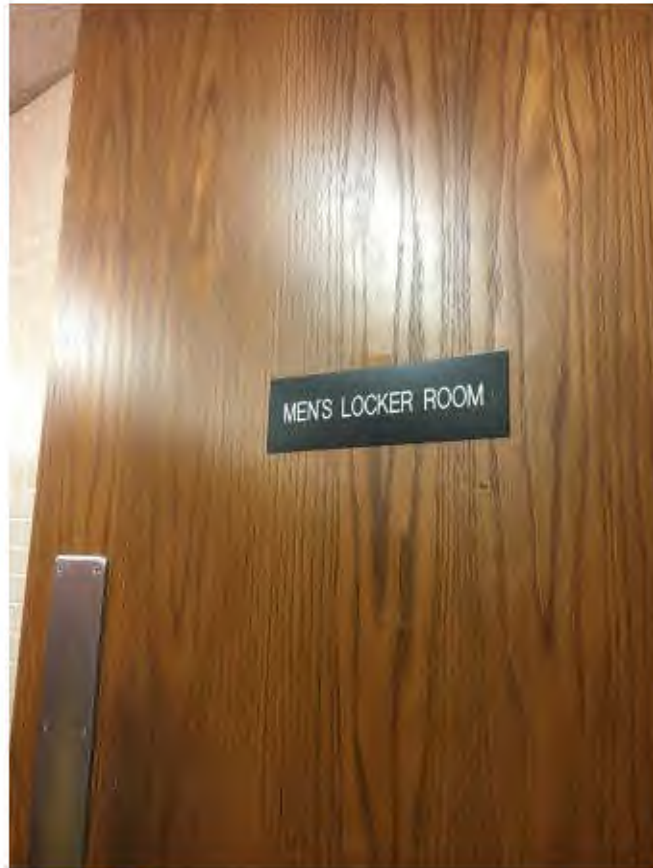
Finding: 84

7 (Medium): Access to goods and services (DOJ level 2) minimally out of compliance. Restrooms (DOJ level 3) – Moderately out of compliance Drinking fountains or public phones (DOJ level 4 & 5) severely out of compliance.

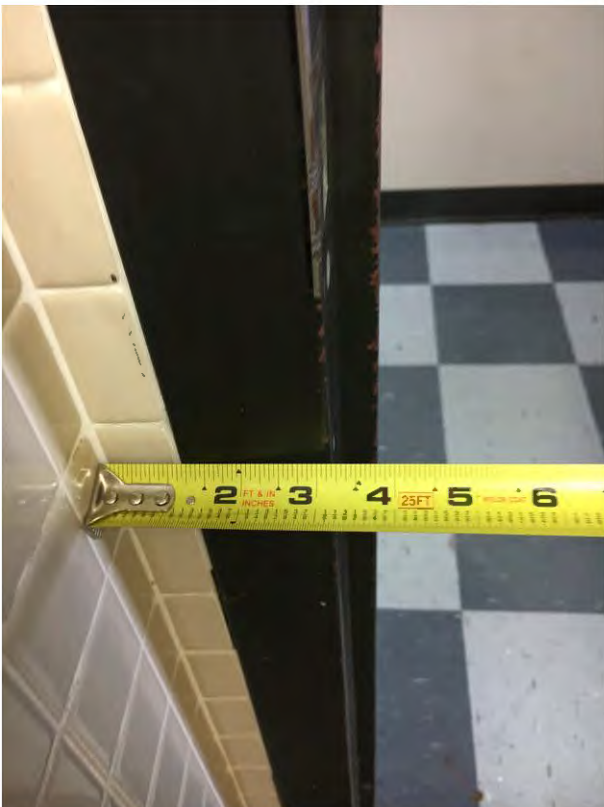
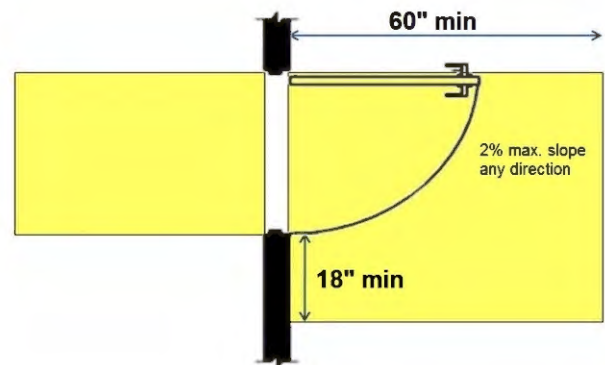
Finding: 85

6 (Medium): Access to goods and services (DOJ level 2) moderately out of compliance. Parking or exterior conditions (DOJ's level 1) – minimally out of compliance. Restrooms (DOJ level 3) – severely out of compliance.

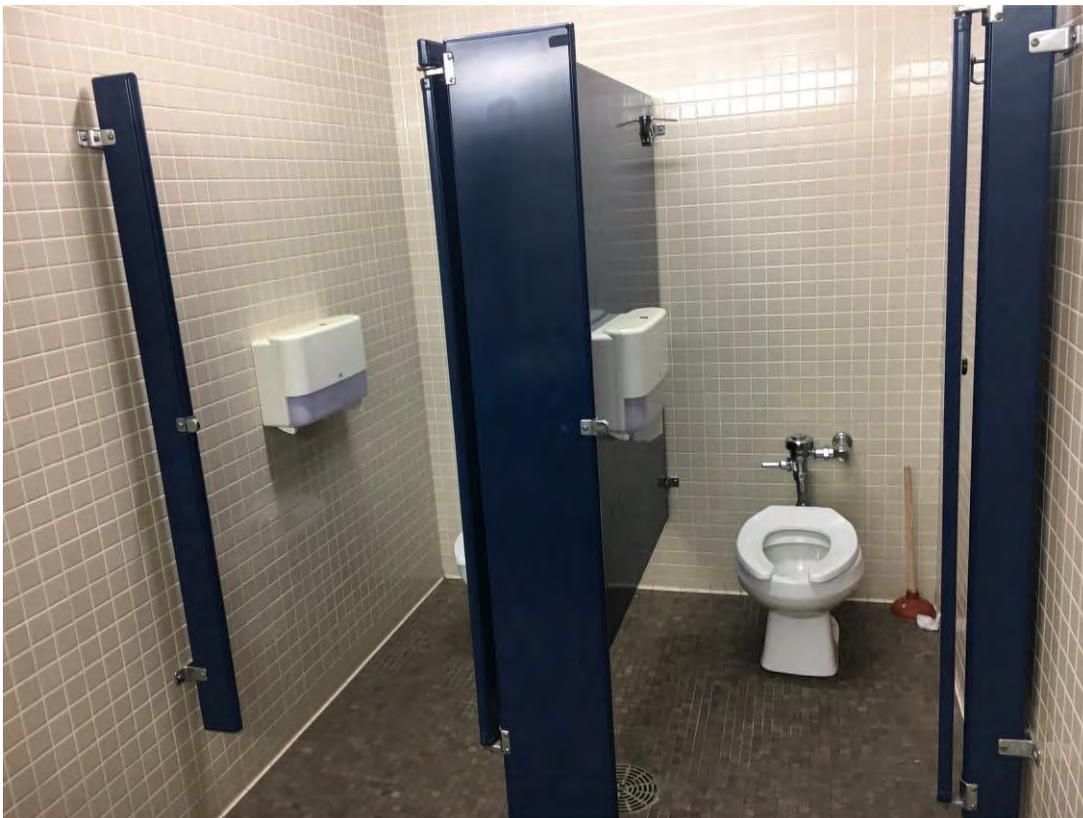
Finding: 86

6 (Medium): Access to goods and services (DOJ level 2) moderately out of compliance. Parking or exterior conditions (DOJ's level 1) – minimally out of compliance. Restrooms (DOJ level 3) – severely out of compliance.

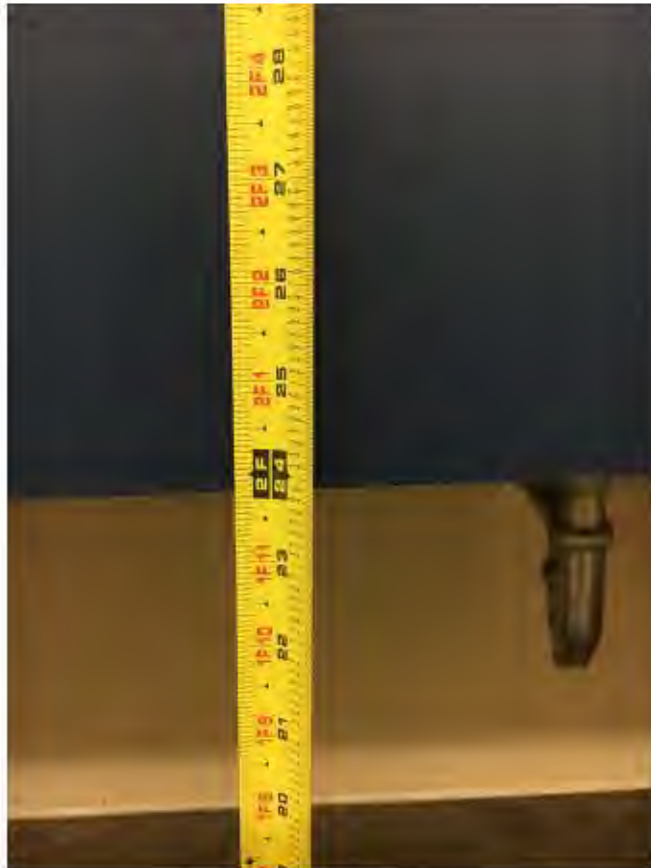
Finding: 87

6 (Medium): Access to goods and services (DOJ level 2) moderately out of compliance. Parking or exterior conditions (DOJ's level 1) – minimally out of compliance. Restrooms (DOJ level 3) – severely out of compliance.

Replace with lever style faucet controls.

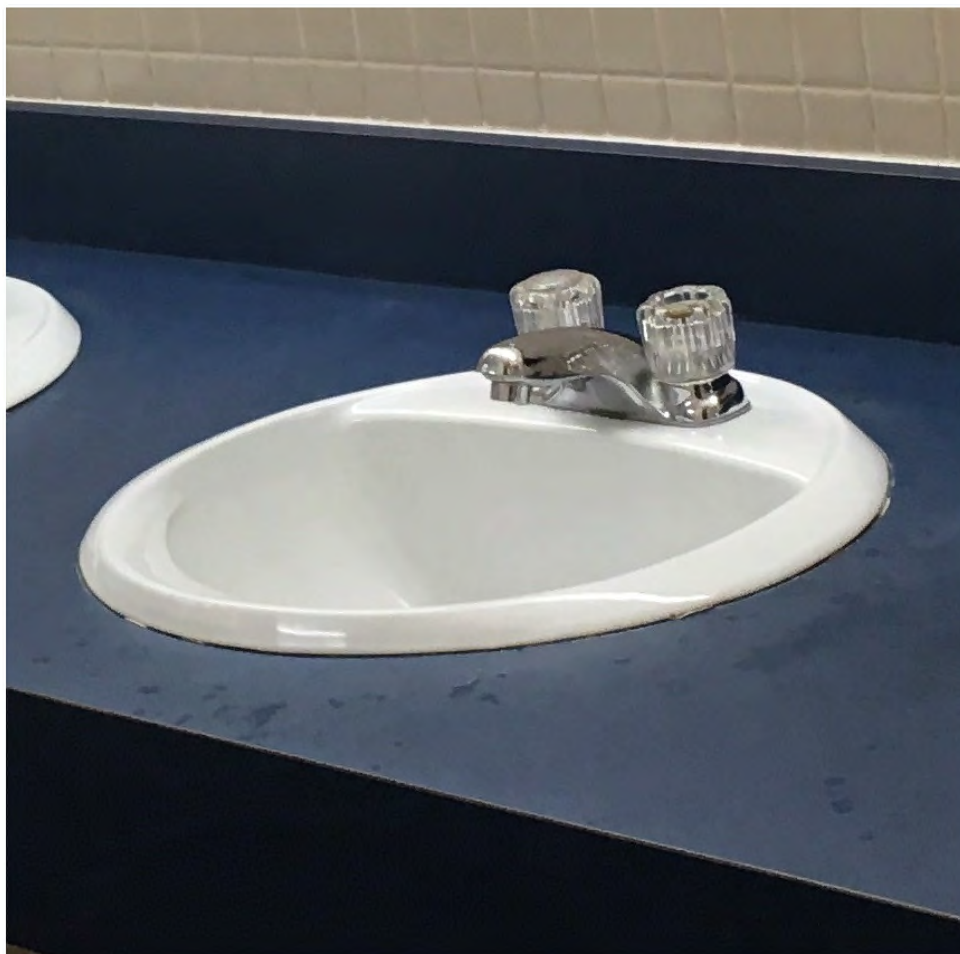
Finding: 88

6 (Medium): Access to goods and services (DOJ level 2) moderately out of compliance. Parking or exterior conditions (DOJ's level 1) – minimally out of compliance. Restrooms (DOJ level 3) – severely out of compliance.

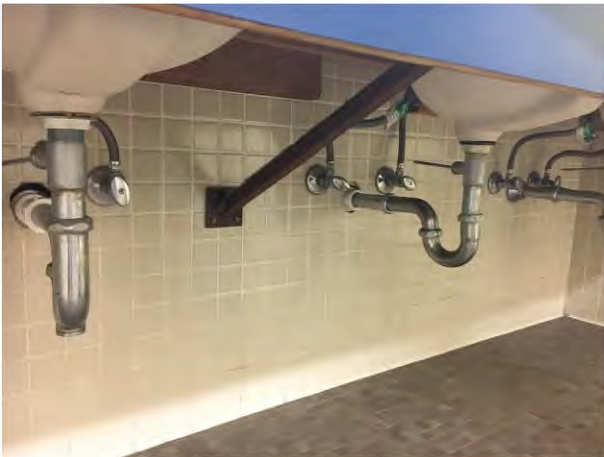
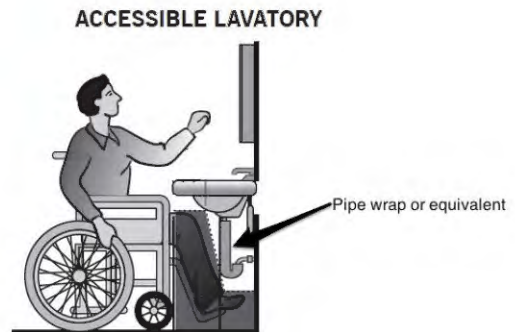
Finding: 89

6 (Medium): Access to goods and services (DOJ level 2) moderately out of compliance. Parking or exterior conditions (DOJ's level 1) – minimally out of compliance. Restrooms (DOJ level 3) – severely out of compliance.

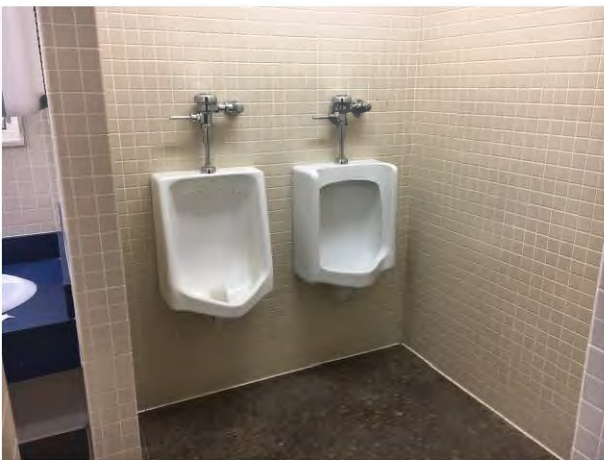
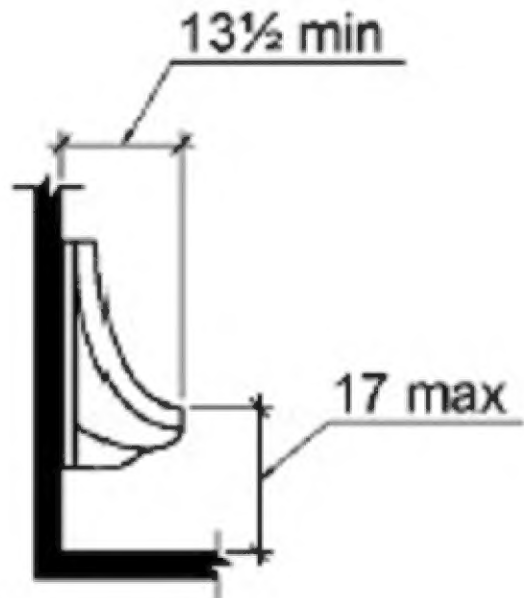
Finding: 90

6 (Medium): Access to goods and services (DOJ level 2) moderately out of compliance. Parking or exterior conditions (DOJ's level 1) – minimally out of compliance. Restrooms (DOJ level 3) – severely out of compliance.

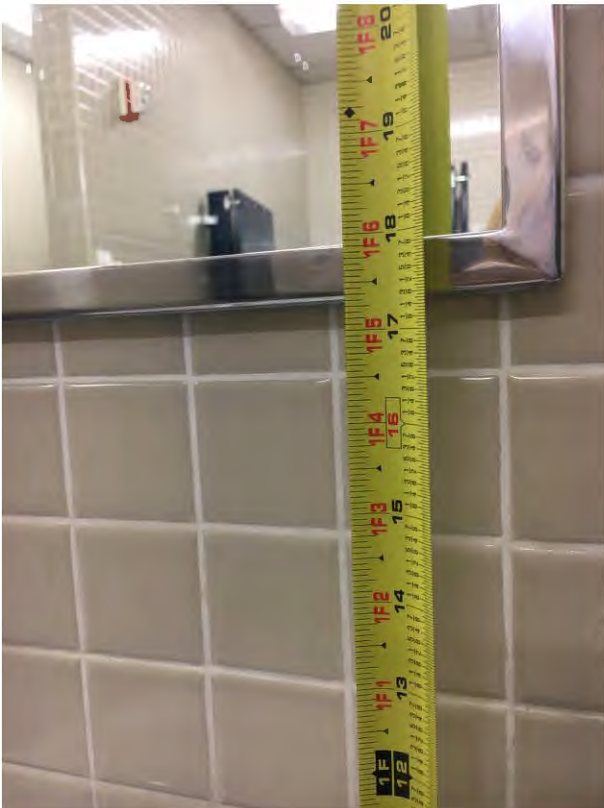
Finding: 91

7 (Medium): Access to goods and services (DOJ level 2) minimally out of compliance. Restrooms (DOJ level 3) – Moderately out of compliance Drinking fountains or public phones (DOJ level 4 & 5) severely out of compliance.

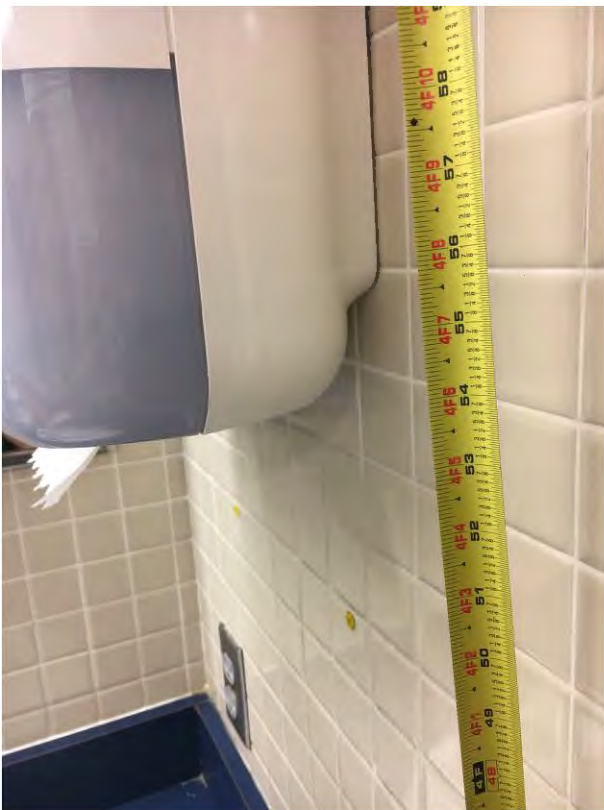
Finding: 92

8 (Medium): Drinking fountains or public phones (DOJ level 4 & 5) - moderately out of compliance.

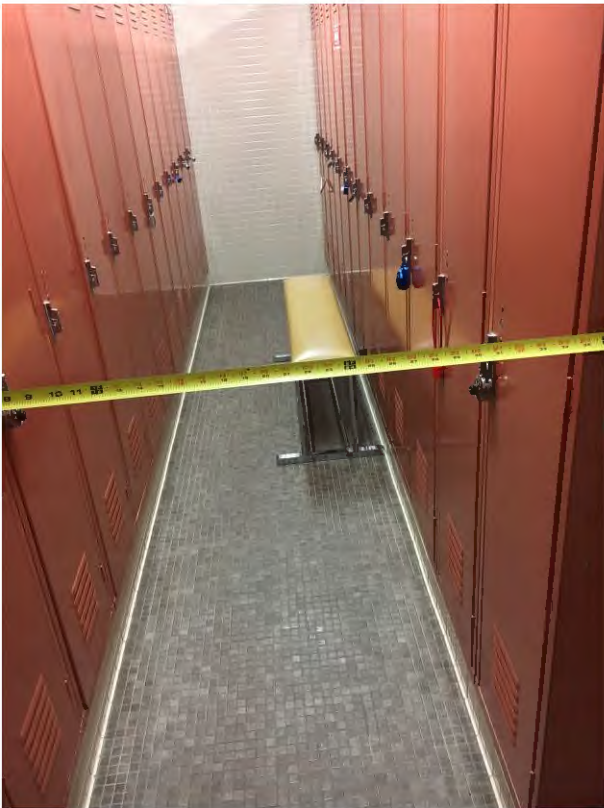
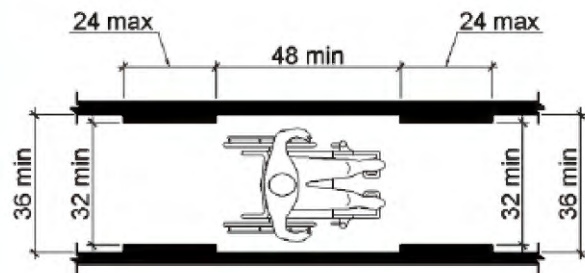
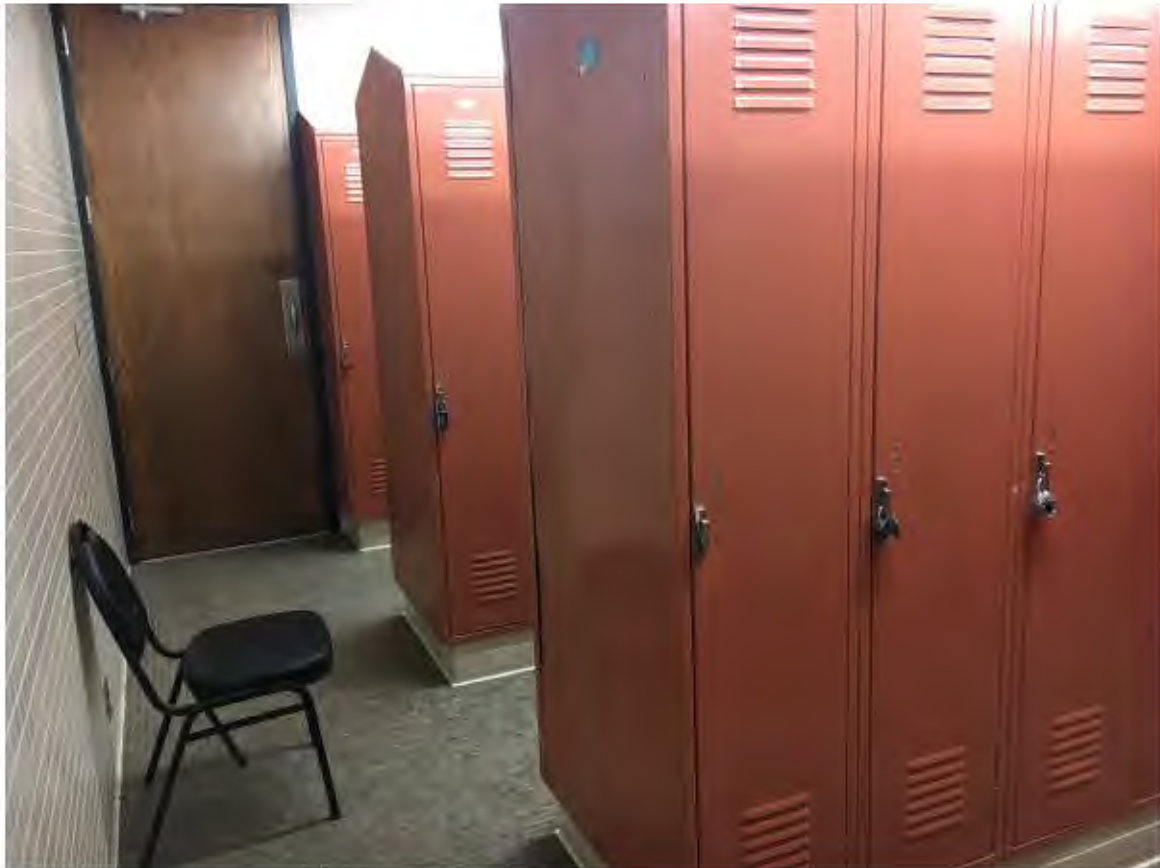
Finding: 93

6 (Medium): Access to goods and services (DOJ level 2) moderately out of compliance. Parking or exterior conditions (DOJ's level 1) – minimally out of compliance. Restrooms (DOJ level 3) – severely out of compliance.

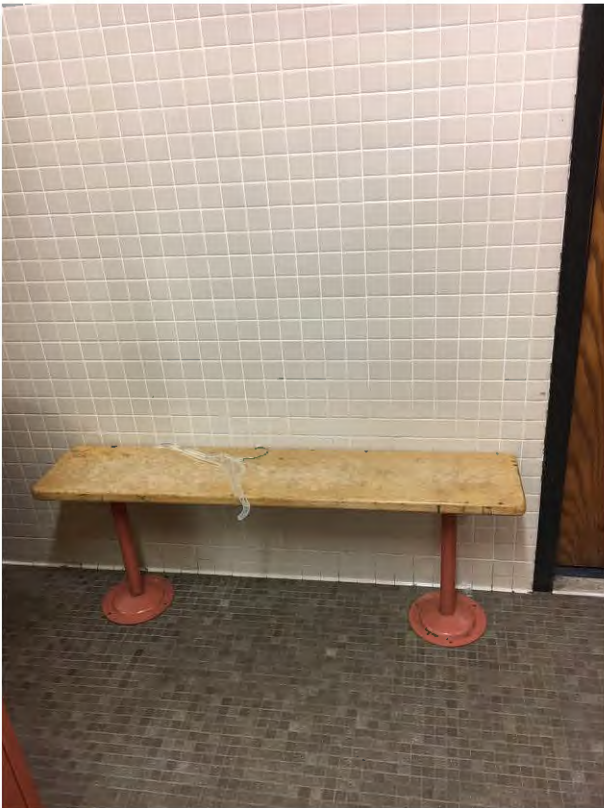
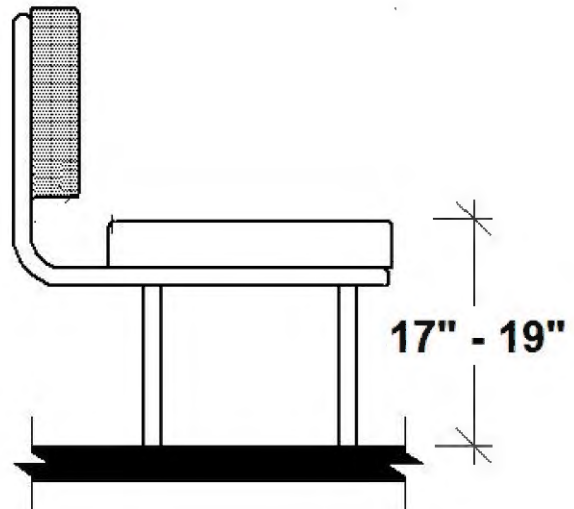
Finding: 94

6 (Medium): Access to goods and services (DOJ level 2) moderately out of compliance. Parking or exterior conditions (DOJ's level 1) – minimally out of compliance. Restrooms (DOJ level 3) – severely out of compliance.

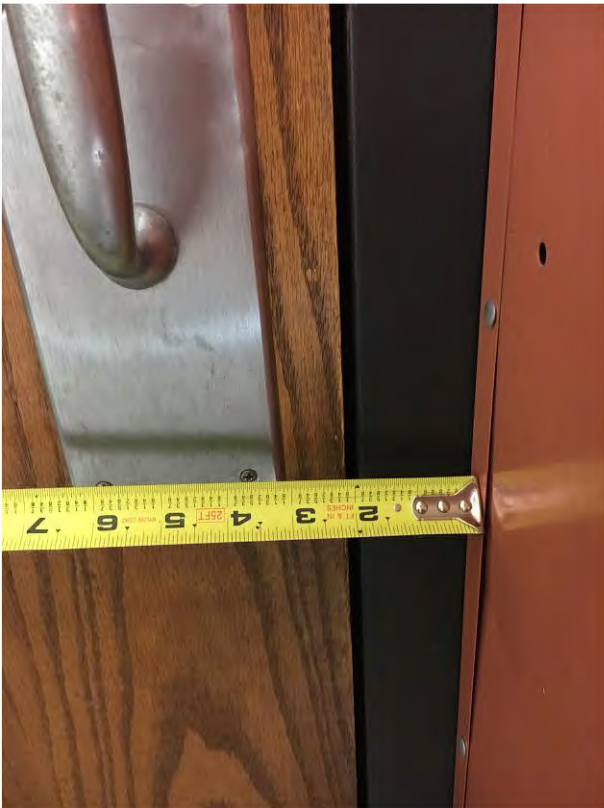
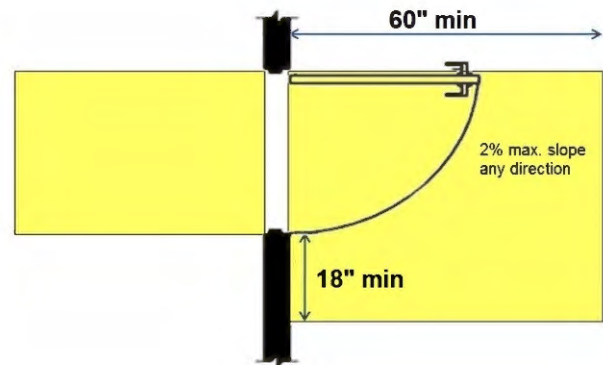
Finding: 95

7 (Medium): Access to goods and services (DOJ level 2) minimally out of compliance. Restrooms (DOJ level 3) – Moderately out of compliance Drinking fountains or public phones (DOJ level 4 & 5) severely out of compliance.

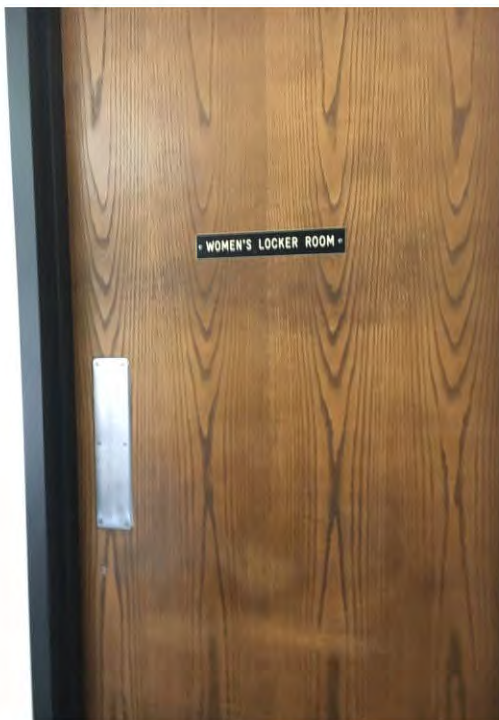
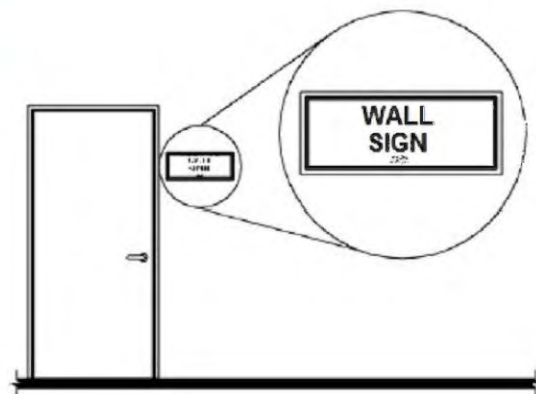
Finding: 96

6 (Medium): Access to goods and services (DOJ level 2) moderately out of compliance. Parking or exterior conditions (DOJ's level 1) – minimally out of compliance. Restrooms (DOJ level 3) – severely out of compliance.

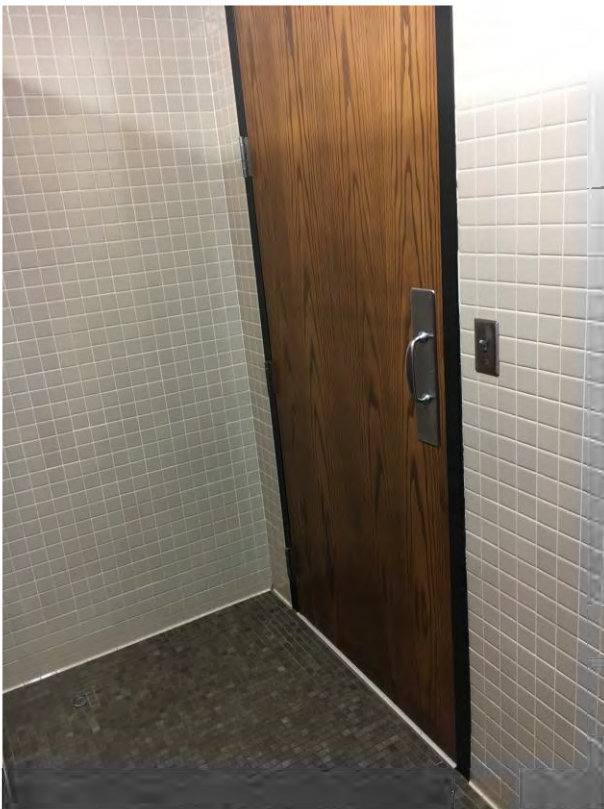
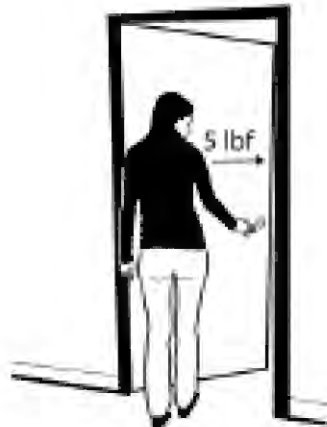
Finding: 97

7 (Medium): Access to goods and services (DOJ level 2) minimally out of compliance. Restrooms (DOJ level 3) – Moderately out of compliance Drinking fountains or public phones (DOJ level 4 & 5) severely out of compliance.

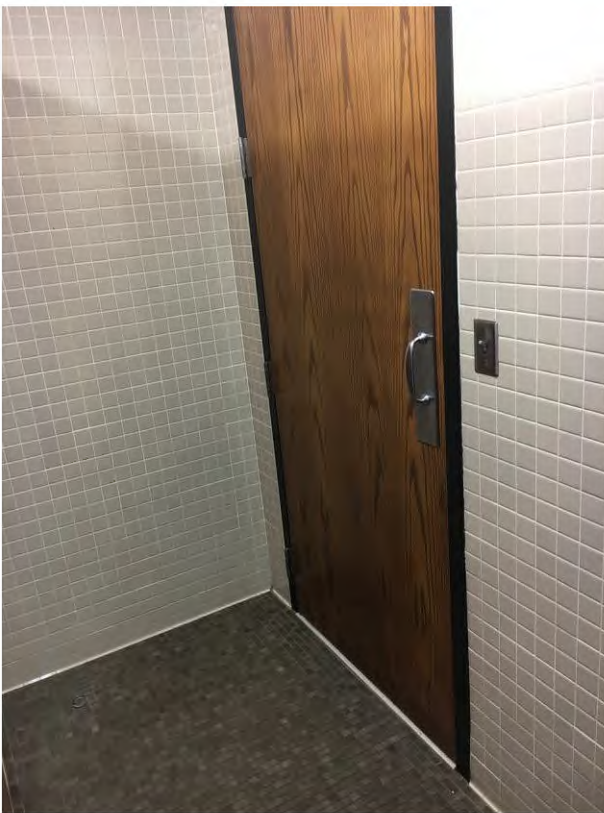
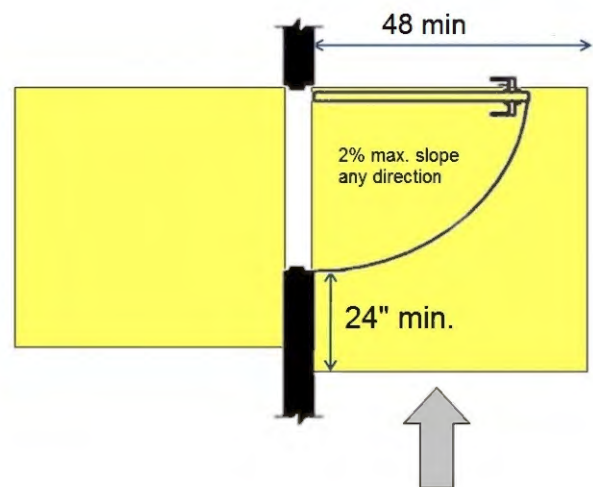
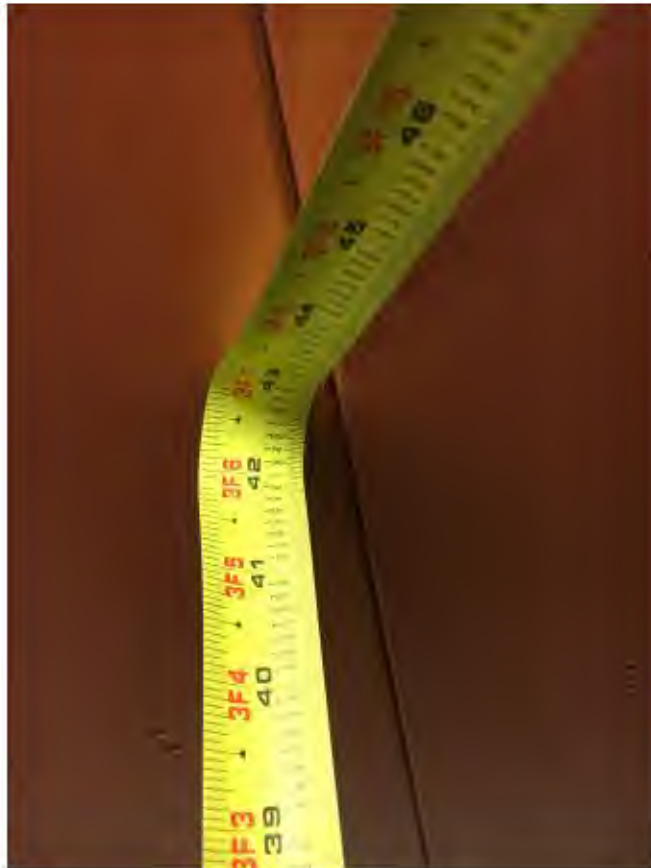
Finding: 98

7 (Medium): Access to goods and services (DOJ level 2) minimally out of compliance. Restrooms (DOJ level 3) – Moderately out of compliance Drinking fountains or public phones (DOJ level 4 & 5) severely out of compliance.

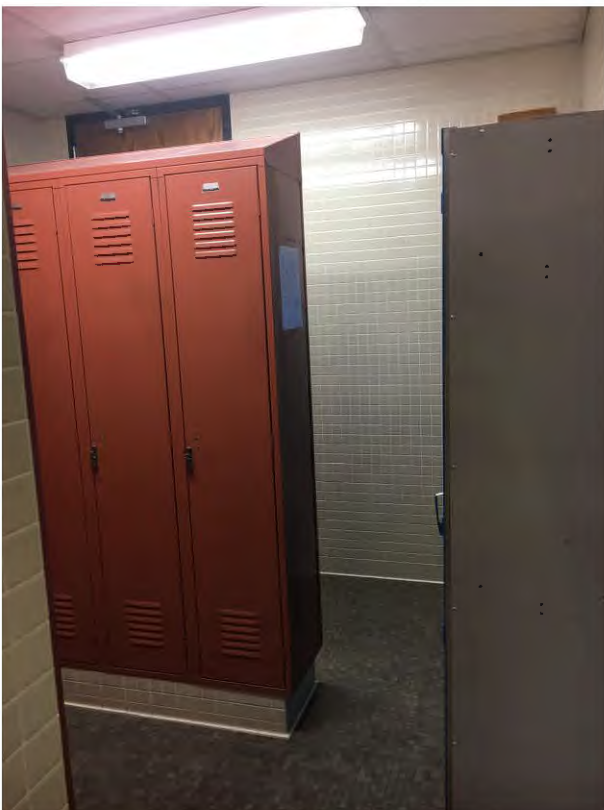
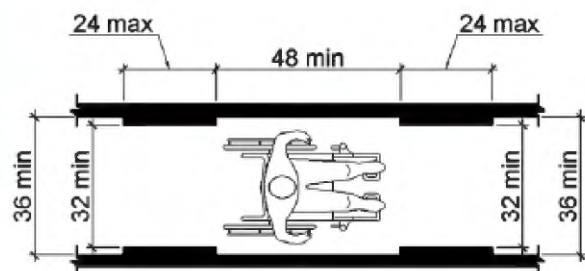
Finding: 99

7 (Medium): Access to goods and services (DOJ level 2) minimally out of compliance. Restrooms (DOJ level 3) – Moderately out of compliance Drinking fountains or public phones (DOJ level 4 & 5) severely out of compliance.

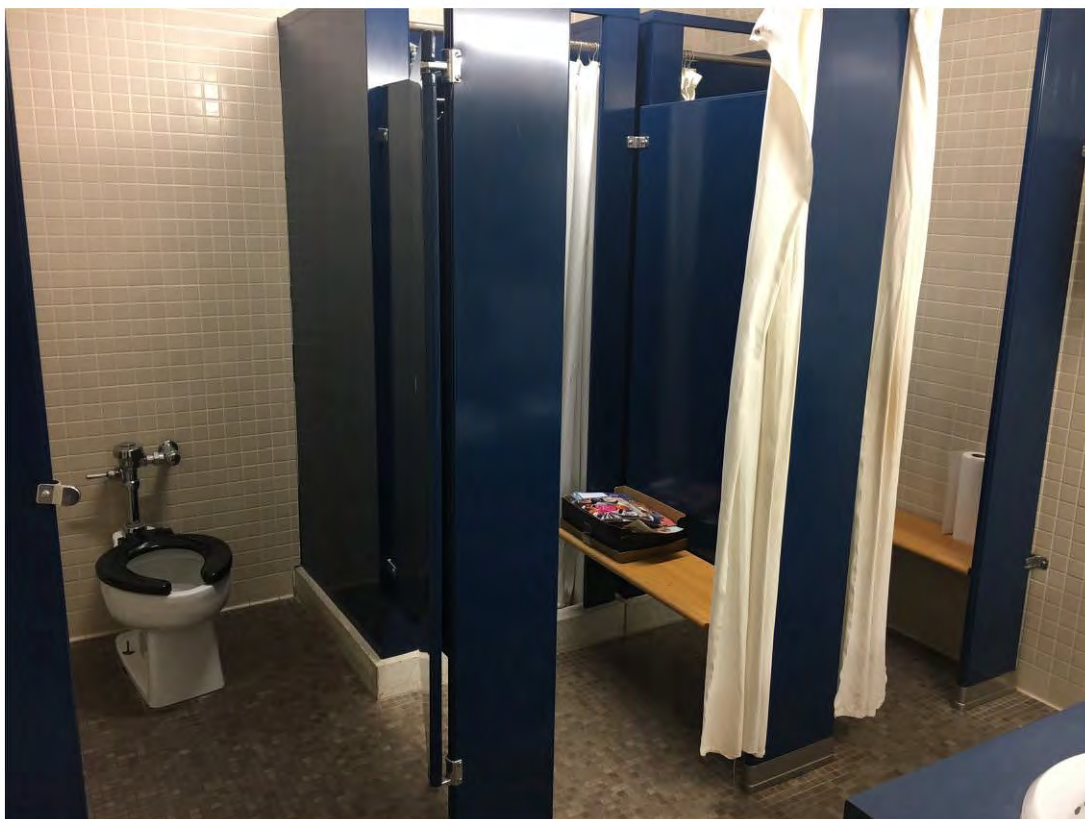
Finding: 100

6 (Medium): Access to goods and services (DOJ level 2) moderately out of compliance. Parking or exterior conditions (DOJ's level 1) – minimally out of compliance. Restrooms (DOJ level 3) – severely out of compliance.

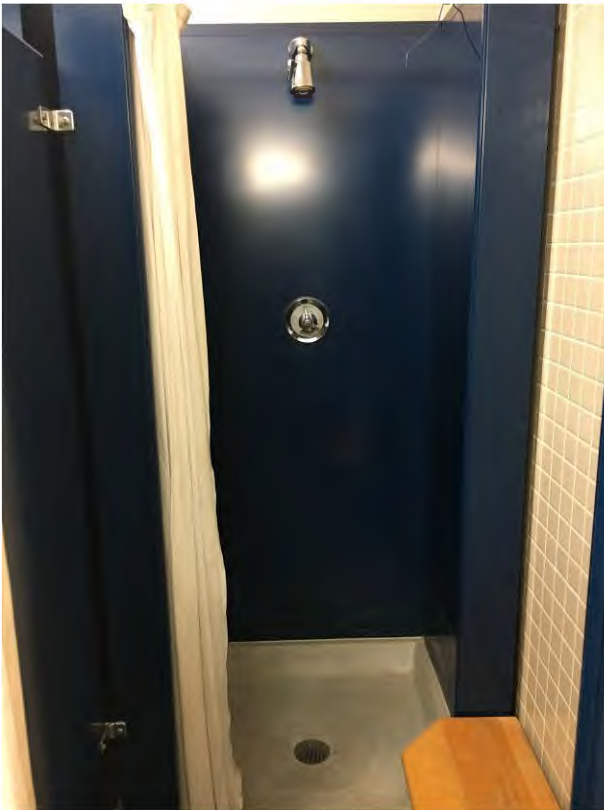
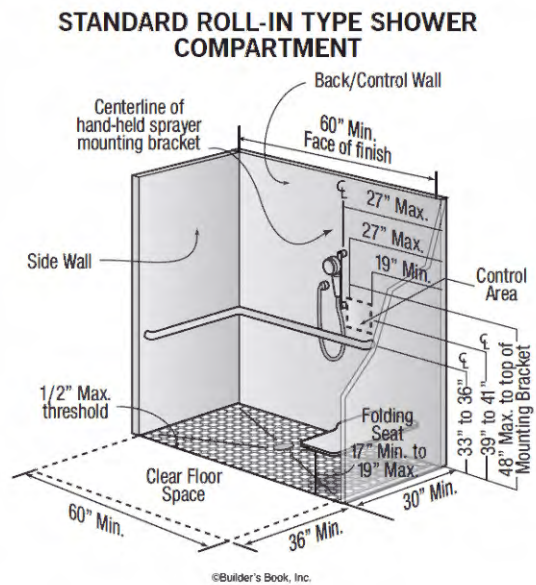
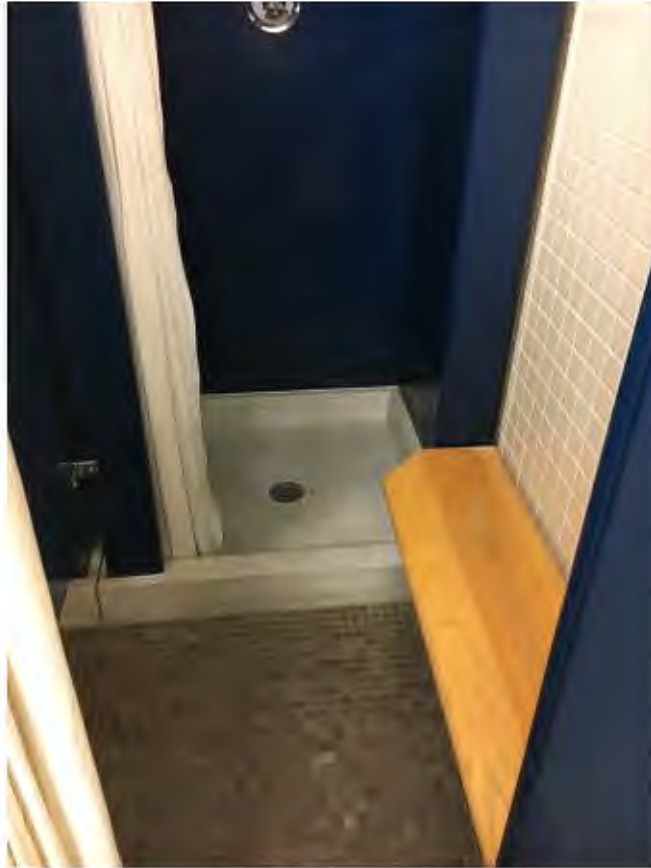
Finding: 101

6 (Medium): Access to goods and services (DOJ level 2) moderately out of compliance. Parking or exterior conditions (DOJ's level 1) – minimally out of compliance. Restrooms (DOJ level 3) – severely out of compliance.

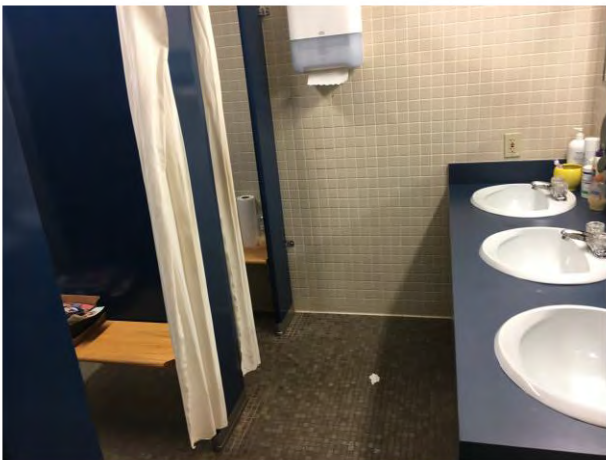
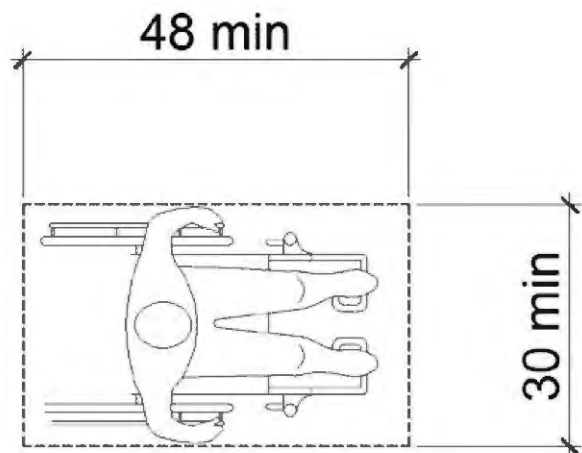
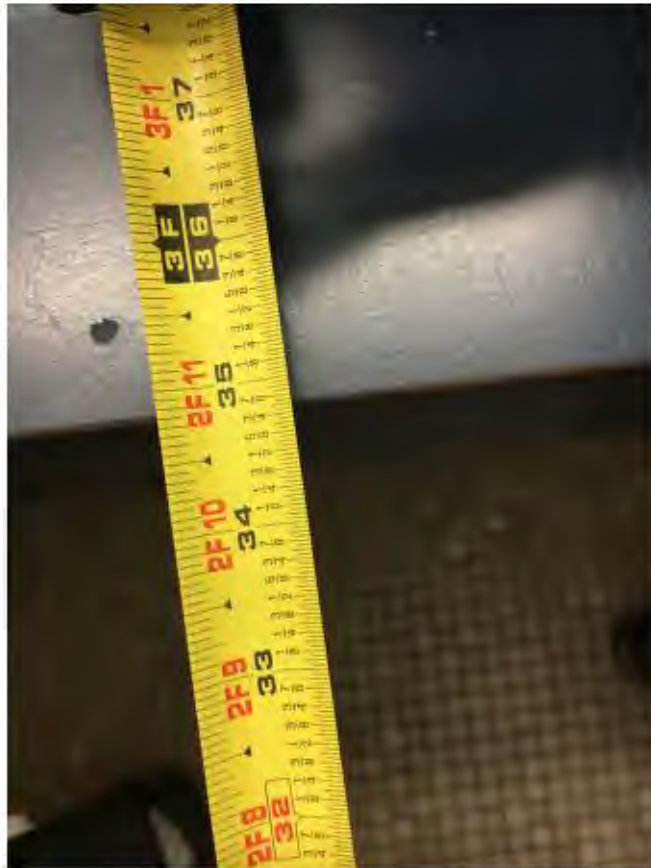
Finding: 102

6 (Medium): Access to goods and services (DOJ level 2) moderately out of compliance. Parking or exterior conditions (DOJ's level 1) – minimally out of compliance. Restrooms (DOJ level 3) – severely out of compliance.

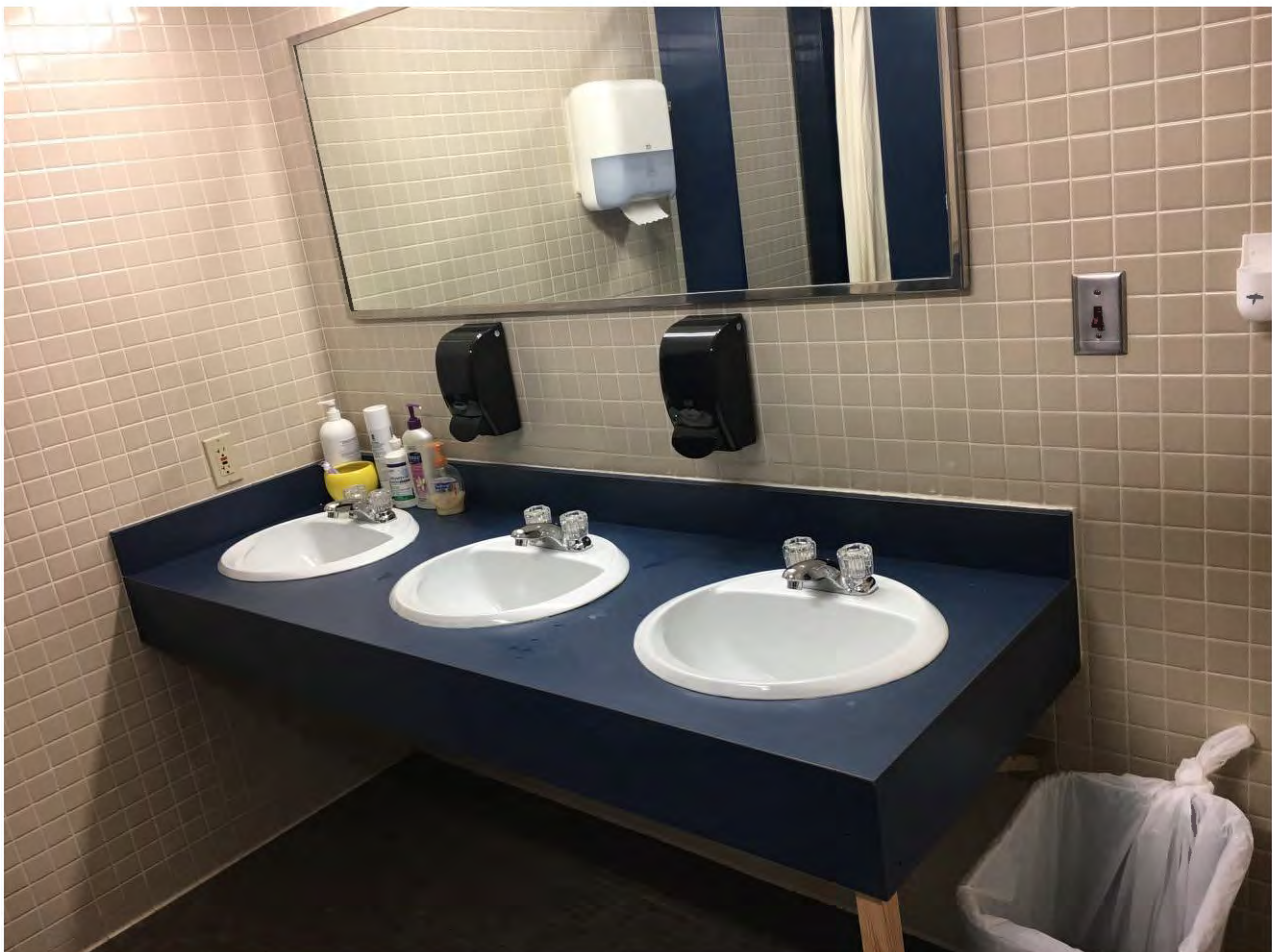
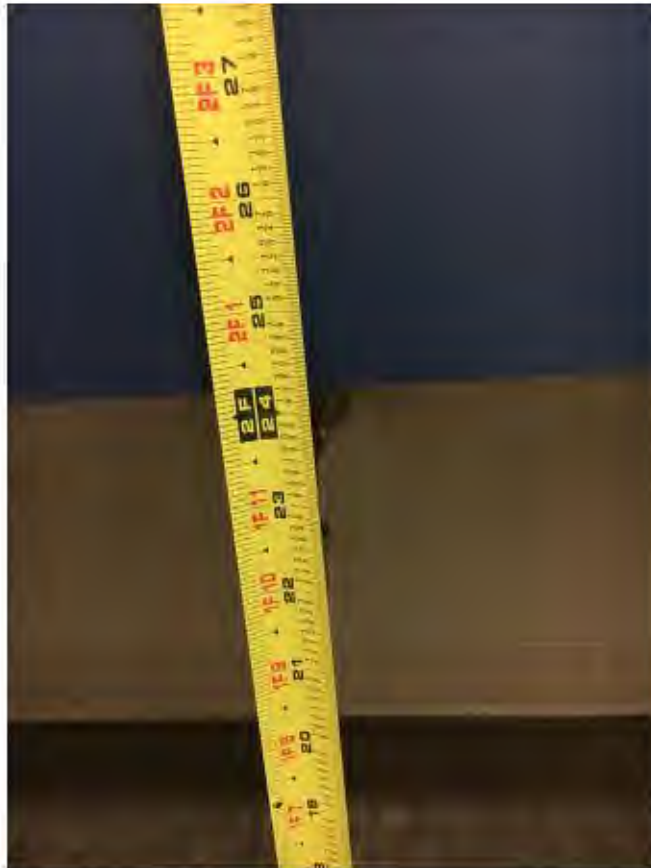
Finding: 103

6 (Medium): Access to goods and services (DOJ level 2) moderately out of compliance. Parking or exterior conditions (DOJ's level 1) – minimally out of compliance. Restrooms (DOJ level 3) – severely out of compliance.

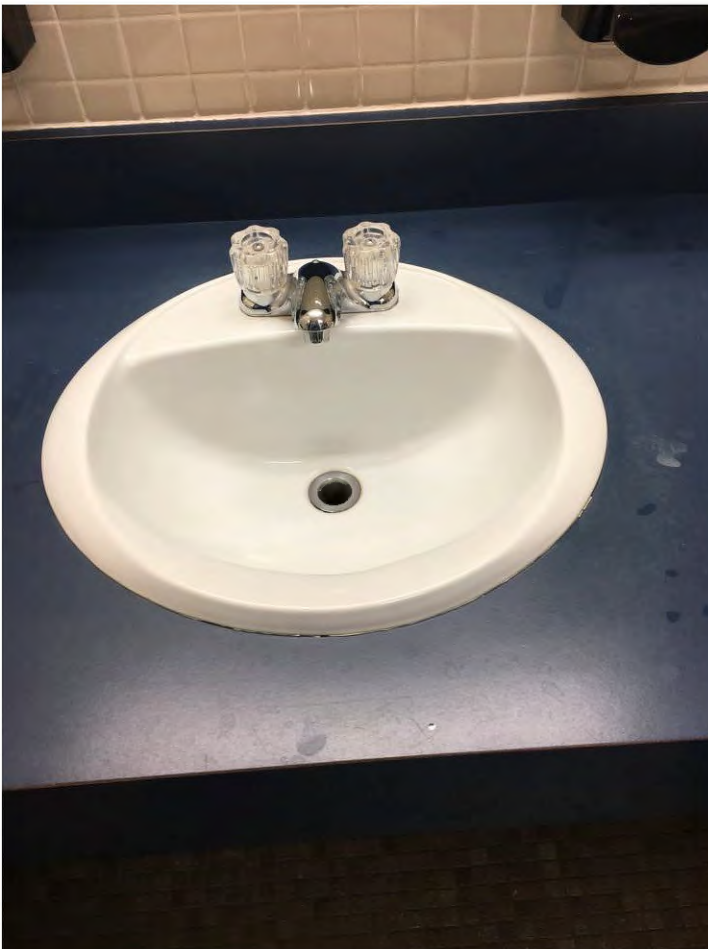
Finding: 104

6 (Medium): Access to goods and services (DOJ level 2) moderately out of compliance. Parking or exterior conditions (DOJ's level 1) – minimally out of compliance. Restrooms (DOJ level 3) – severely out of compliance.

Replace with lever style faucet controls.

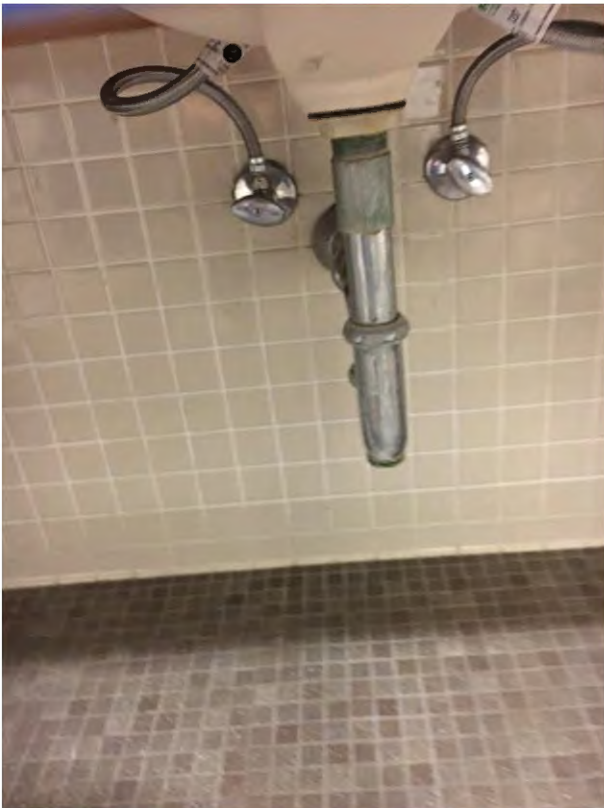
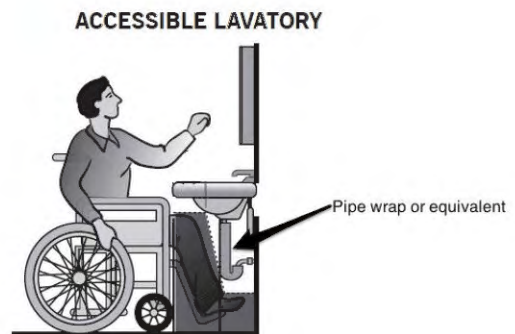
Finding: 105

7 (Medium): Access to goods and services (DOJ level 2) minimally out of compliance. Restrooms (DOJ level 3) – Moderately out of compliance Drinking fountains or public phones (DOJ level 4 & 5) severely out of compliance.
