City of Norman
ADA Self-Evaluation and Transition Plan
Building Cost Projection Summary
5/1/2018

Municipal Complex - Building A

Accessibility Evaluation

Inspection Date: 09/20/2017

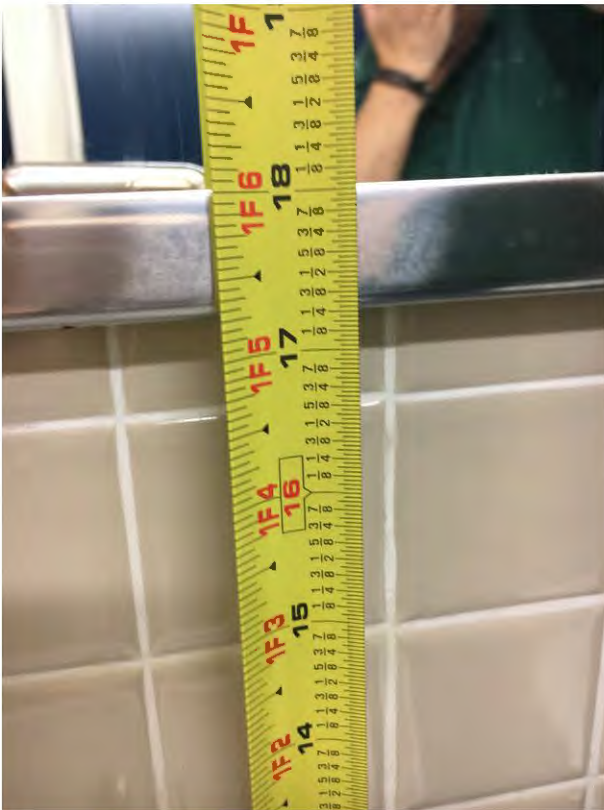
Finding: 106

7 (Medium): Access to goods and services (DOJ level 2) minimally out of compliance. Restrooms (DOJ level 3) – Moderately out of compliance Drinking fountains or public phones (DOJ level 4 & 5) severely out of compliance.

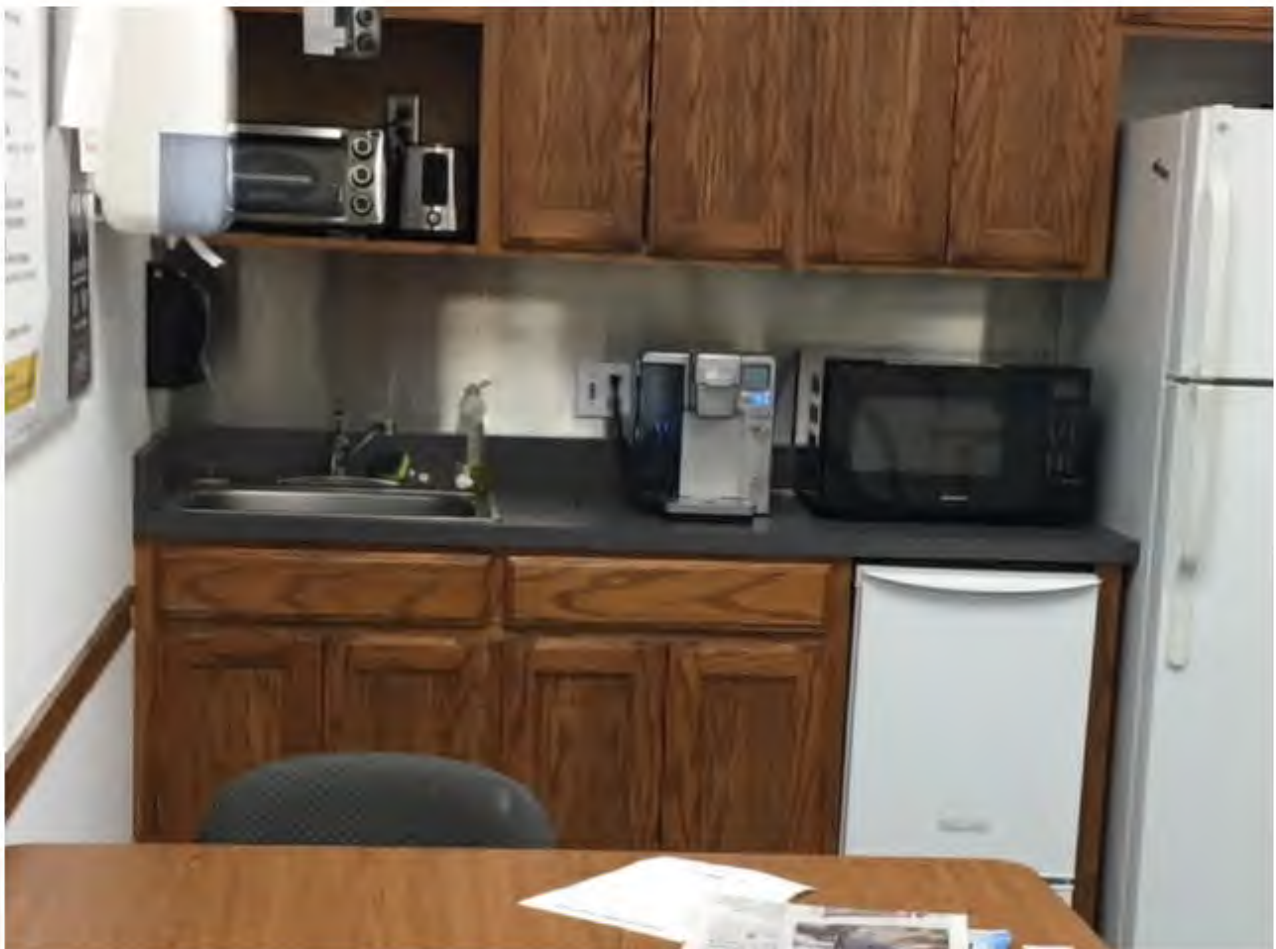
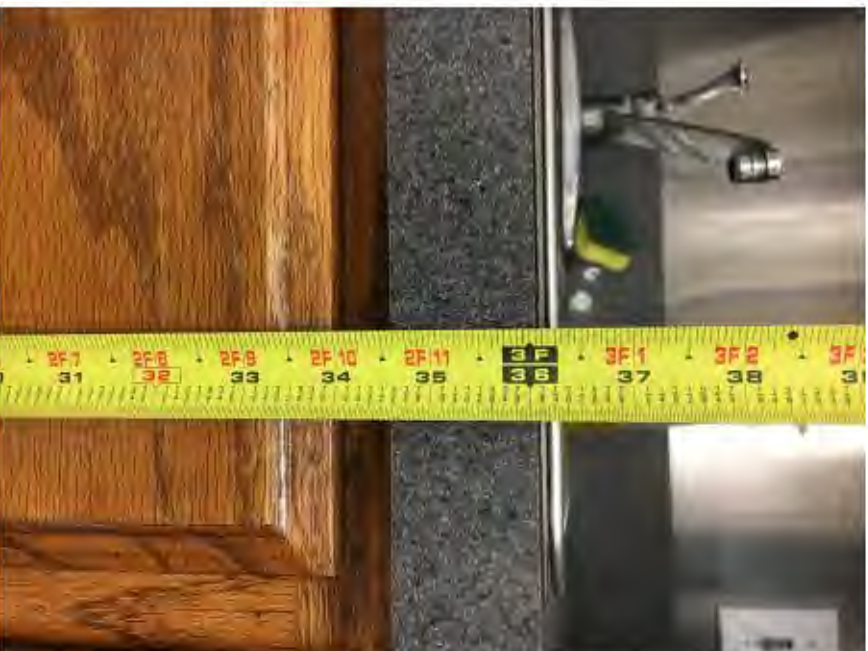
Finding: 107

7 (Medium): Access to goods and services (DOJ level 2) minimally out of compliance. Restrooms (DOJ level 3) – Moderately out of compliance Drinking fountains or public phones (DOJ level 4 & 5) severely out of compliance.

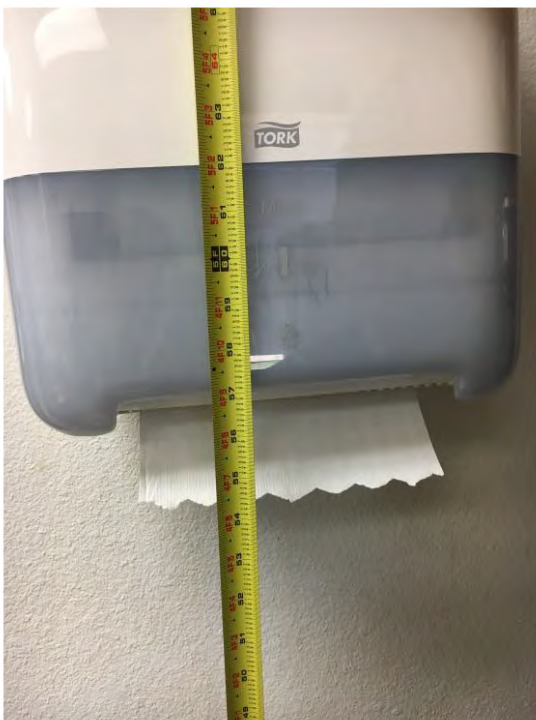
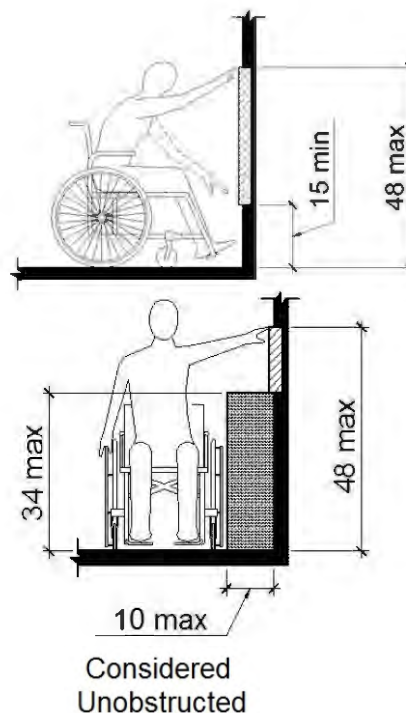
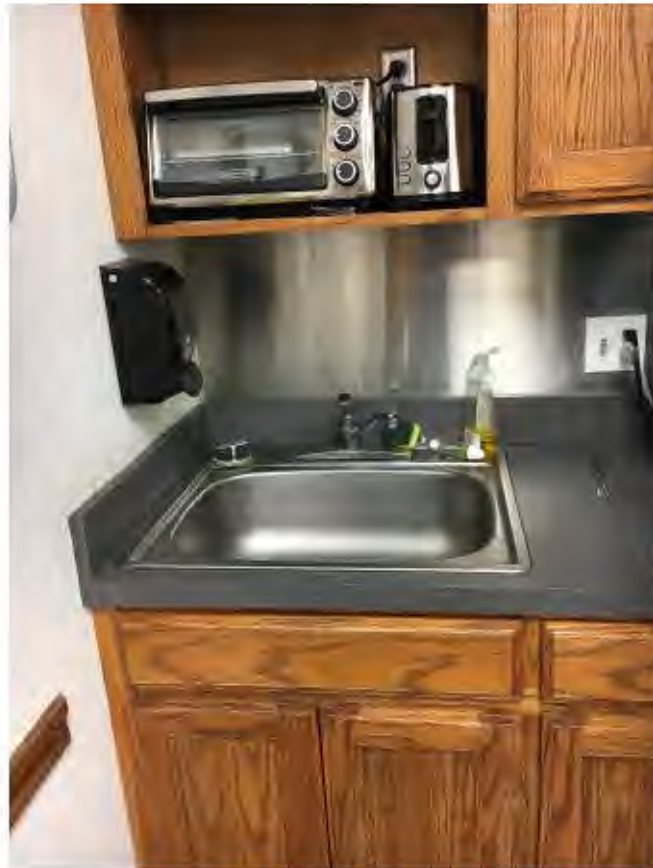
Finding: 108

7 (Medium): Access to goods and services (DOJ level 2) minimally out of compliance. Restrooms (DOJ level 3) – Moderately out of compliance Drinking fountains or public phones (DOJ level 4 & 5) severely out of compliance.

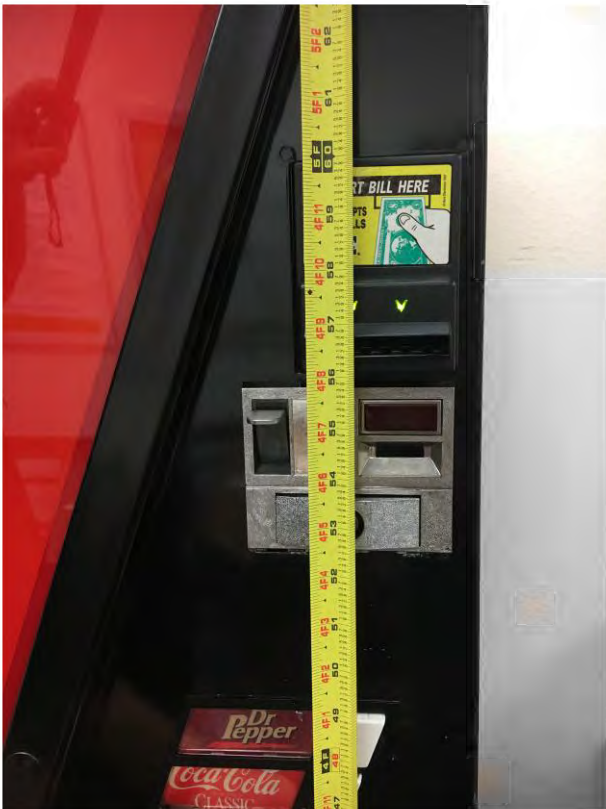
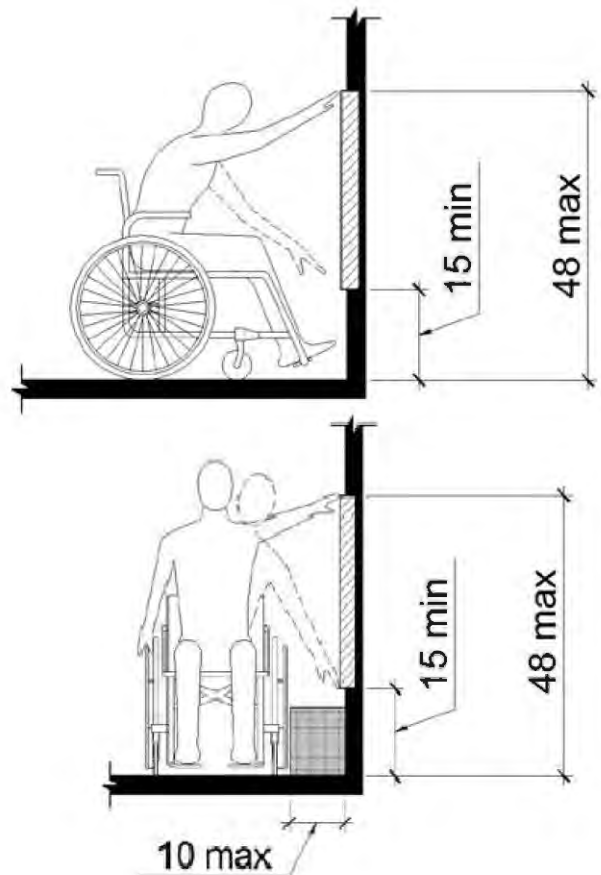
Finding: 109

11 (Low): Client is a Title II agency, elements are out of compliance but may be able to handled programmatically, or do not need to be handled unless or until they hire a person with a disability.

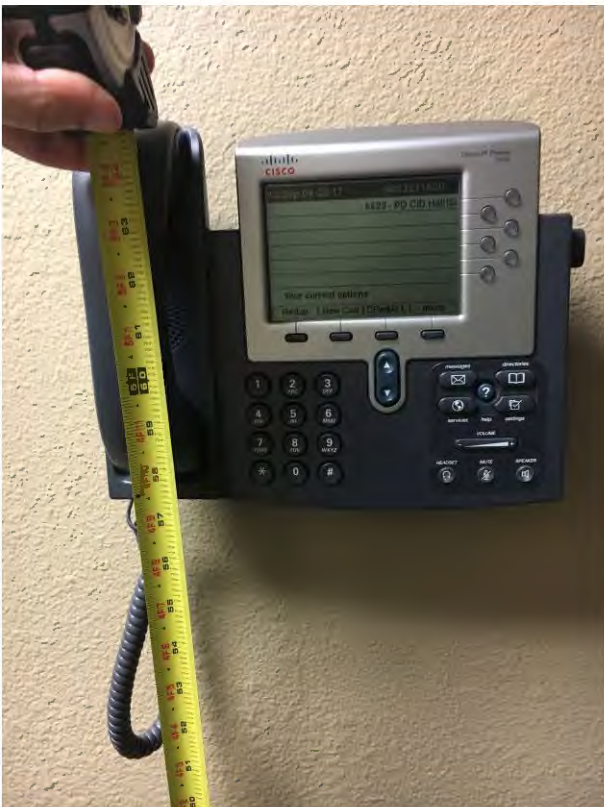
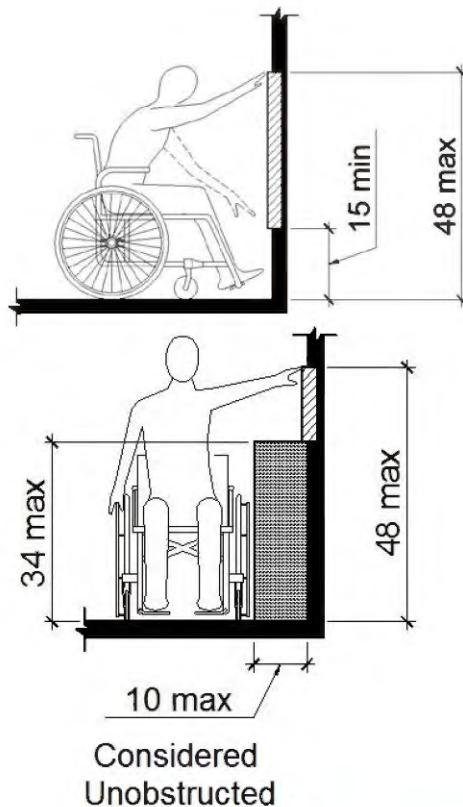
Police Station - Basement General

Finding: 111

6 (Medium): Access to goods and services (DOJ level 2) moderately out of compliance. Parking or exterior conditions (DOJ's level 1) – minimally out of compliance. Restrooms (DOJ level 3) – severely out of compliance.

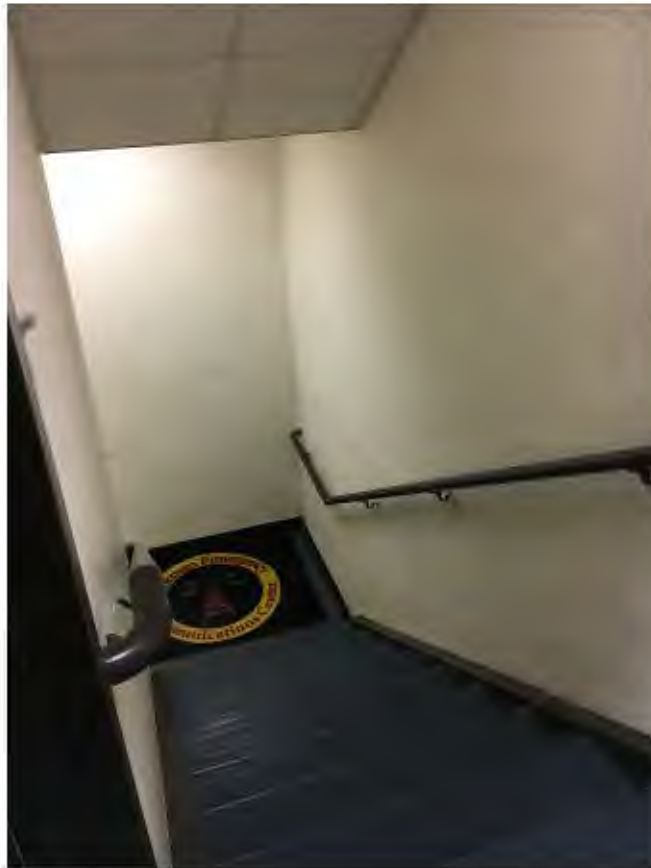
Police Station - Basement General

Finding: 112

7 (Medium): Access to goods and services (DOJ level 2) minimally out of compliance. Restrooms (DOJ level 3) – Moderately out of compliance Drinking fountains or public phones (DOJ level 4 & 5) severely out of compliance.

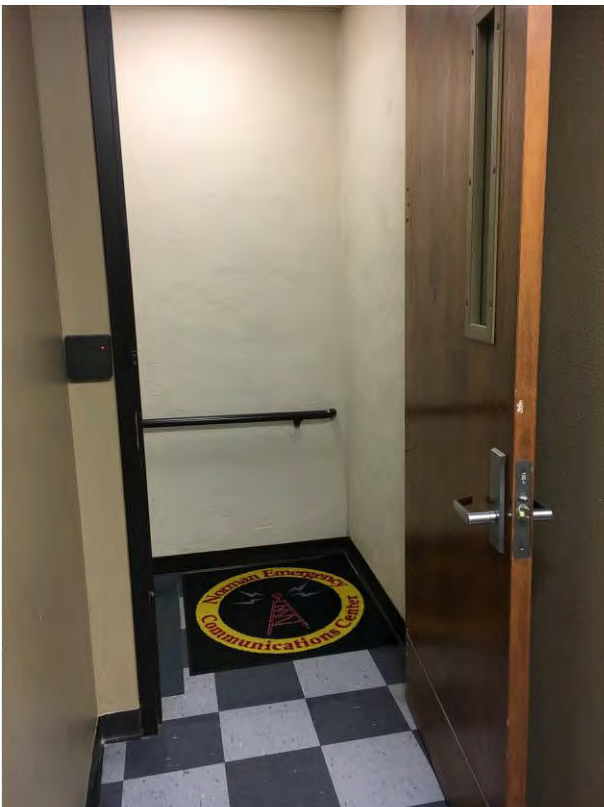
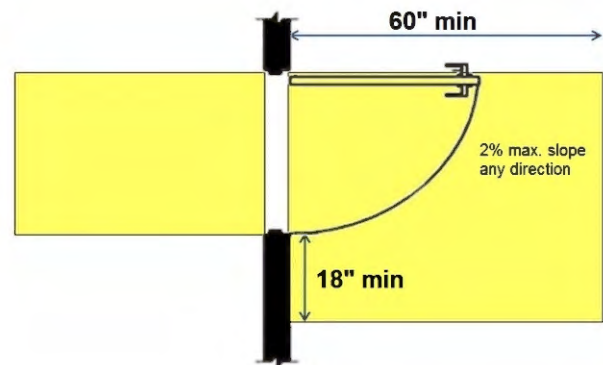
Police Station - Basement General

Finding: 113

7 (Medium): Access to goods and services (DOJ level 2) minimally out of compliance. Restrooms (DOJ level 3) – Moderately out of compliance Drinking fountains or public phones (DOJ level 4 & 5) severely out of compliance.

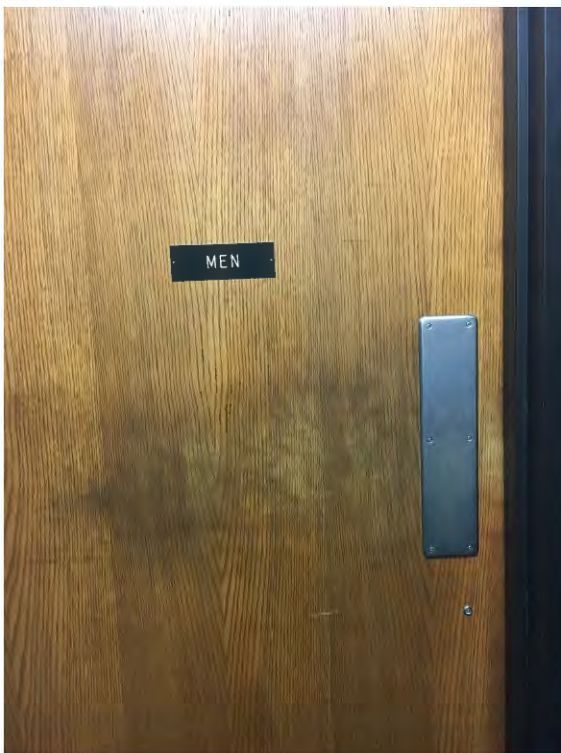
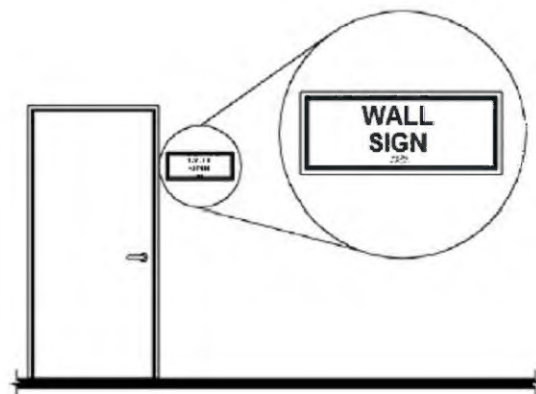
Police Station - Basement Men's Restroom

Finding: 115

7 (Medium): Access to goods and services (DOJ level 2) minimally out of compliance. Restrooms (DOJ level 3) – Moderately out of compliance Drinking fountains or public phones (DOJ level 4 & 5) severely out of compliance.

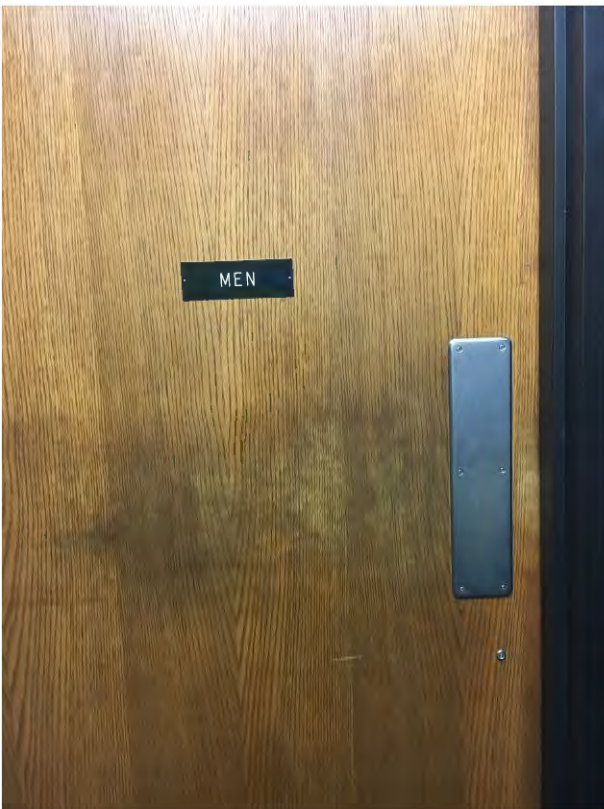
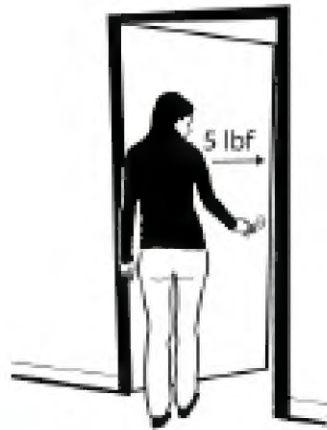
Police Station - Basement Men's Restroom

Finding: 116

6 (Medium): Access to goods and services (DOJ level 2) moderately out of compliance. Parking or exterior conditions (DOJ's level 1) – minimally out of compliance. Restrooms (DOJ level 3) – severely out of compliance.

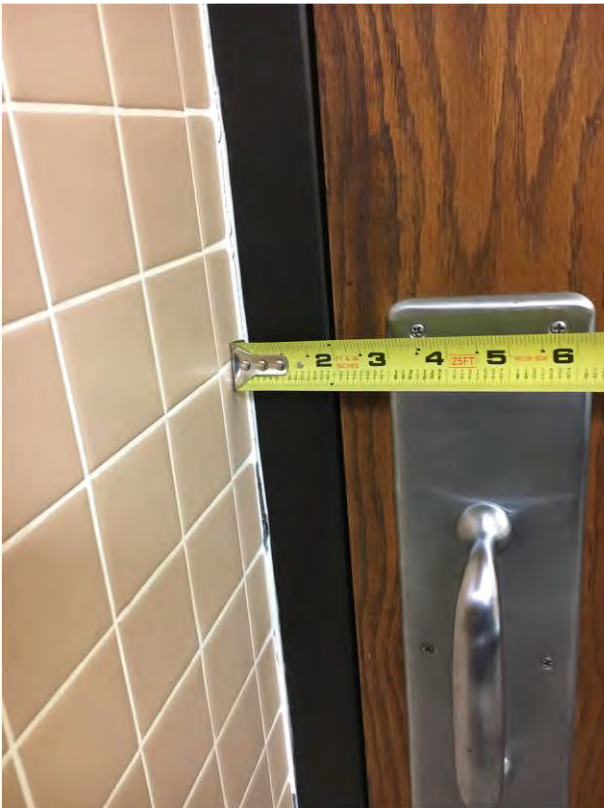
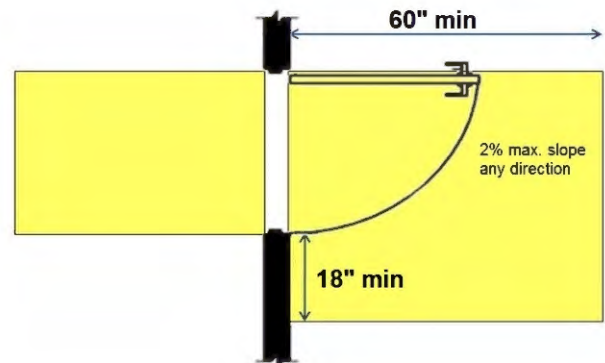
Police Station - Basement Men's Restroom

Finding: 117

6 (Medium): Access to goods and services (DOJ level 2) moderately out of compliance. Parking or exterior conditions (DOJ's level 1) – minimally out of compliance. Restrooms (DOJ level 3) – severely out of compliance.

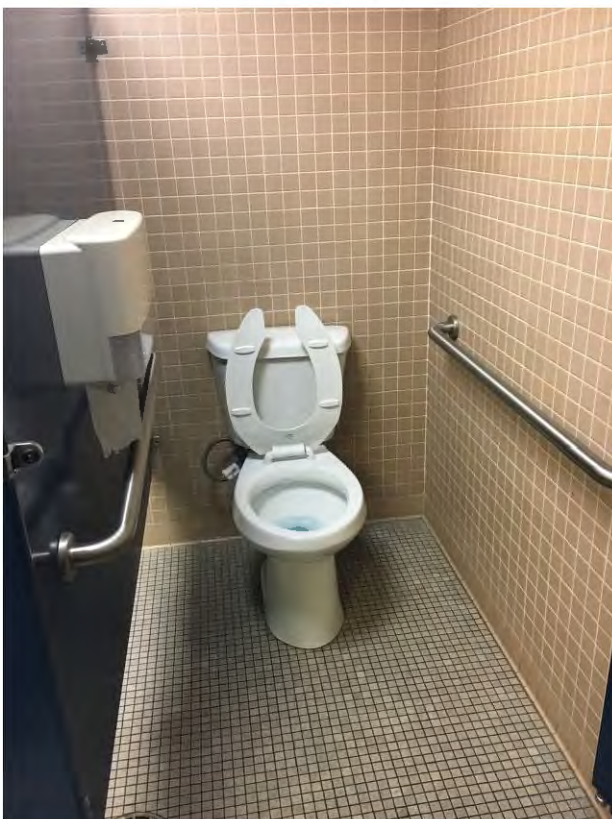
Police Station - Basement Men's Restroom

Finding: 118

7 (Medium): Access to goods and services (DOJ level 2) minimally out of compliance. Restrooms (DOJ level 3) – Moderately out of compliance Drinking fountains or public phones (DOJ level 4 & 5) severely out of compliance.

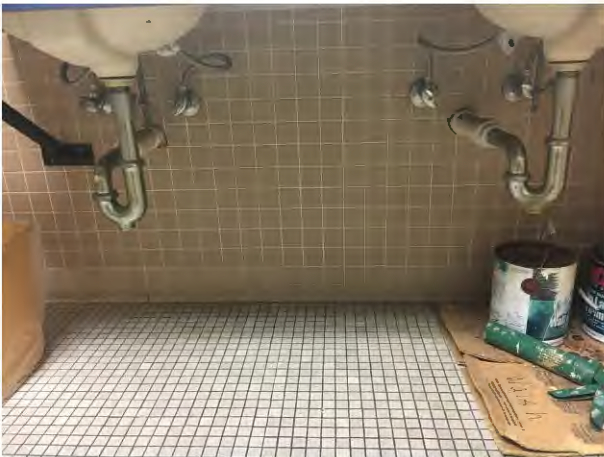
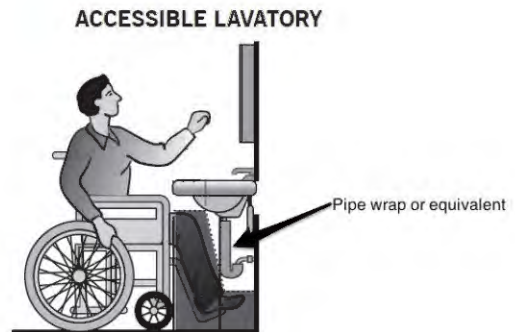
Police Station - Basement Men's Restroom

Finding: 119

11 (Low): Client is a Title II agency, elements are out of compliance but may be able to handled programmatically, or do not need to be handled unless or until they hire a person with a disability.

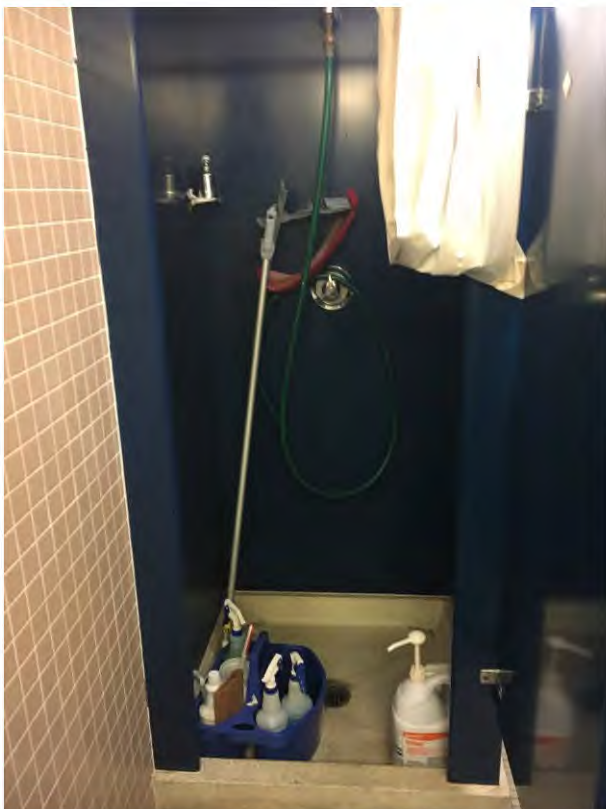
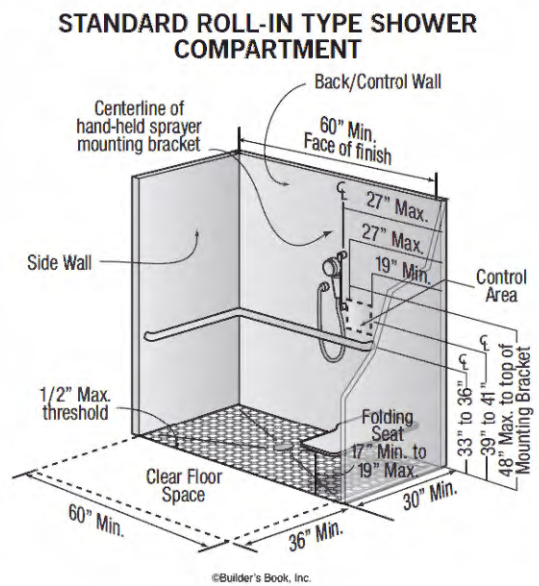
Police Station - Basement Men's Restroom

Finding: 120

8 (Medium): Drinking fountains or public phones (DOJ level 4 & 5) - moderately out of compliance.

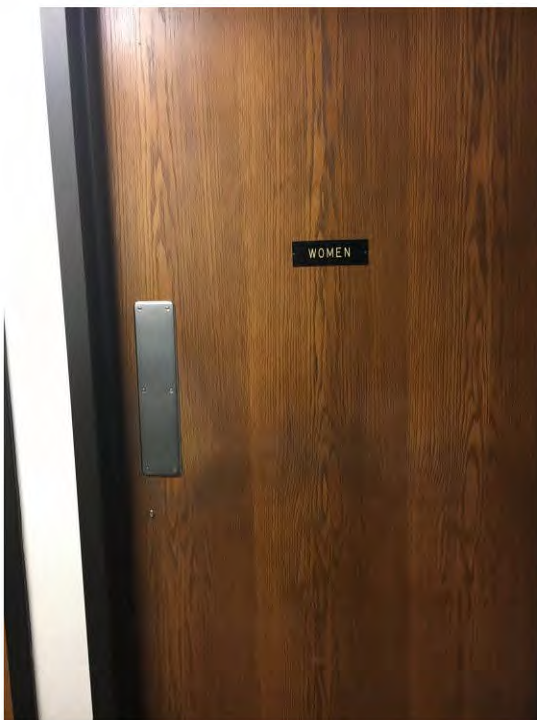
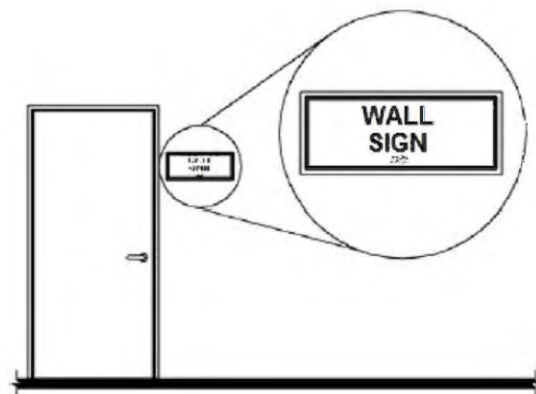
Police Station - Basement Women's Restroom

Finding: 122

7 (Medium): Access to goods and services (DOJ level 2) minimally out of compliance. Restrooms (DOJ level 3) – Moderately out of compliance Drinking fountains or public phones (DOJ level 4 & 5) severely out of compliance.

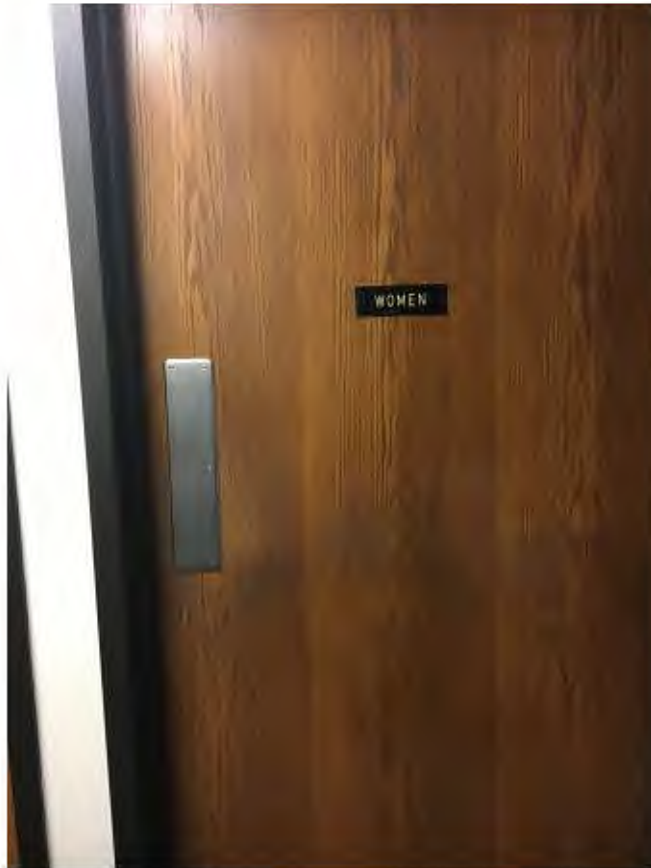
Police Station - Basement Women's Restroom

Finding: 123

7 (Medium): Access to goods and services (DOJ level 2) minimally out of compliance. Restrooms (DOJ level 3) – Moderately out of compliance Drinking fountains or public phones (DOJ level 4 & 5) severely out of compliance.

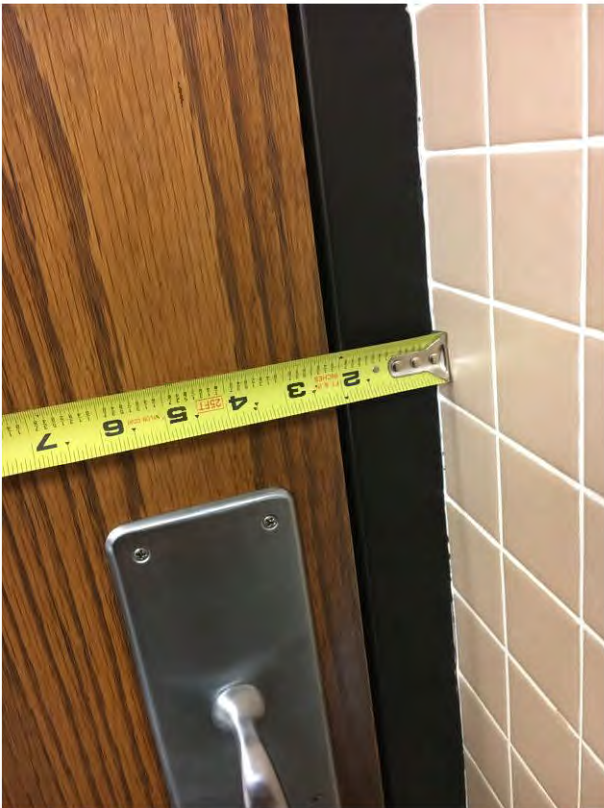
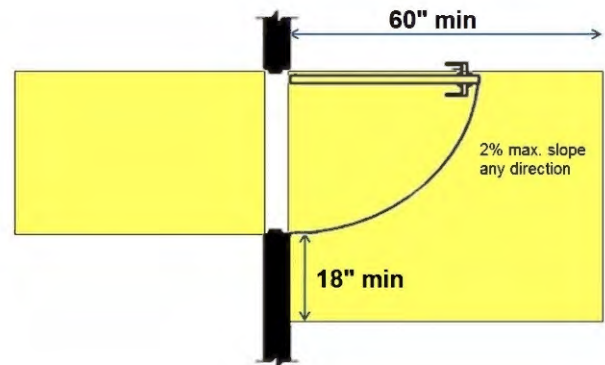
Police Station - Basement Women's Restroom

Finding: 124

6 (Medium): Access to goods and services (DOJ level 2) moderately out of compliance. Parking or exterior conditions (DOJ's level 1) – minimally out of compliance. Restrooms (DOJ level 3) – severely out of compliance.

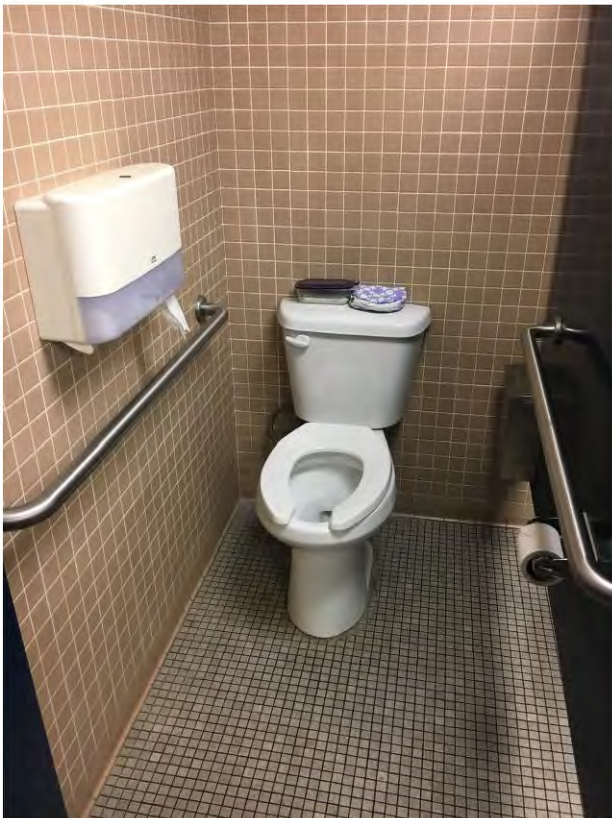
Police Station - Basement Women's Restroom

Finding: 125

6 (Medium): Access to goods and services (DOJ level 2) moderately out of compliance. Parking or exterior conditions (DOJ's level 1) – minimally out of compliance. Restrooms (DOJ level 3) – severely out of compliance.

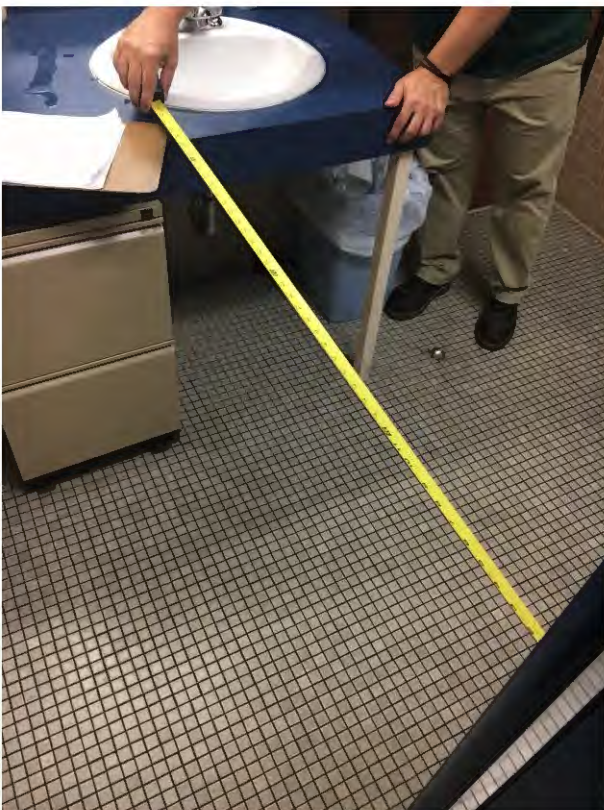
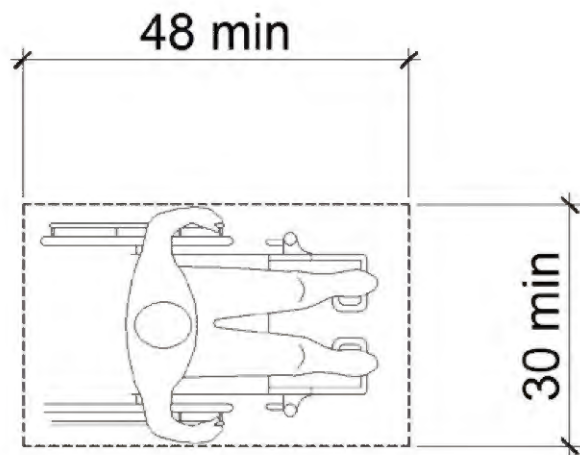
Police Station - Basement Women's Restroom

Finding: 126

7 (Medium): Access to goods and services (DOJ level 2) minimally out of compliance. Restrooms (DOJ level 3) – Moderately out of compliance Drinking fountains or public phones (DOJ level 4 & 5) severely out of compliance.

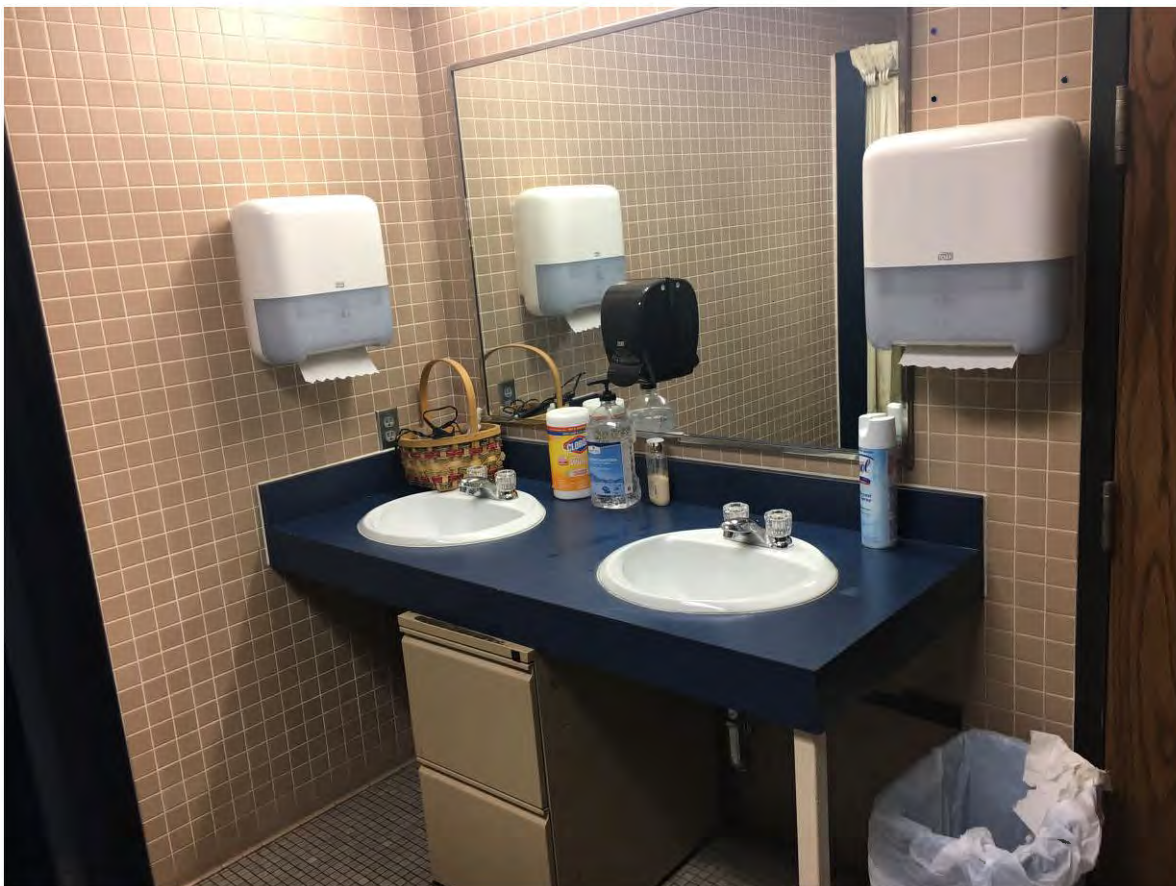
Police Station - Basement Women's Restroom

Finding: 127

6 (Medium): Access to goods and services (DOJ level 2) moderately out of compliance. Parking or exterior conditions (DOJ's level 1) – minimally out of compliance. Restrooms (DOJ level 3) – severely out of compliance.

Replace with lever style faucet controls.

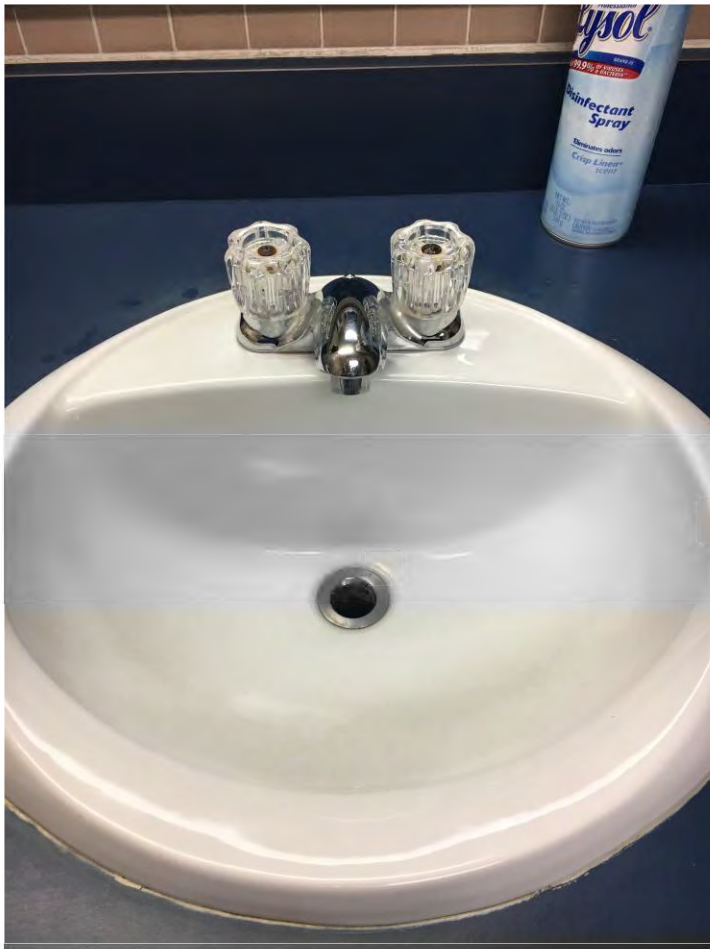
Police Station - Basement Women's Restroom

Finding: 128

7 (Medium): Access to goods and services (DOJ level 2) minimally out of compliance. Restrooms (DOJ level 3) – Moderately out of compliance Drinking fountains or public phones (DOJ level 4 & 5) severely out of compliance.

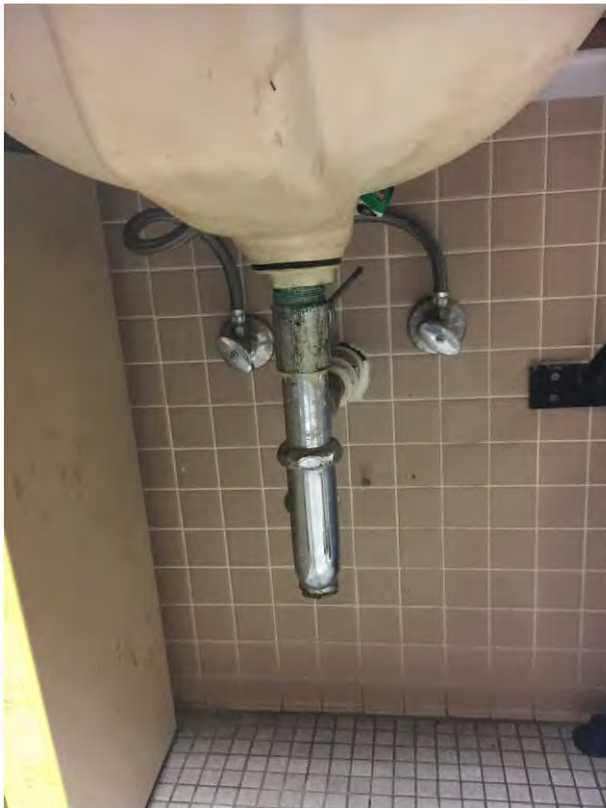
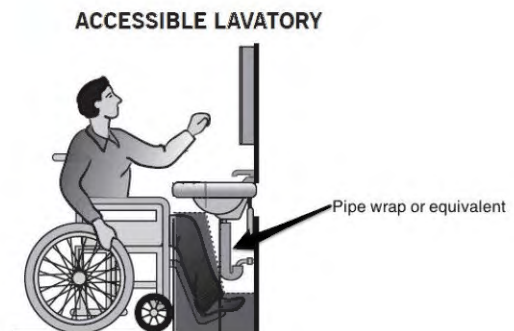
Police Station - Basement Women's Restroom

Finding: 129

11 (Low): Client is a Title II agency, elements are out of compliance but may be able to handled programmatically, or do not need to be handled unless or until they hire a person with a disability.

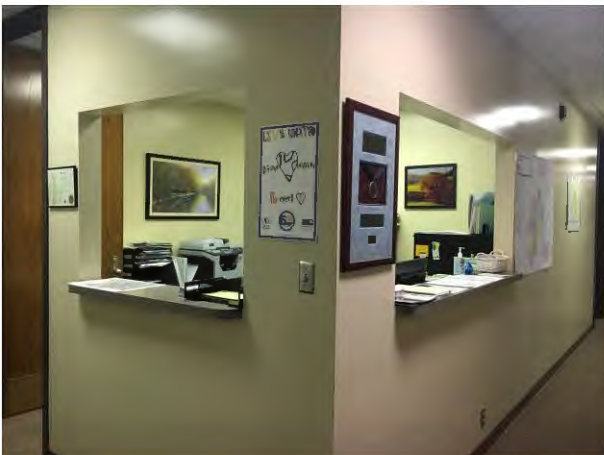
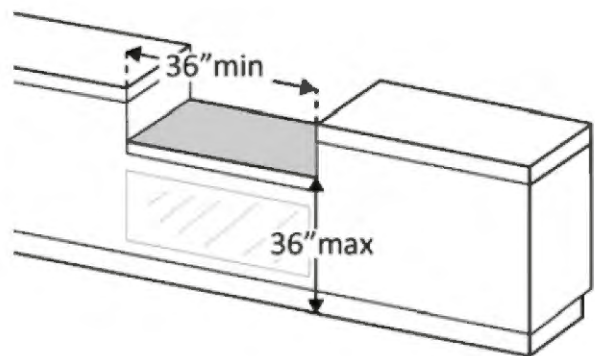
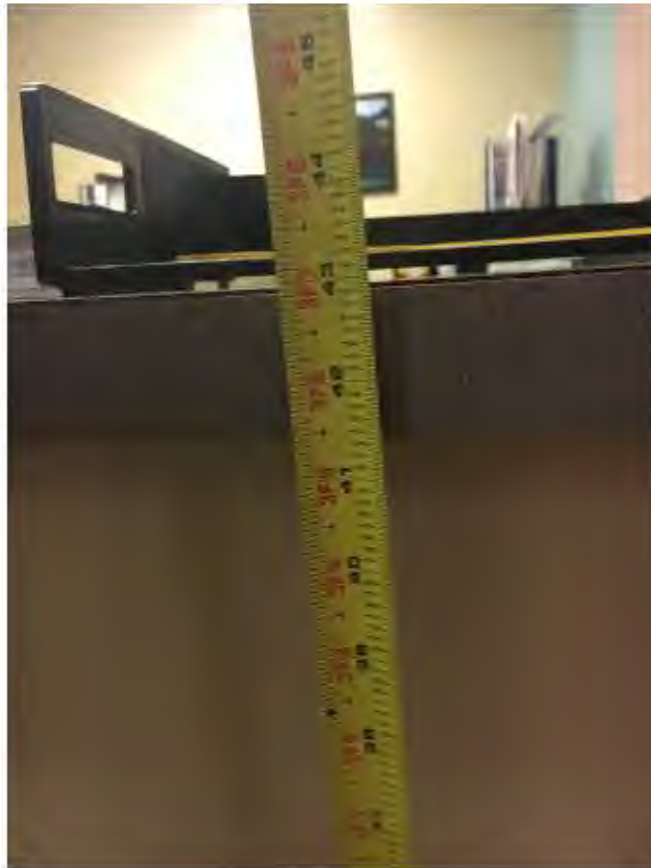
Finding: 3

7 (Medium): Access to goods and services (DOJ level 2) minimally out of compliance. Restrooms (DOJ level 3) – Moderately out of compliance Drinking fountains or public phones (DOJ level 4 & 5) severely out of compliance.

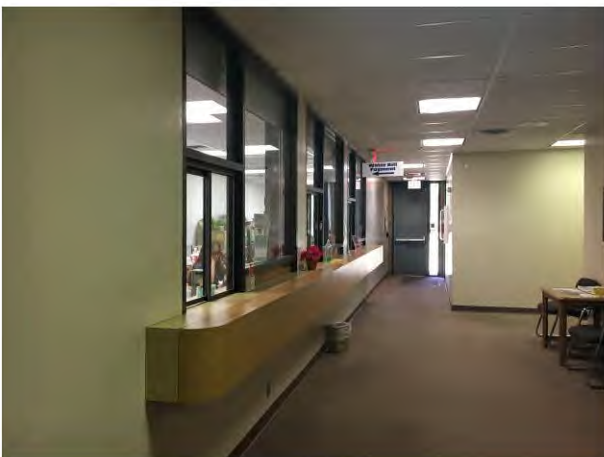
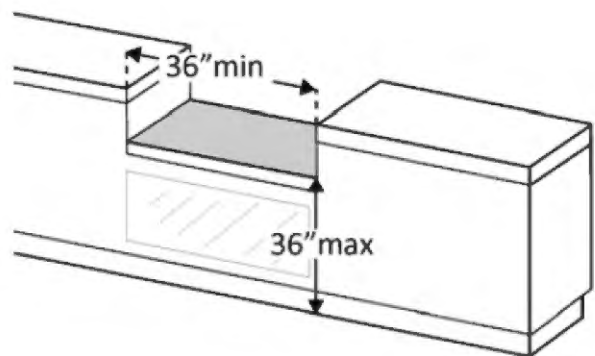
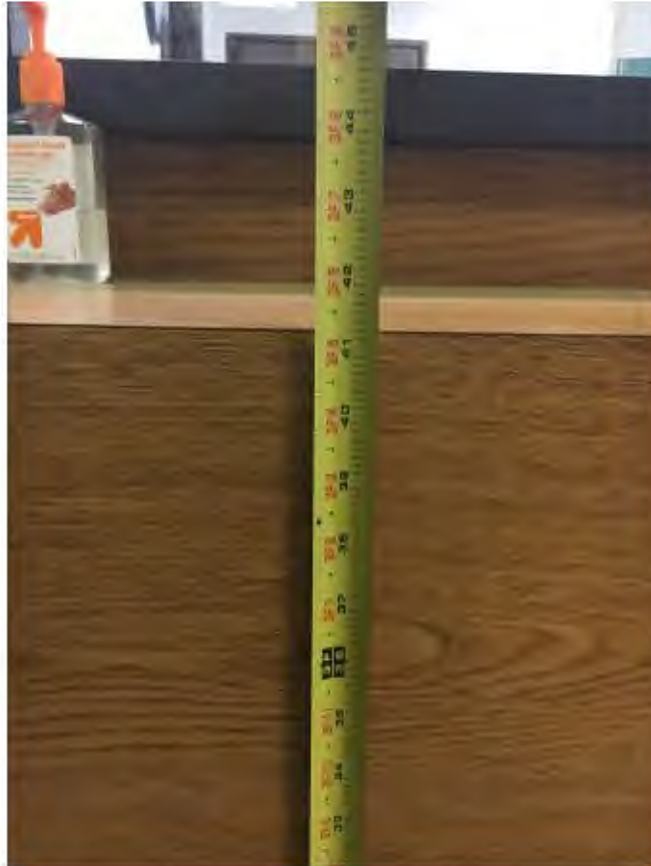
Finding: 4

7 (Medium): Access to goods and services (DOJ level 2) minimally out of compliance. Restrooms (DOJ level 3) – Moderately out of compliance Drinking fountains or public phones (DOJ level 4 & 5) severely out of compliance.

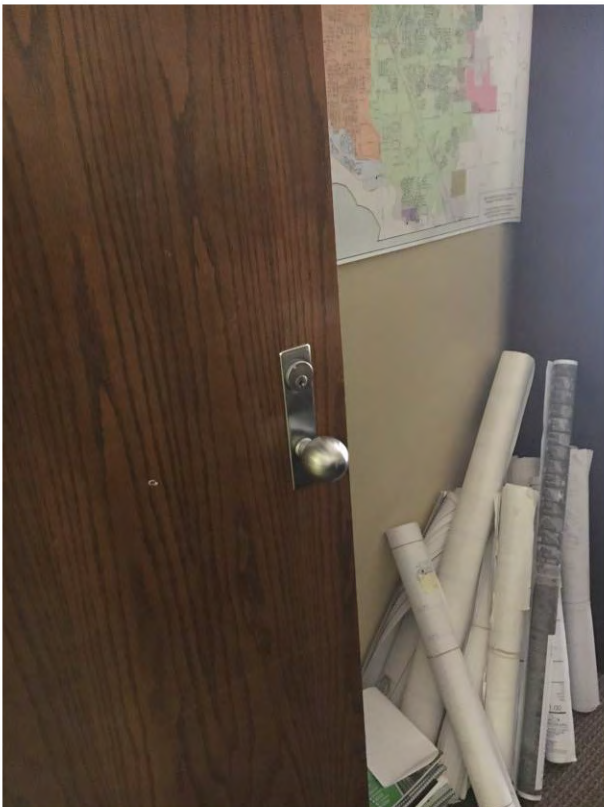
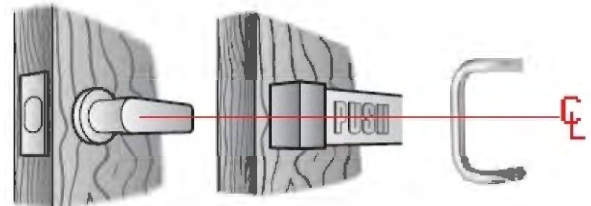
Finding: 5

5 (Medium): Access to goods and services issues (DOJ level 2) - severely out of compliance.

Replace with lever style door hardware.

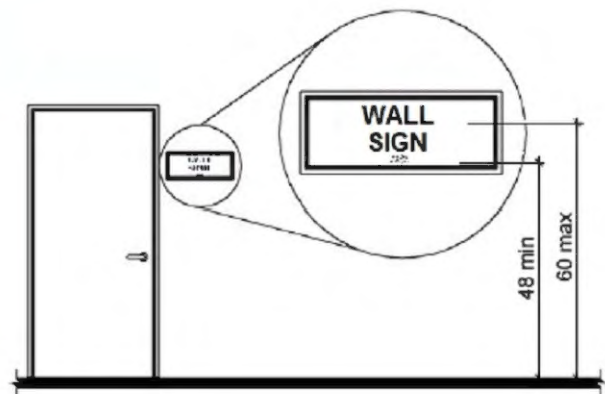
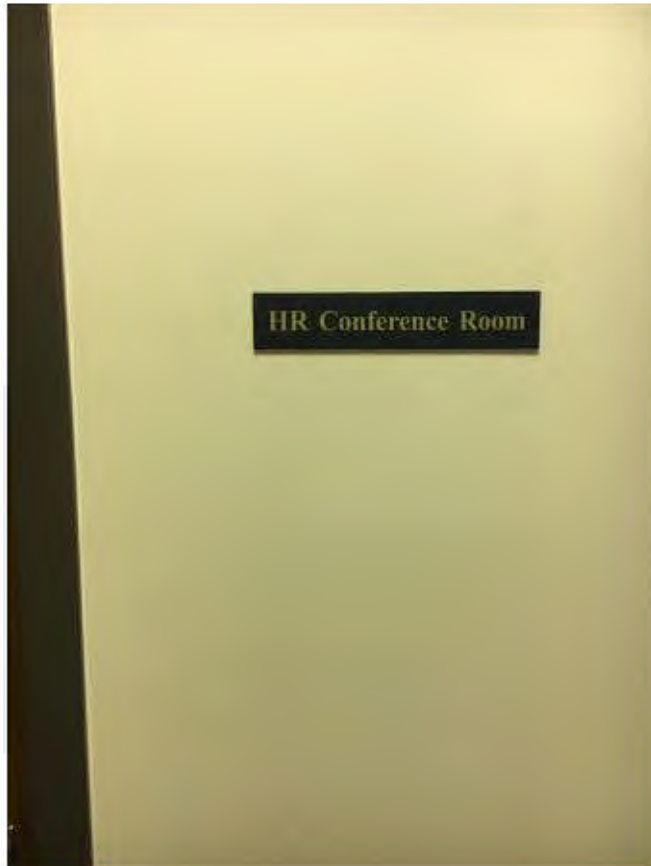
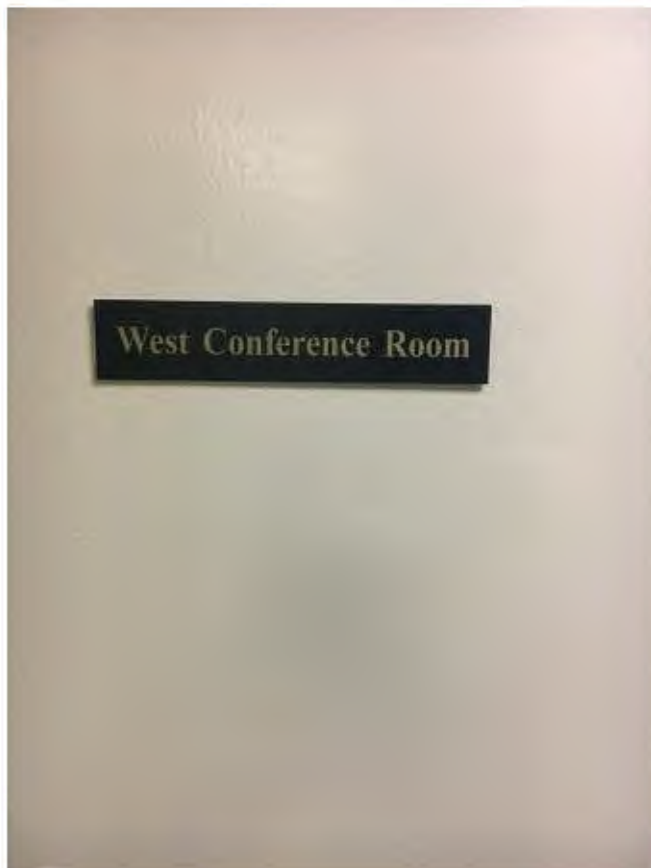
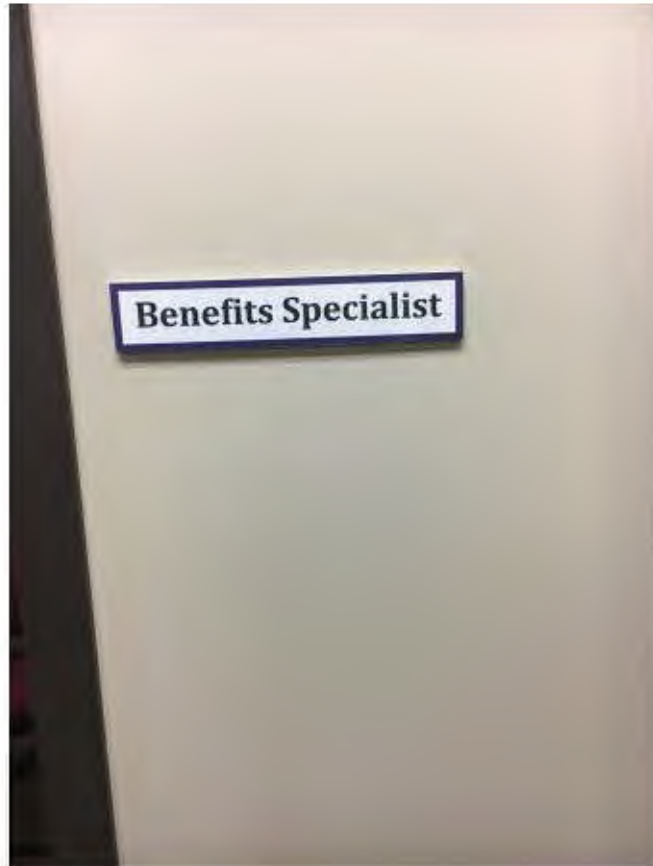
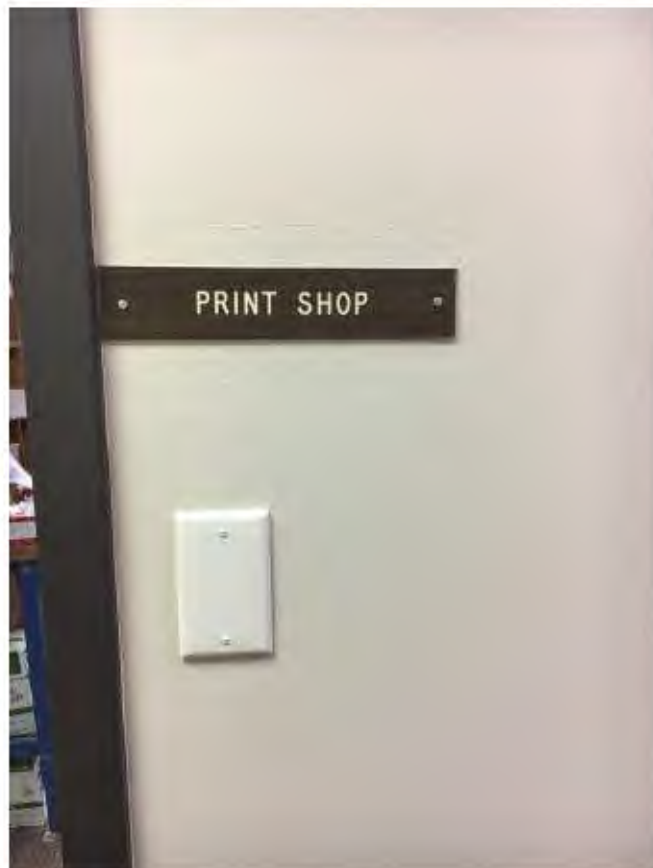
Finding #6 Additional Finding Photos

There are 5 room signs that are missing Braille and tactile characters.

6 (Medium): Access to goods and services (DOJ level 2) moderately out of compliance. Parking or exterior conditions (DOJ's level 1) – minimally out of compliance. Restrooms (DOJ level 3) – severely out of compliance.

Replace with signage that has Braille and tactile characters and mount signage on the latch side of the doors.
