City of Norman
ADA Self-Evaluation and Transition Plan
Building Cost Projection Summary
5/1/2018

Municipal Complex - Building A

Accessibility Evaluation

Inspection Date: 09/20/2017

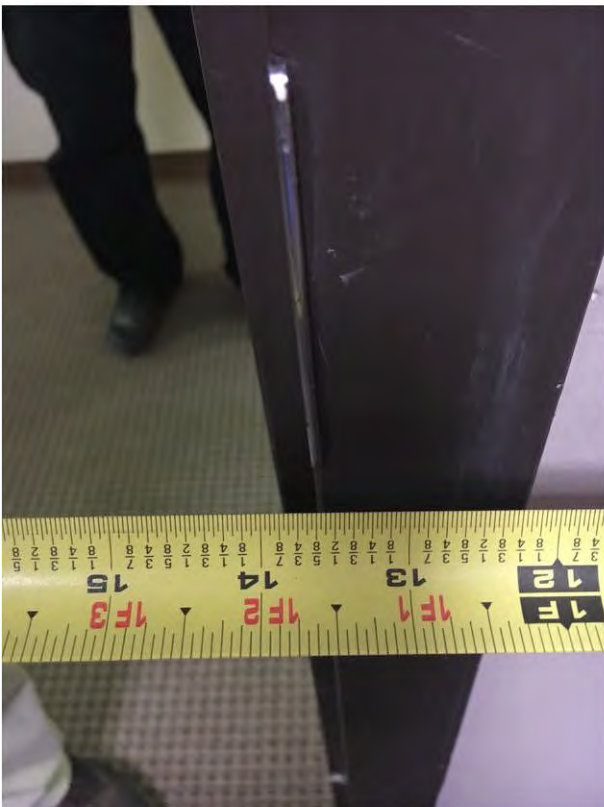
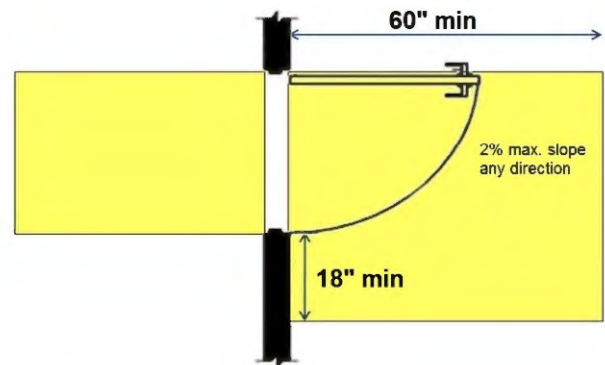
Finding: 7

7 (Medium): Access to goods and services (DOJ level 2) minimally out of compliance. Restrooms (DOJ level 3) – Moderately out of compliance Drinking fountains or public phones (DOJ level 4 & 5) severely out of compliance.

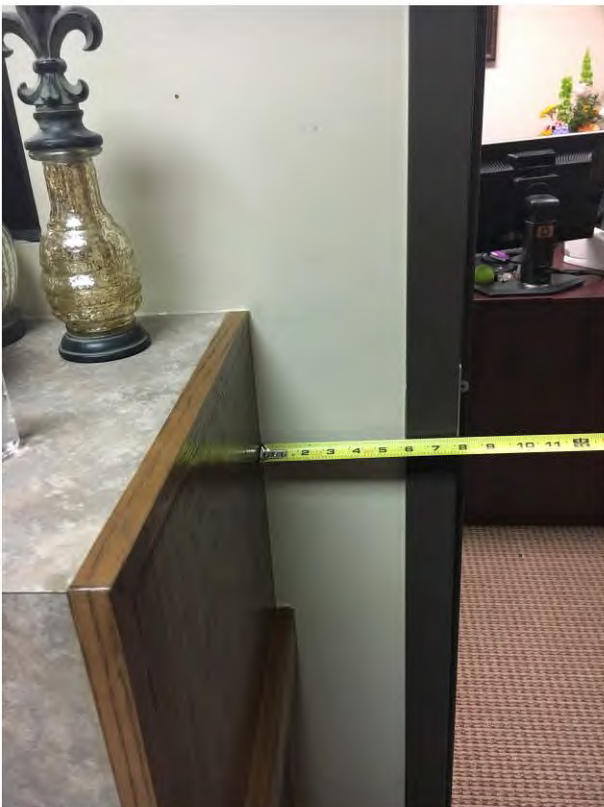
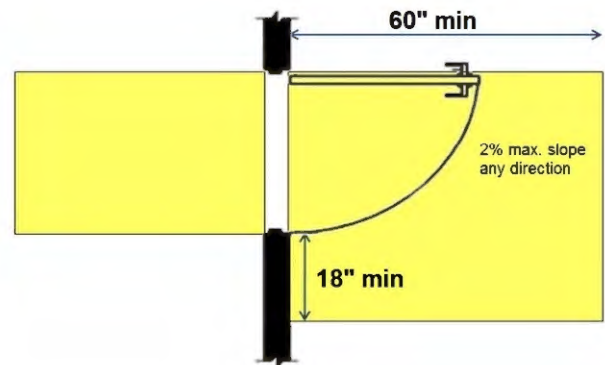
Finding: 8

7 (Medium): Access to goods and services (DOJ level 2) minimally out of compliance. Restrooms (DOJ level 3) – Moderately out of compliance Drinking fountains or public phones (DOJ level 4 & 5) severely out of compliance.

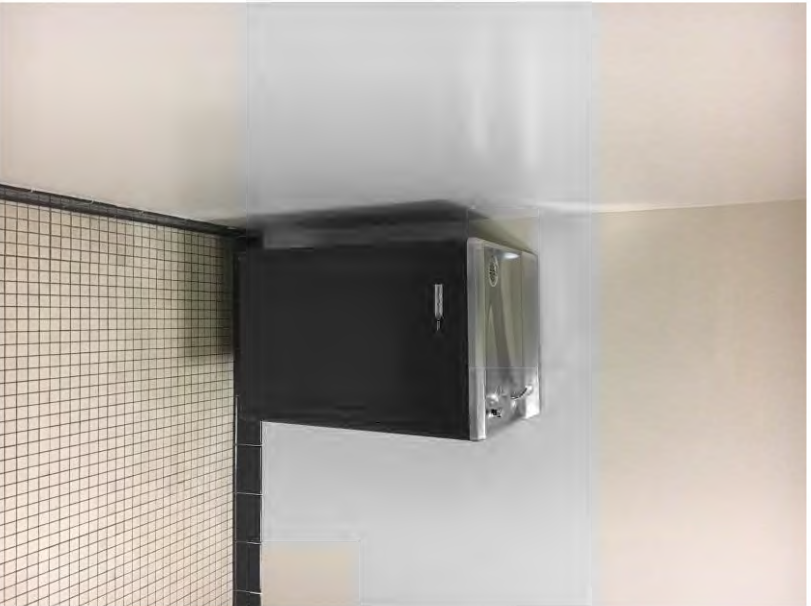
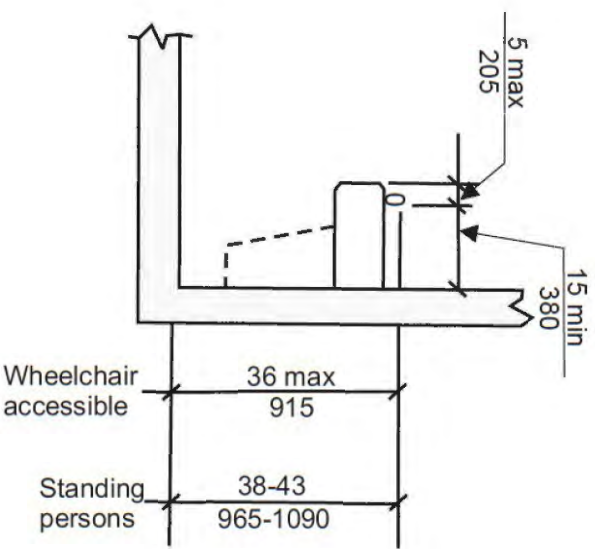
Finding: 9

7 (Medium): Access to goods and services (DOJ level 2) minimally out of compliance. Restrooms (DOJ level 3) – Moderately out of compliance Drinking fountains or public phones (DOJ level 4 & 5) severely out of compliance.

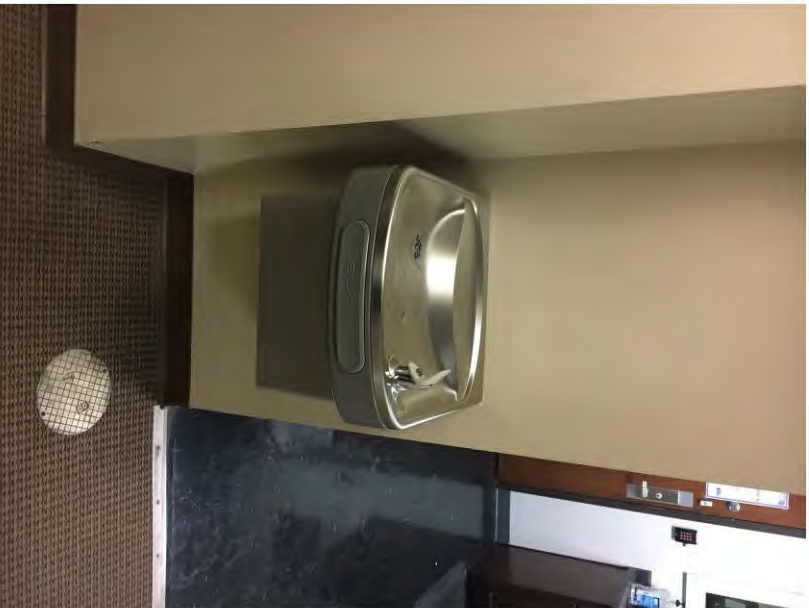
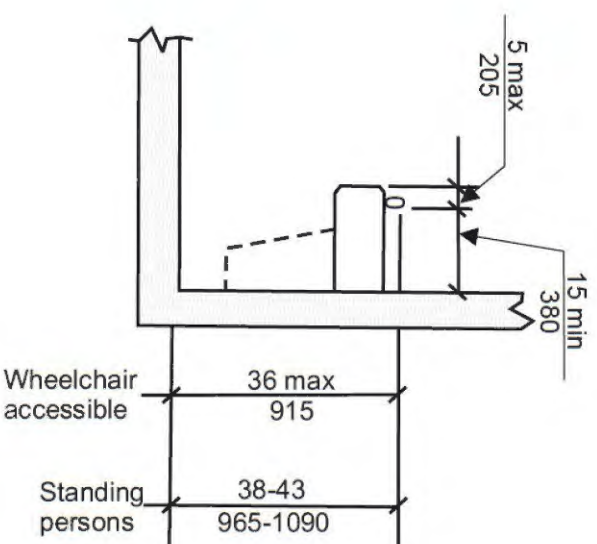
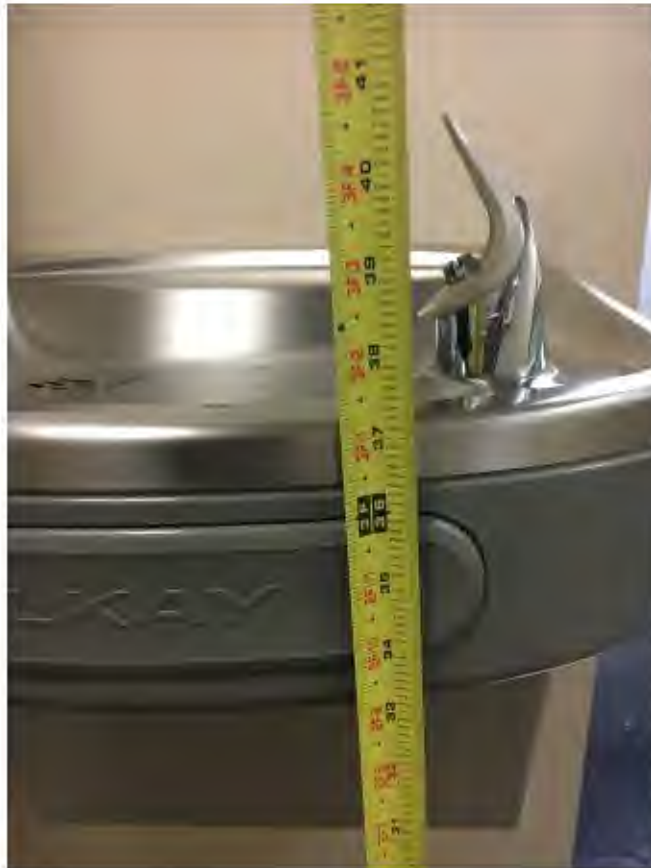
Finding: 10

7 (Medium): Access to goods and services (DOJ level 2) minimally out of compliance. Restrooms (DOJ level 3) – Moderately out of compliance Drinking fountains or public phones (DOJ level 4 & 5) severely out of compliance.

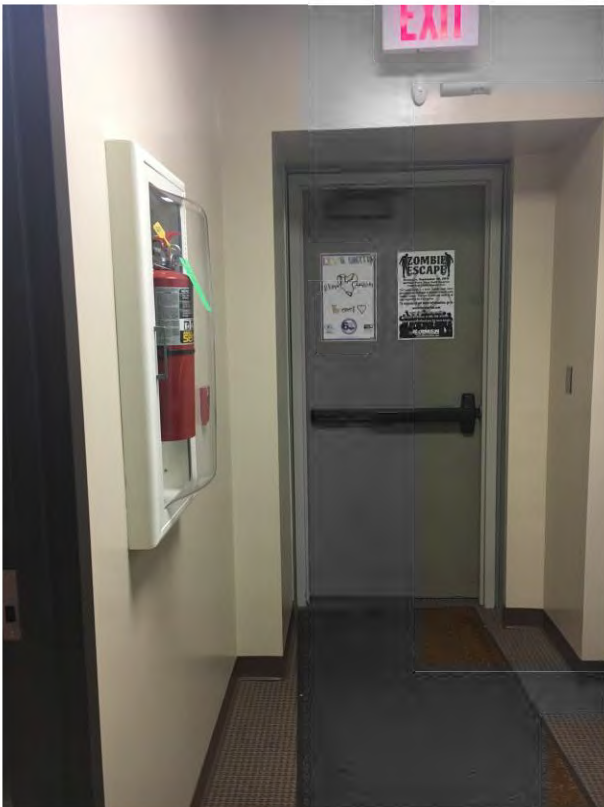
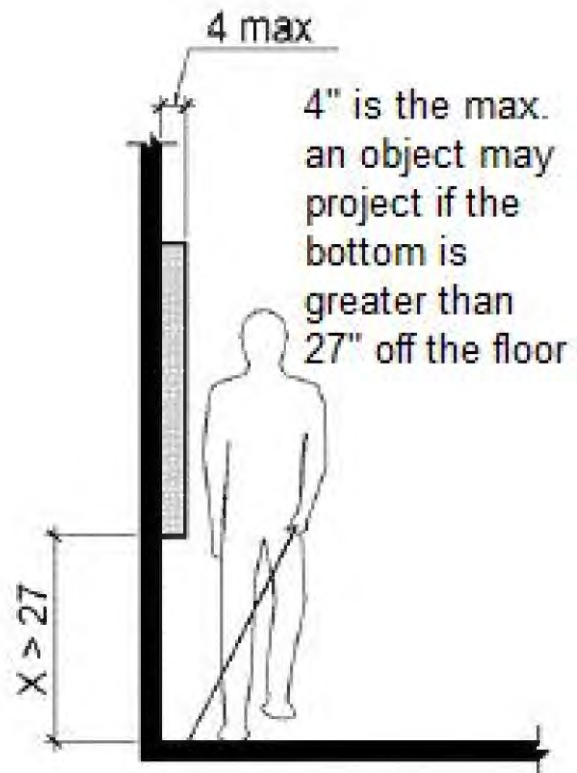
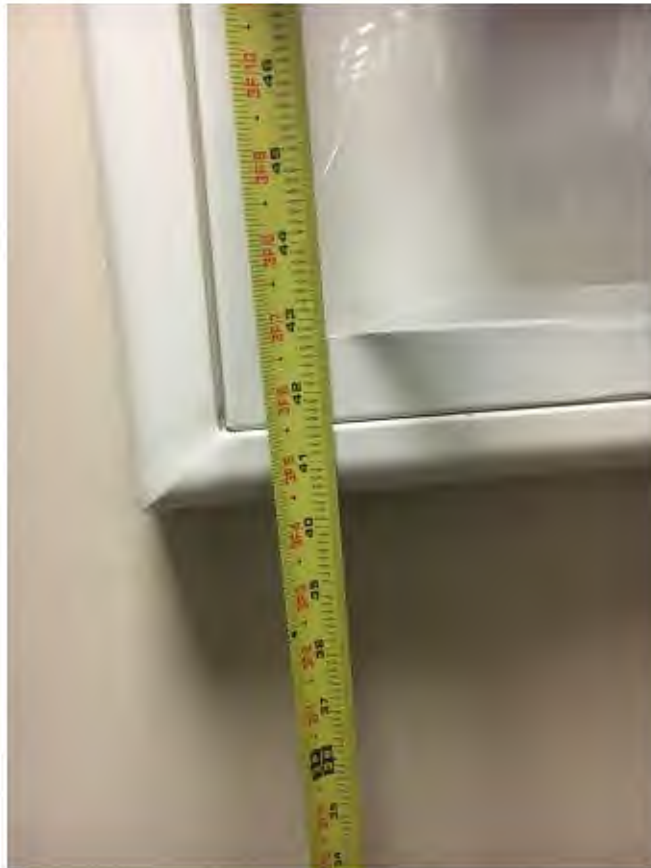
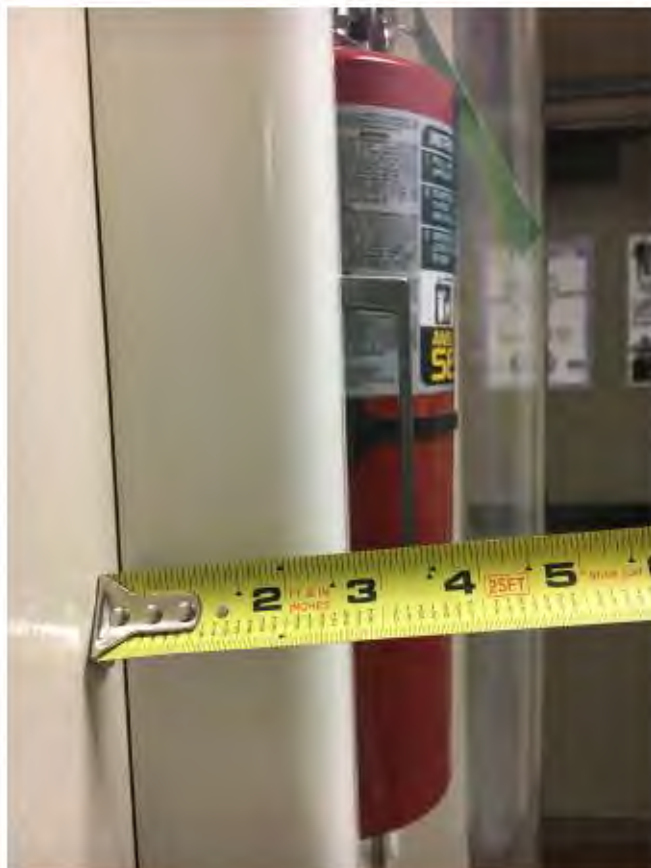
Finding: 11

11 (Low): Client is a Title II agency, elements are out of compliance but may be able to handled programmatically, or do not need to be handled unless or until they hire a person with a disability.

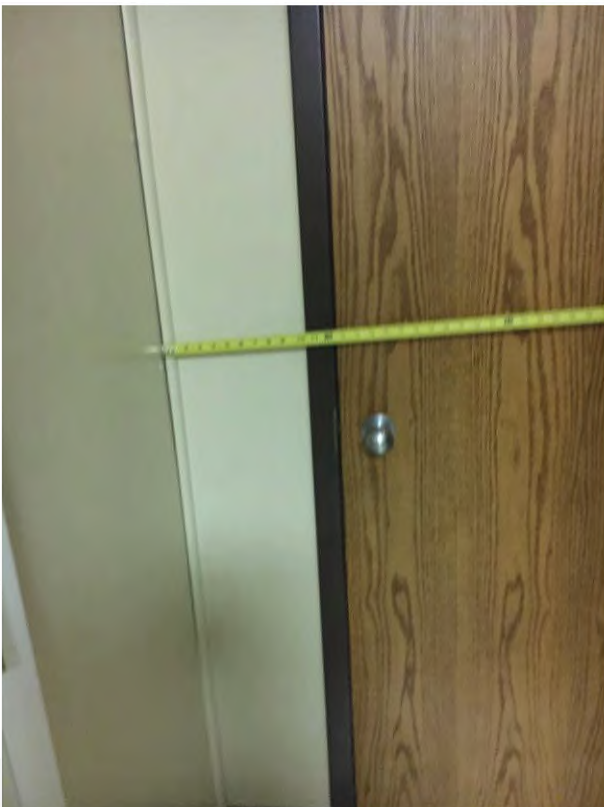
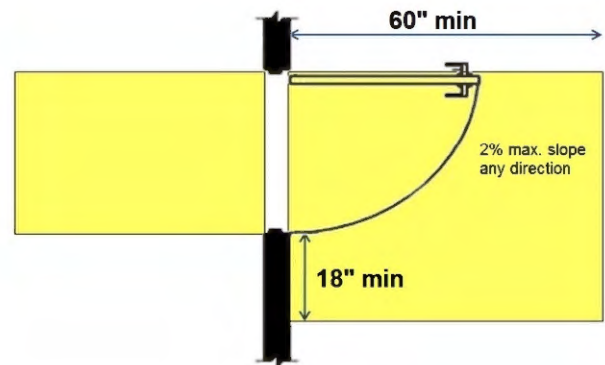
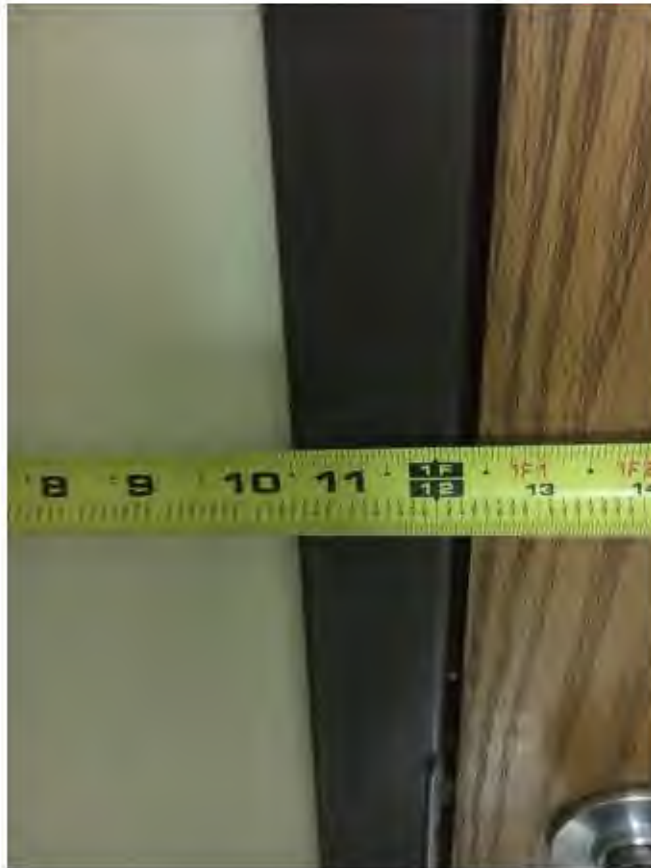
Finding: 12

6 (Medium): Access to goods and services (DOJ level 2) moderately out of compliance. Parking or exterior conditions (DOJ's level 1) – minimally out of compliance. Restrooms (DOJ level 3) – severely out of compliance.

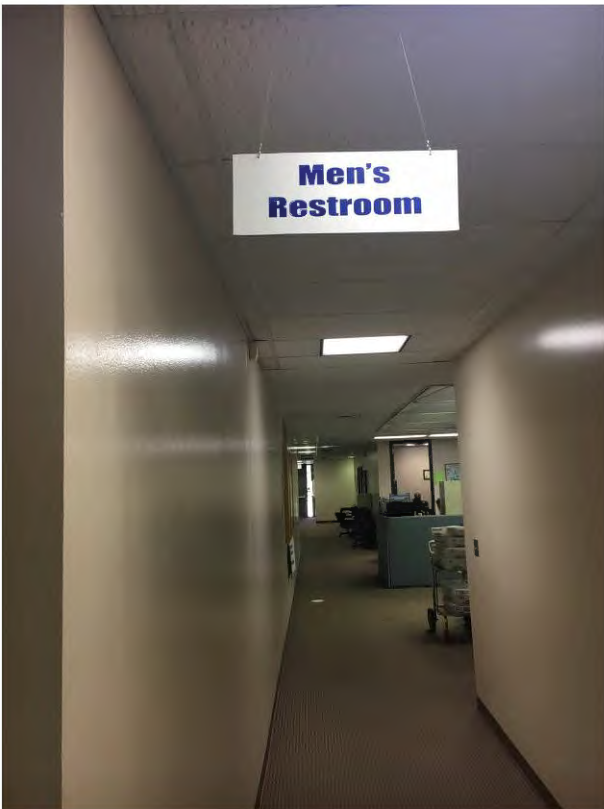
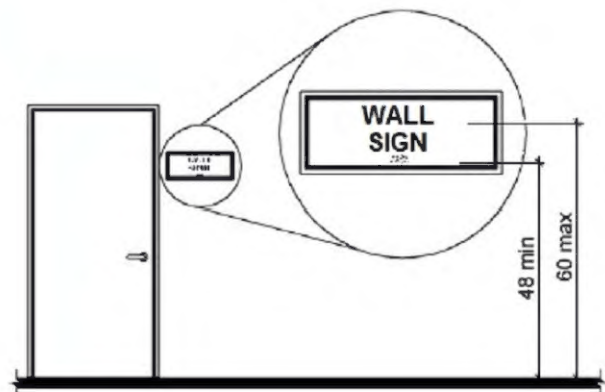
Finding: 13

6 (Medium): Access to goods and services (DOJ level 2) moderately out of compliance. Parking or exterior conditions (DOJ's level 1) – minimally out of compliance. Restrooms (DOJ level 3) – severely out of compliance.

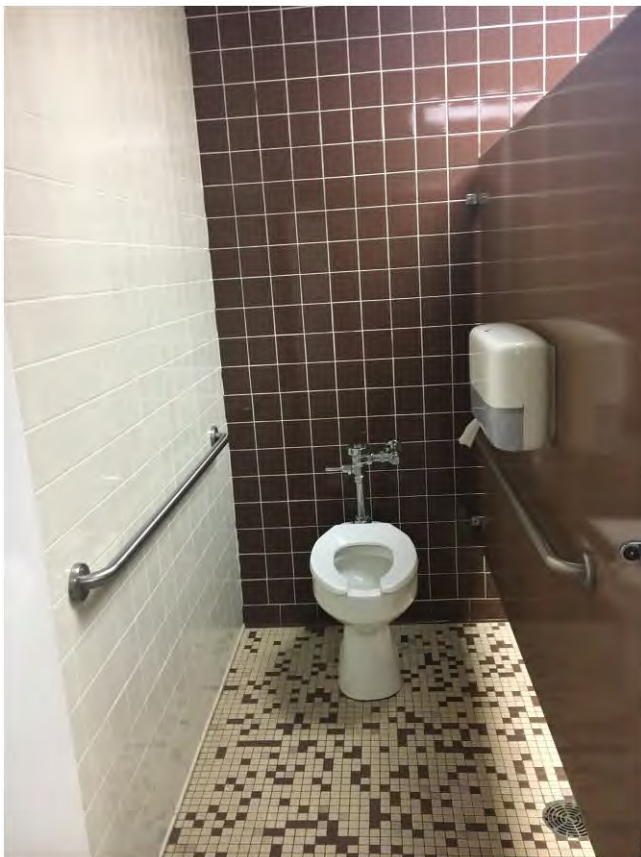
Finding: 14

6 (Medium): Access to goods and services (DOJ level 2) moderately out of compliance. Parking or exterior conditions (DOJ's level 1) – minimally out of compliance. Restrooms (DOJ level 3) – severely out of compliance.

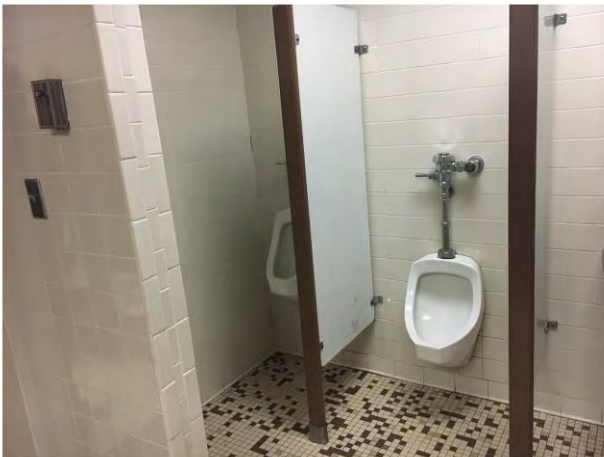
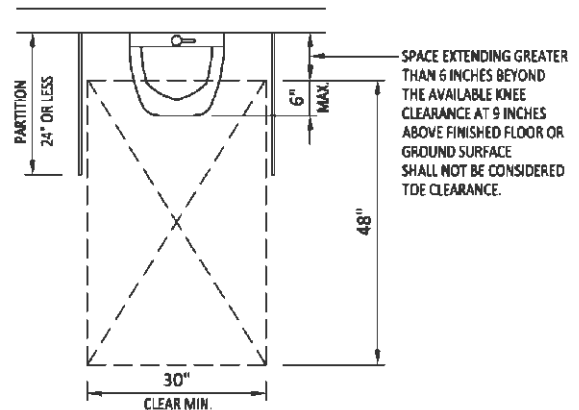
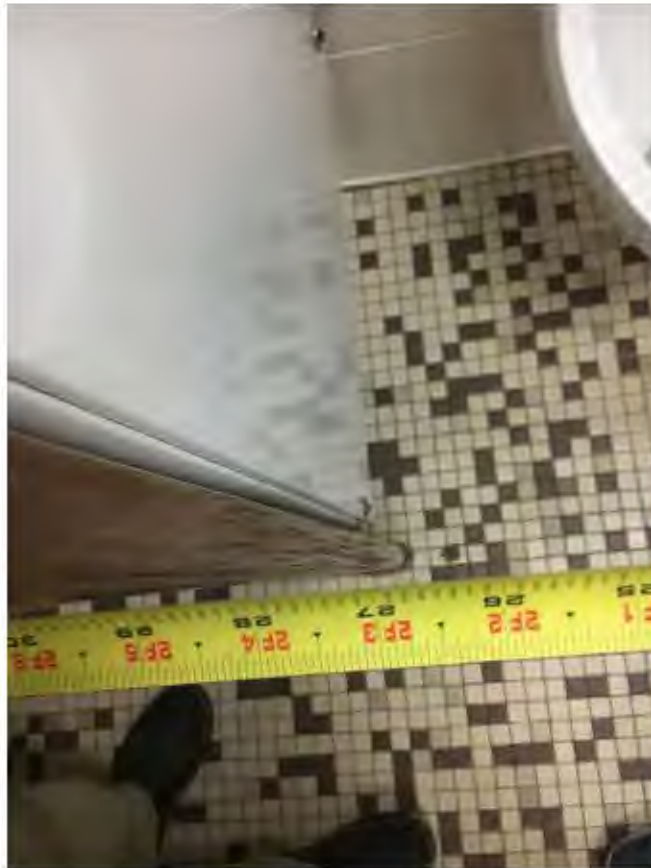
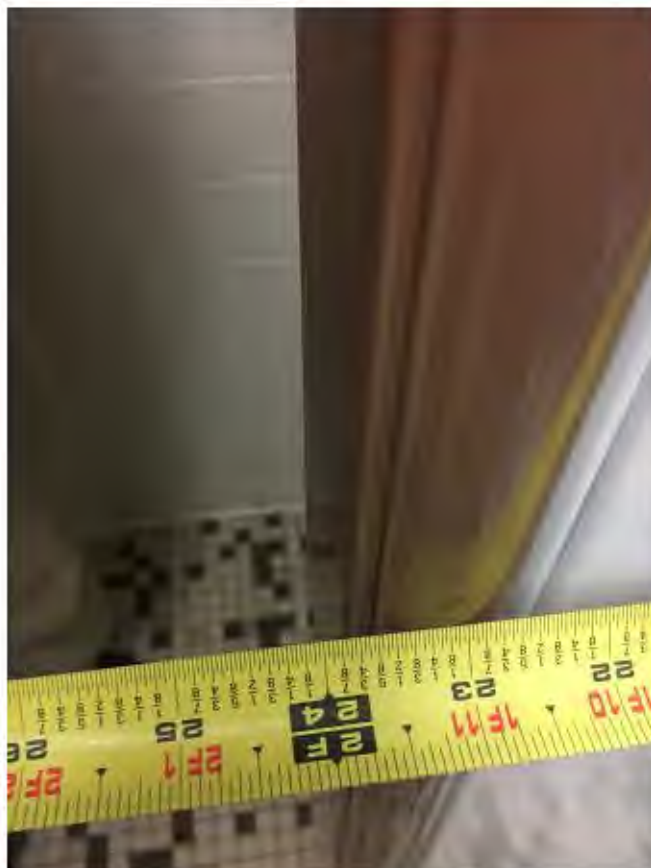
Finding: 15

9 (Low): Restrooms (DOJ level 3) – minimally out of compliance.

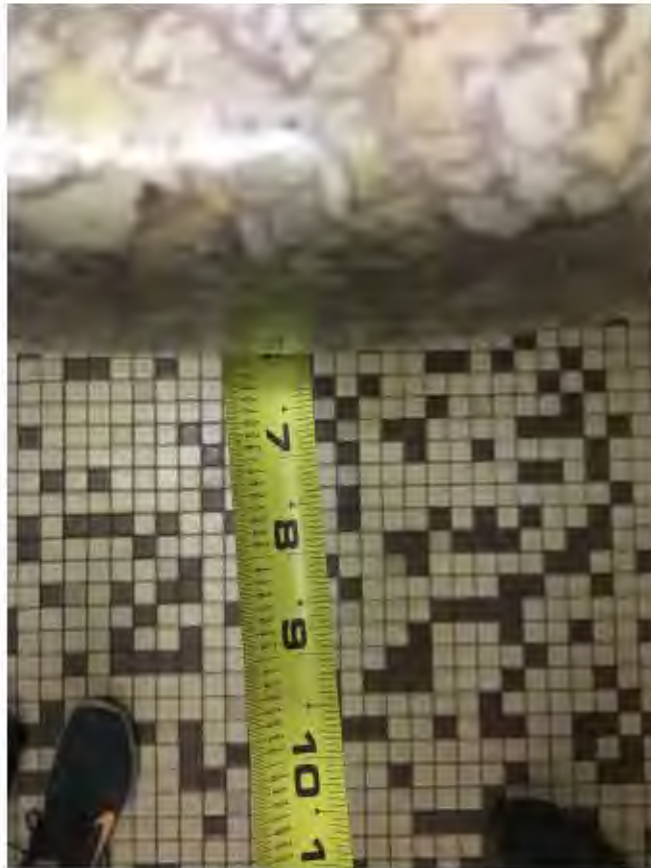
Finding: 17

9 (Low): Restrooms (DOJ level 3) – minimally out of compliance.

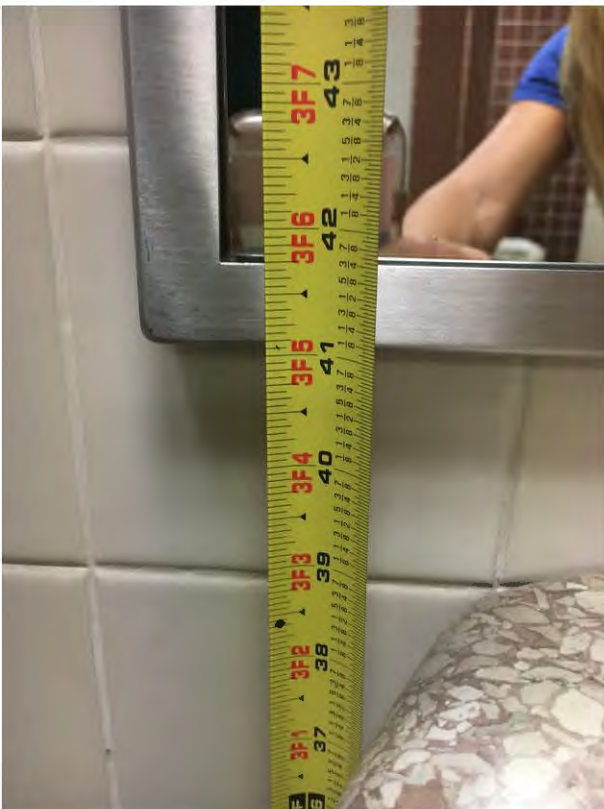
Finding: 18

6 (Medium): Access to goods and services (DOJ level 2) moderately out of compliance. Parking or exterior conditions (DOJ's level 1) – minimally out of compliance. Restrooms (DOJ level 3) – severely out of compliance.

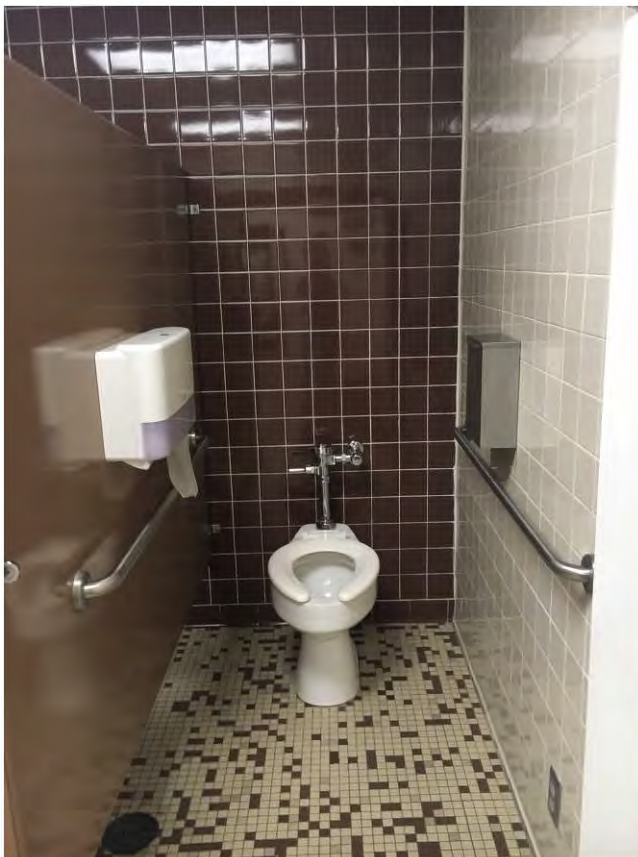
Finding: 19

6 (Medium): Access to goods and services (DOJ level 2) moderately out of compliance. Parking or exterior conditions (DOJ's level 1) – minimally out of compliance. Restrooms (DOJ level 3) – severely out of compliance.

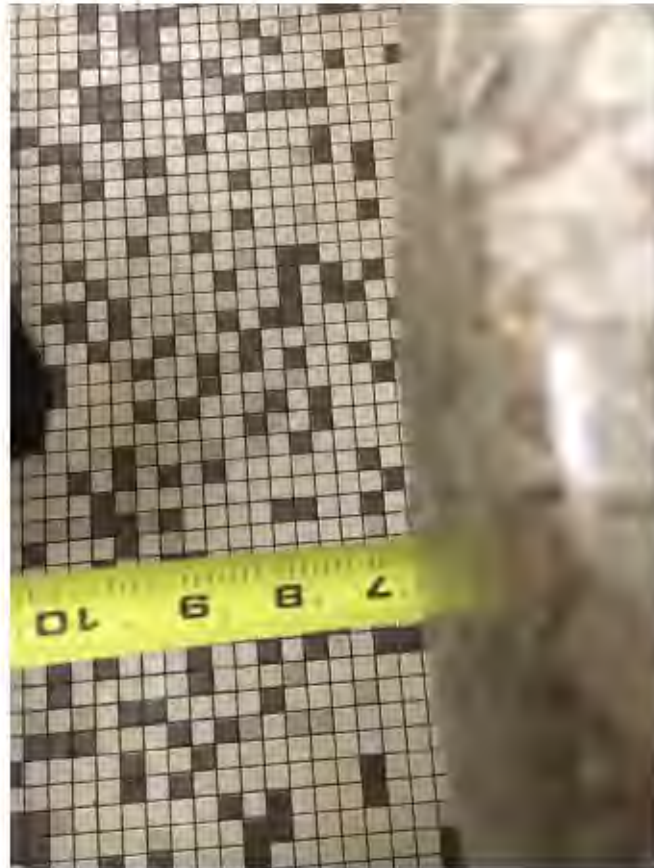
Finding: 20

9 (Low): Restrooms (DOJ level 3) – minimally out of compliance.

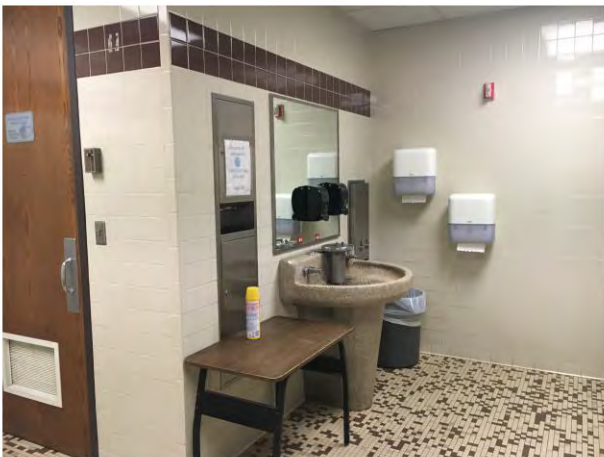
Finding: 21

9 (Low): Restrooms (DOJ level 3) – minimally out of compliance.

Replace with a dispenser that has controls that do not require grasping and twisting to operate.

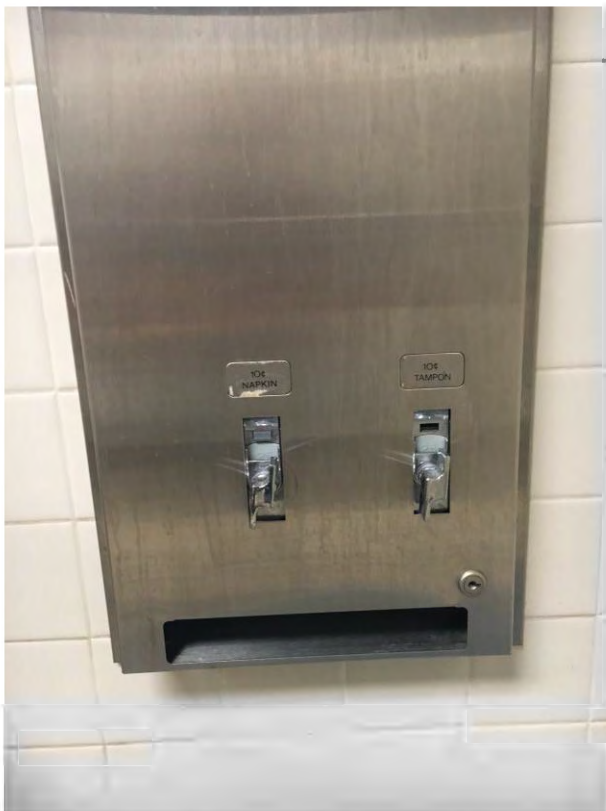
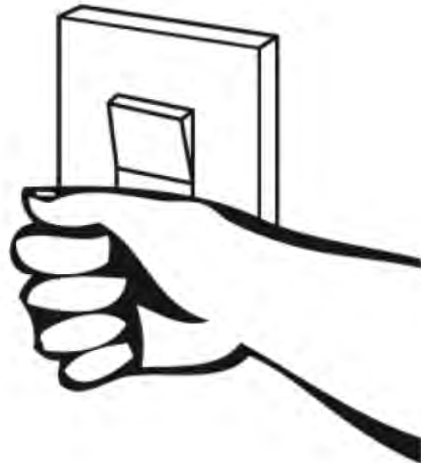
Finding: 22

7 (Medium): Access to goods and services (DOJ level 2) minimally out of compliance. Restrooms (DOJ level 3) – Moderately out of compliance Drinking fountains or public phones (DOJ level 4 & 5) severely out of compliance.

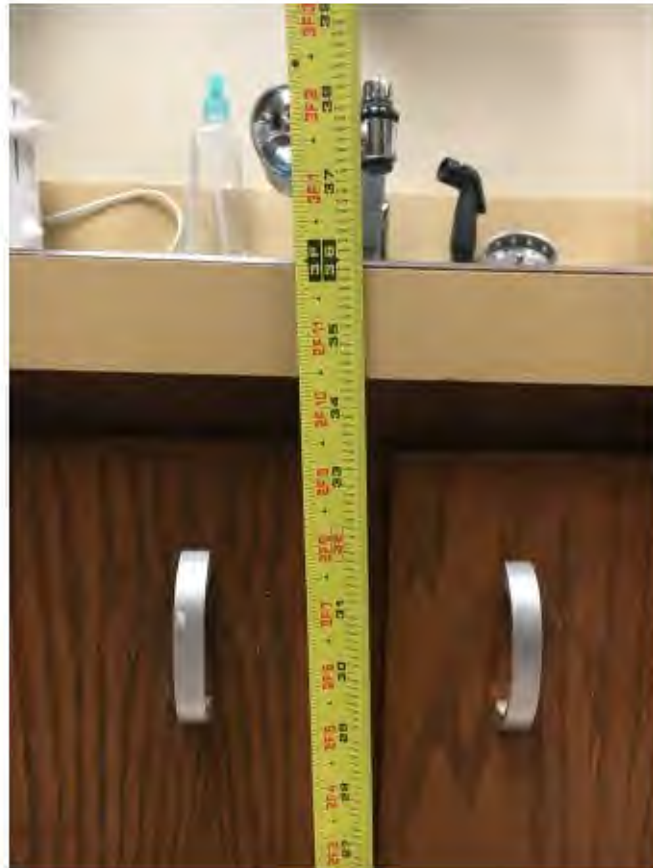
Finding: 23

7 (Medium): Access to goods and services (DOJ level 2) minimally out of compliance. Restrooms (DOJ level 3) – Moderately out of compliance Drinking fountains or public phones (DOJ level 4 & 5) severely out of compliance.

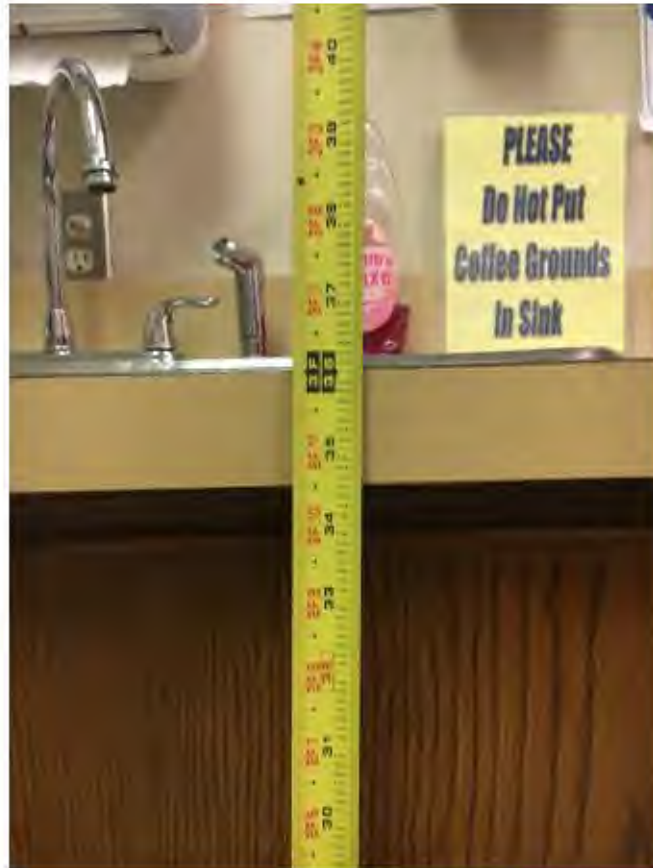
Finding: 24

11 (Low): Client is a Title II agency, elements are out of compliance but may be able to handled programmatically, or do not need to be handled unless or until they hire a person with a disability.
