City of Norman ADA Self-Evaluation and Transition Plan Park Cost Projection Summary 5/1/2018

Site Accessibility Evaluation

201 W Daws St Norman, OK 73069

Accessibility Evaluation

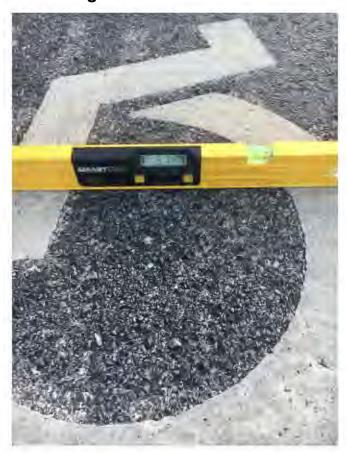
Finding #1 Additional Finding Photos

The running slope of the right accessible parking stall is between 3.0% and 5.7%.

Modify paving to achieve slopes no greater than 2% in all directions.

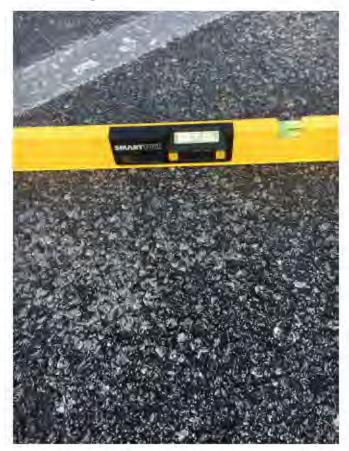
Finding #2 Additional Finding Photos

The running slope of the access aisle (long dimension) exceeds 2%.

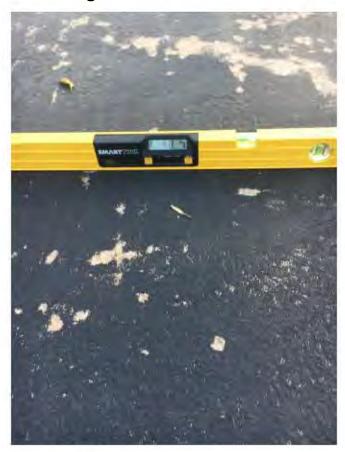
Finding #3 Additional Finding Photos

The running slope on the left parking space facing Daws has a running slope of 4.8%. Additionally, the pavement is cracked and broken.

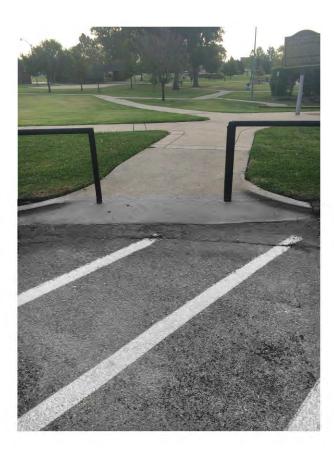
Finding #10 Additional Finding Photos

The path leading from the accessible parking to the sidewalk has cracked, uneven pavement.

Remove and replace concrete to achieve a smooth transition.

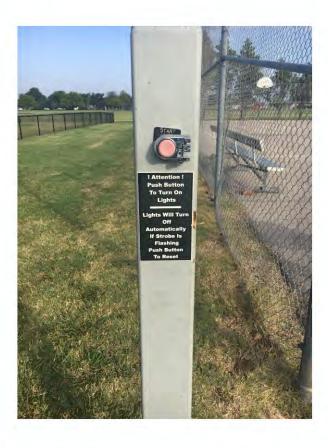
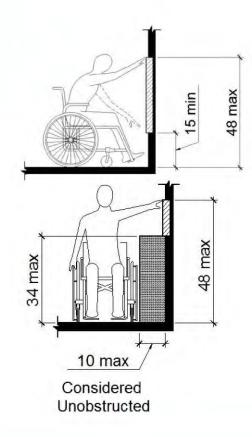
Finding: 31

The light control panel at the basketball court is mounted with the highest operable part at 53" above the ground where a maximum of 48" is required.

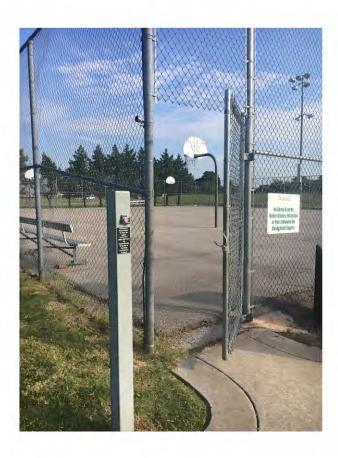
The left entrance into the basketball courts has broken, uneven pavement with a change in level of 1-5/8".

Modify the paving at the entrance to provide a smooth surface.

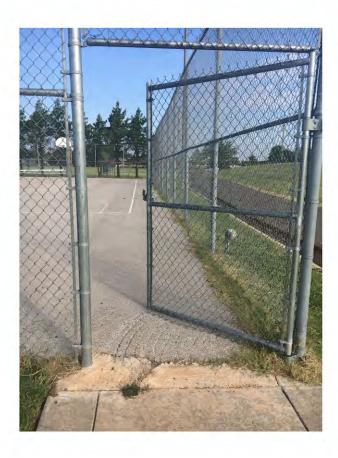
The right entrance into the basketball courts has broken, uneven pavement with a 12.7% slope.

Modify the paving at the entrance to provide a smooth surface with slopes no greater than 2% in all directions.

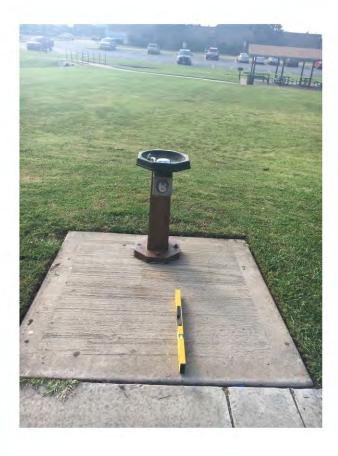
Finding: 36

The 30" x 48" minimum clear floor space required at the drinking fountain has a 3.9% slope.

Remove and replace paving to achieve slopes no greater than 2% in all directions.

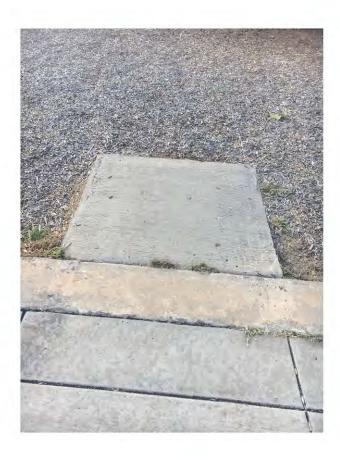
Finding: 38

The concrete pad leading onto the playground has cross slopes from 10.3% to 13.9%.

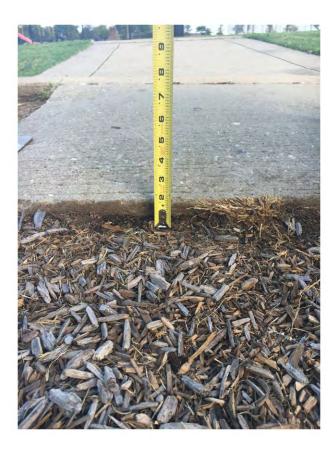
Finding: 39

There is a 1-3/8" drop off from the walkway onto the playground.

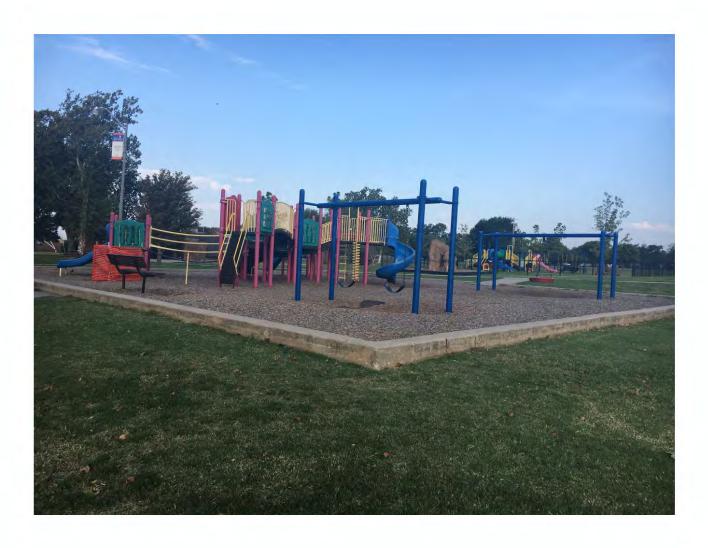
Finding: 40

The park surface consists of woodchips which is not stable.

Replace playground surface throughout the play area.

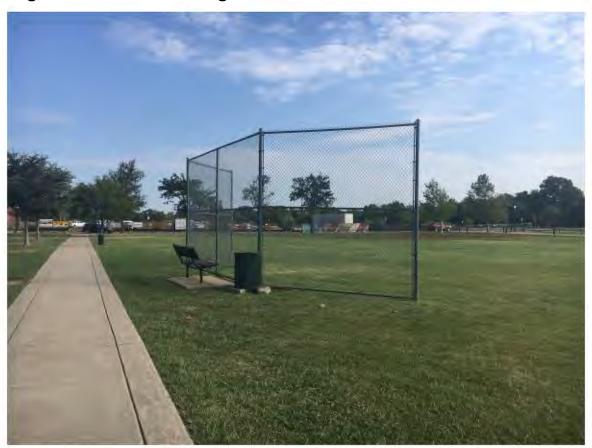
Finding #45 Additional Finding Photos

There is no accessible route to the spectator benches provided at the baseball backstops.

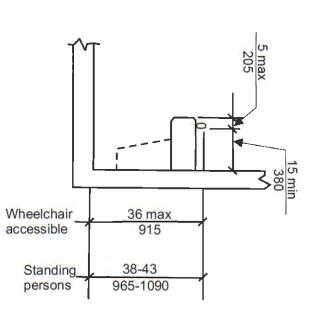
Finding: 19

clearance or clear floor space. Additionally, there is not one provided for a standing person. The drinking fountain provided by the small children's play ground does not have the required knee

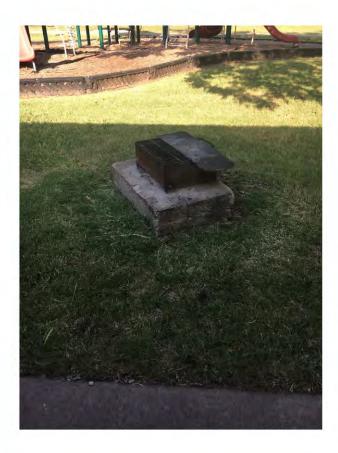
Finding: 20

There is no accessible route to the grills provided at the park.

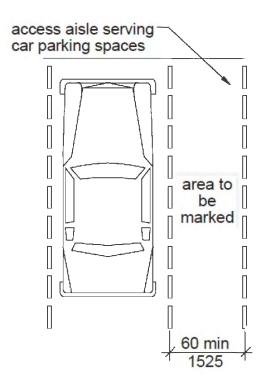
Finding: 8

The access aisle is missing at the accessible parking stall.

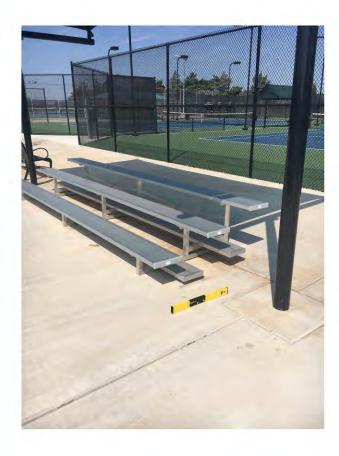
Finding: 12

The companion seating area next to the spectator bleachers has slopes from 4.1% to 4.8%.

Modify paving to ensure a level area with slopes no greater than 2%. Cost is included in Finding #10.

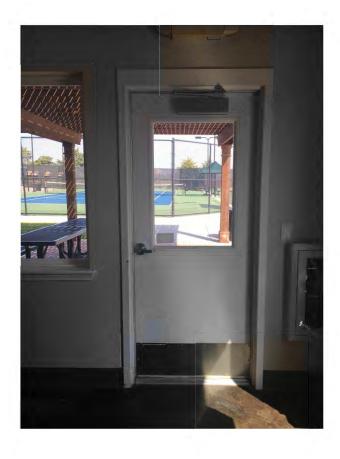
Finding: 21

The threshold at the back door that leads to the tennis courts is 3/4" high.

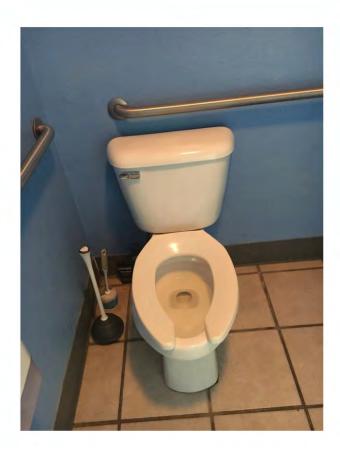
Finding: 25

The flush handle is located on the wrong side of the toilet.

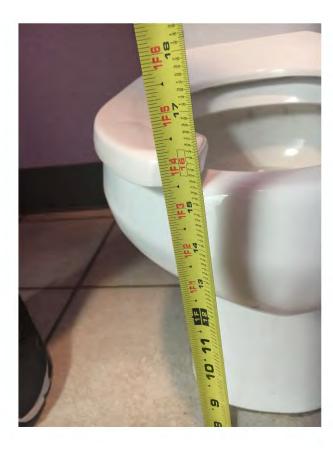
Finding: 30

The toilet seat is at 16" to the top of the seat.

Replace toilet seat with a taller seat to achieve 17"-19" height.

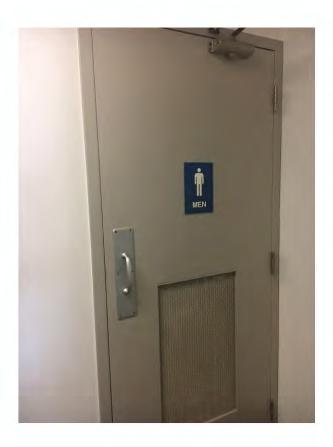
Finding: 42

Signage is mounted on door and does not have Braille or tactile characters.

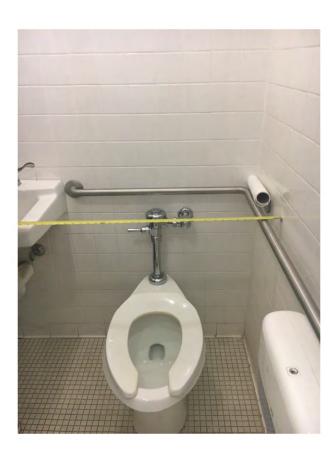
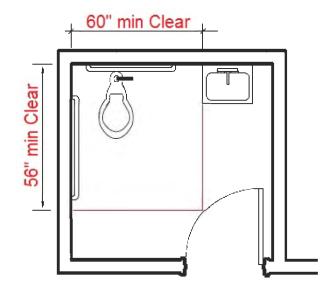
Finding: 50

The rear grab bar does not extend 12" minimum to the centerline of the water closet and is only 32" long.

6 (Medium): Access to goods and services (DOJ level 2) moderately out of compliance. Parking or exterior conditions (DOJ's level 1) – minimally out of compliance. Restrooms (DOJ level 3) – severely out of compliance.

Replace rear grab bar with one that is a minimum of 36" long.

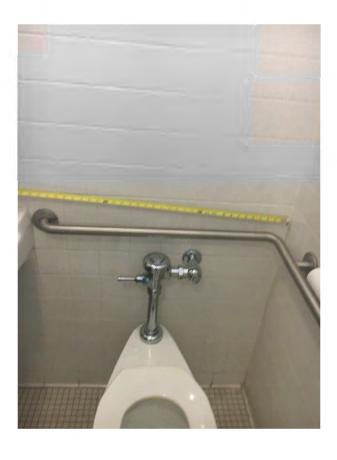
Finding: 51

9 (Low): Restrooms (DOJ level 3) - minimally out of compliance.

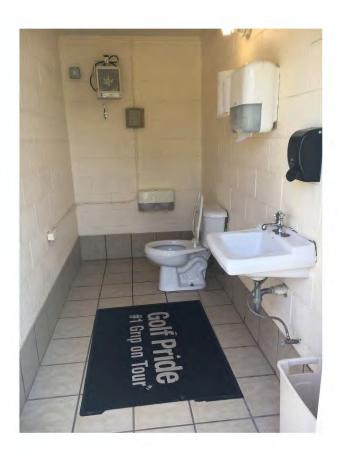
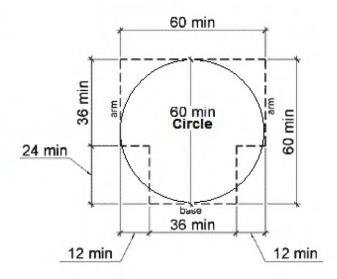
Finding: 57

The centerline of the toilet is 37" from the sidewall.

Relocate water closet so the centerline is 16"-18" from the side wall.

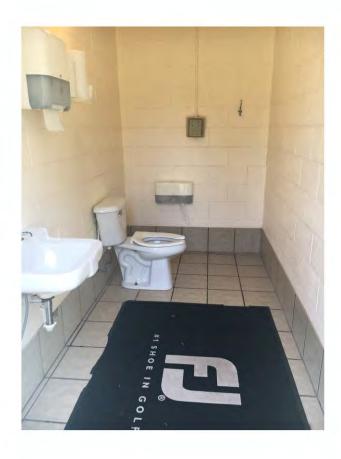
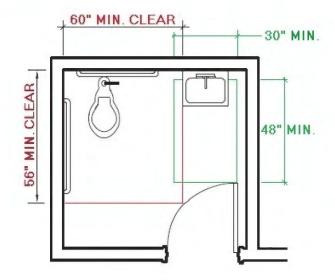
Finding: 65

The toilet is 37-1/2" to the centerline from the side wall.

Relocate water closet so the centerline is 16"-18" from the side wall.

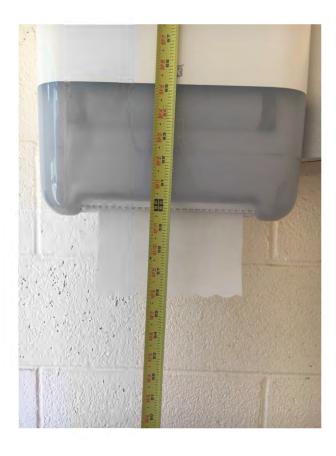
Finding: 69

9 (Low): Restrooms (DOJ level 3) - minimally out of compliance.

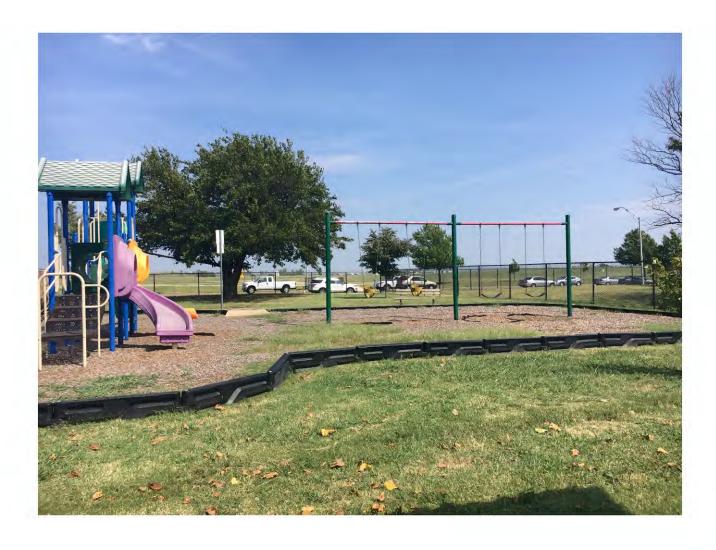
Finding: 73

There is no accessible route to the bench at the playground.

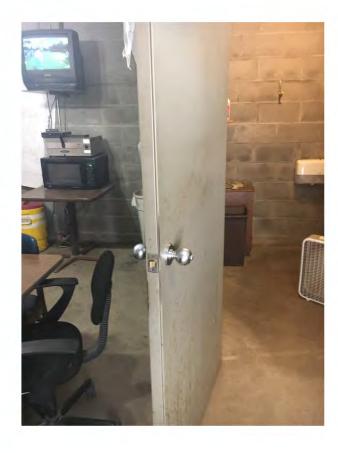
Lever Panic Bar Loop Handle

Replace with lever style door hardware.

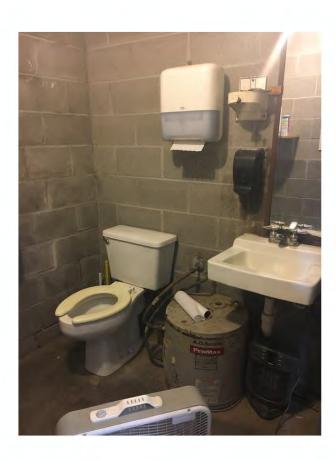
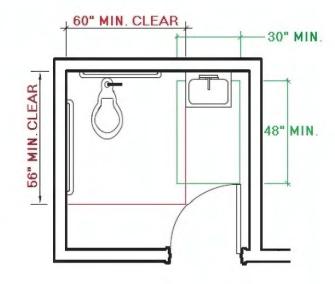
The restroom does not have the required minimum clear floor space or maneuvering clearances for the water closet. The restroom does not have the required minimum clear floor space or maneuvering clearances for the lavatory. Grab bars are missing. Flush control is on the closed side. Paper towel dispenser is too high and does not have required clear floor space.

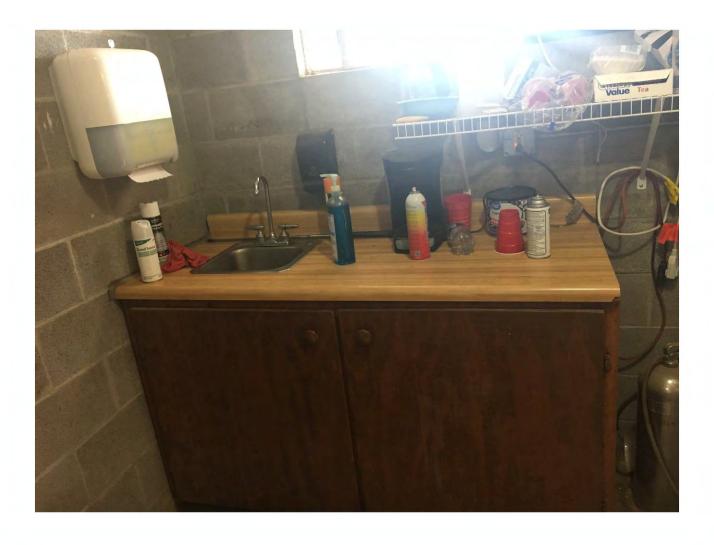
Finding: 80

The top of the sink in the maintenance break room is too high at 36-3/4".
